CITY FACILITIES STUDY

ALTERNATIVE ANALYSIS appendices

EXISTING FACILITIES ASSESSMENT

City of Tualatin
Community Services Building
Facility Condition Assessment

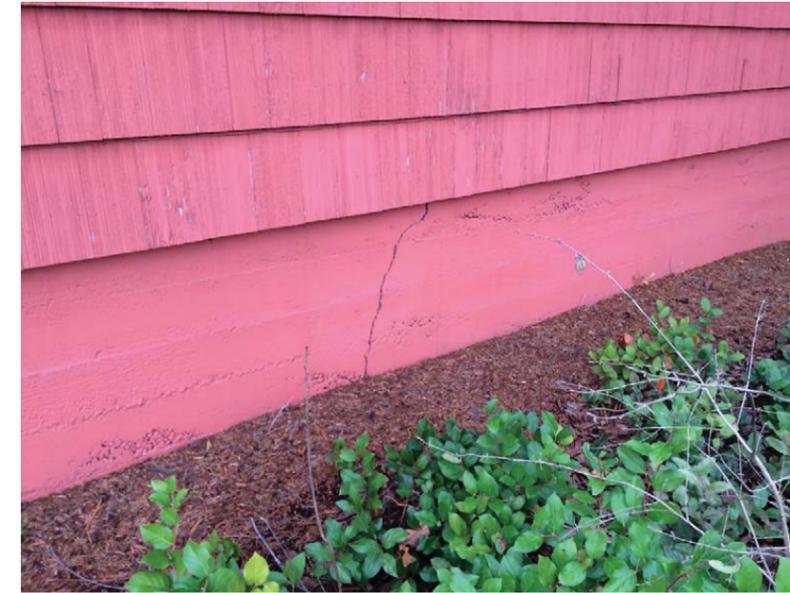
A10 – FOUNDATIONS (foundations, slab-on-grade, etc.)		
Item		Comments/Findings
A10.1	General condition	<ul style="list-style-type: none"> CIP concrete foundation walls appeared to be in good shape Some minor cracking was observed above grade at the south and west sides; refer to Figure A10.1; there was no apparent water intrusion observed in the basement at these same locations
Recommendations		
A10.1.1	Monitor basement walls for additional cracking, water intrusion, or other signs of settlement

Figure A10.1 Minor cracking observed at basement walls (this location at south side)

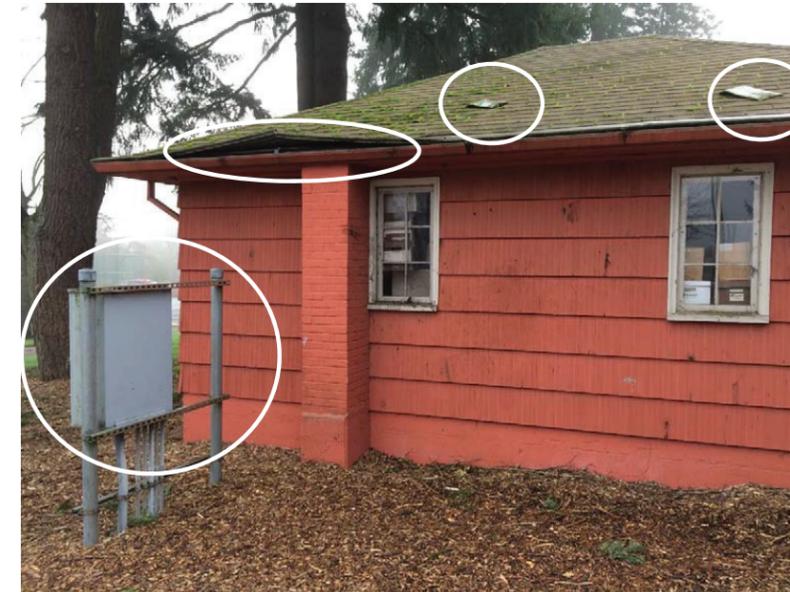
B30 – EXTERIOR HORIZONTAL ENCLOSURES (roofing, horizontal openings, etc.)		
Item		Comments/Findings
B30.1	Type and condition of roofing system	<ul style="list-style-type: none"> Roofing is three-tab asphalt shingles, which may be near the end of its life-span (10-15 years) It was observed that moss has grown on the east side. Refer to Figure B30.1
B30.2	Other issues	<ul style="list-style-type: none"> Flashings, vents, etc. all appear in acceptable condition Access to the roof was not available; observations were made from the ground level The roof at the Garage north of the building appeared to have been recently damaged, possibly by the early December windstorm or from actions by users of the skateboard park adjacent; Staff reported that the damage had been repaired (skateboard park users have sometimes accessed the roof by climbing on the power meter stanchions adjacent to the garage); several old skateboard decks had been thrown onto the roof of the garage; refer to Figure B30.2

Figure B30.2 Damage at eave edge of Garage roof; Staff indicated that following the inspection, the observed damage at the Garage roof had been repaired; roof access may be possible by adjacent electrical equipment; abandoned skateboard decks on Garage roof

Recommendations		
B30.1.1	Confirm age and life-span remaining for existing roofing; replace if necessary, possibly adding a layer of plywood sheathing if required to improve the structure's lateral force resistance (refer to B10.3). Replacement roofing with metal roofing system has been proposed in the City's Capital Improvement Plan.	
B30.2.1	Monitor conditions of flashings, vents, gutters, downspouts, etc.; recommend investigation for replacement as necessary at next reroofing. Staff indicated that following the inspection, the observed damage at the Garage roof had been repaired.

Consider means to avoid access to the Garage roof, and inspect roof regularly for recurring damage.

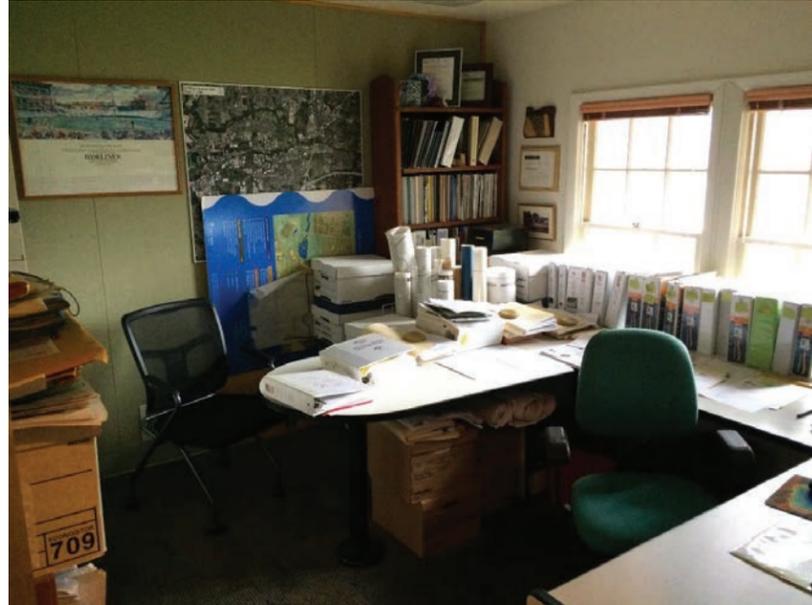
Figure B10.5A Office functions impose loads differently than residential use

B10.3.2	It should be confirmed whether during previous re-roofings additional plywood sheathing was added to improve diaphragm strength; this could be provided in upcoming re-roofing (refer to B30.1).	
B10.4	None	
B10.5.1	It should be confirmed that locations currently bearing large furniture or file storage loads are adequately supported on structure below.	
B10.5.2	It is recommended that loads be minimized and distributed where they are in the middle of rooms or not adjacent to major structural support below the floor.

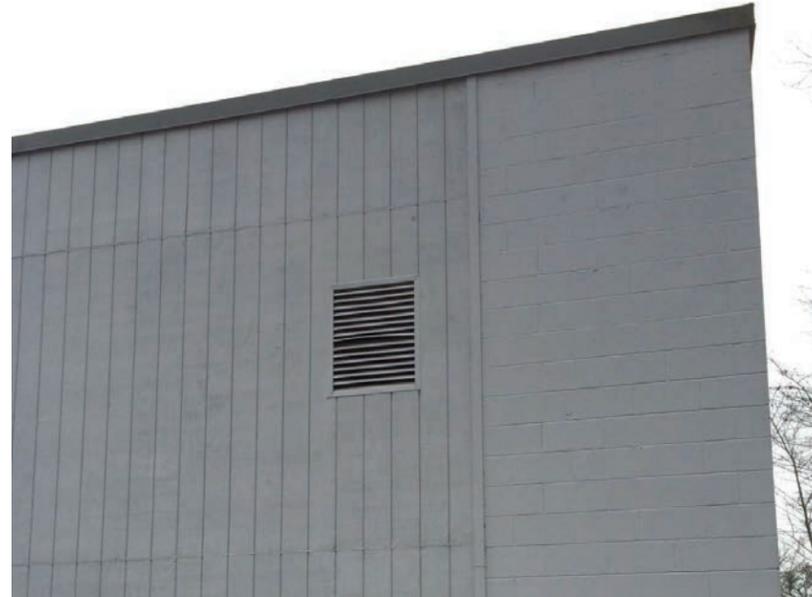
Figure B30.1C Louver at north is disused, staff noted that capped at interior

- confirm adequate closure of louver from interior to avoid moisture damage. Remove disused louver and close the opening from exterior to prevent introduction of moisture into wall cavity or interior space.

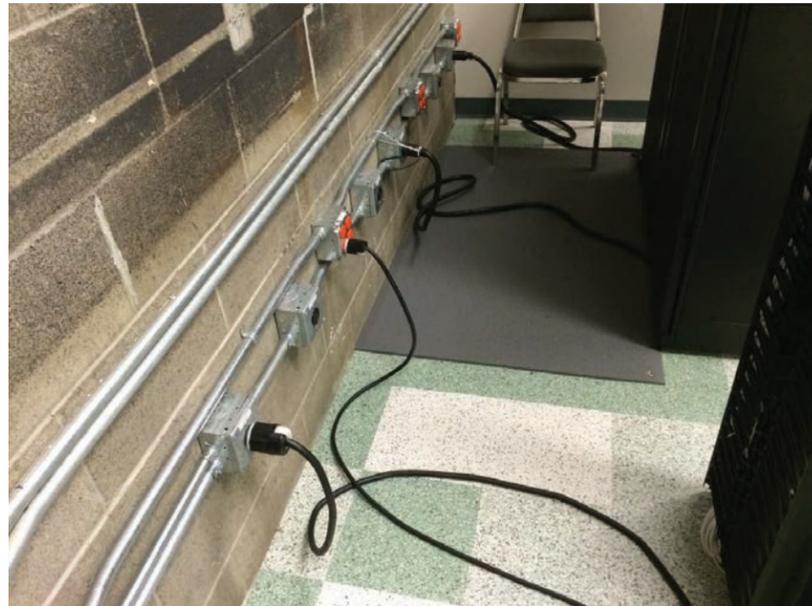
Figure D50.17 Potential trip hazard at power cords from server racks to wall outlets

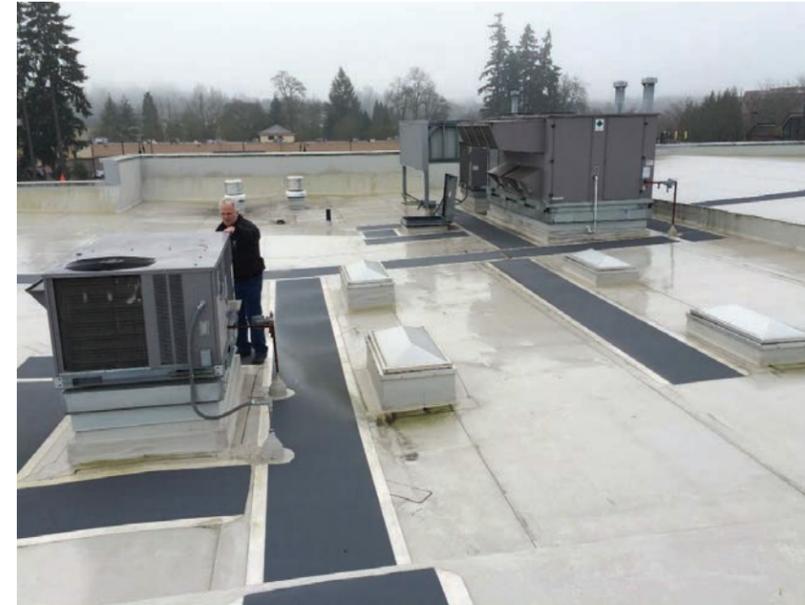
Figure B30.1 Rooftop conditions observed

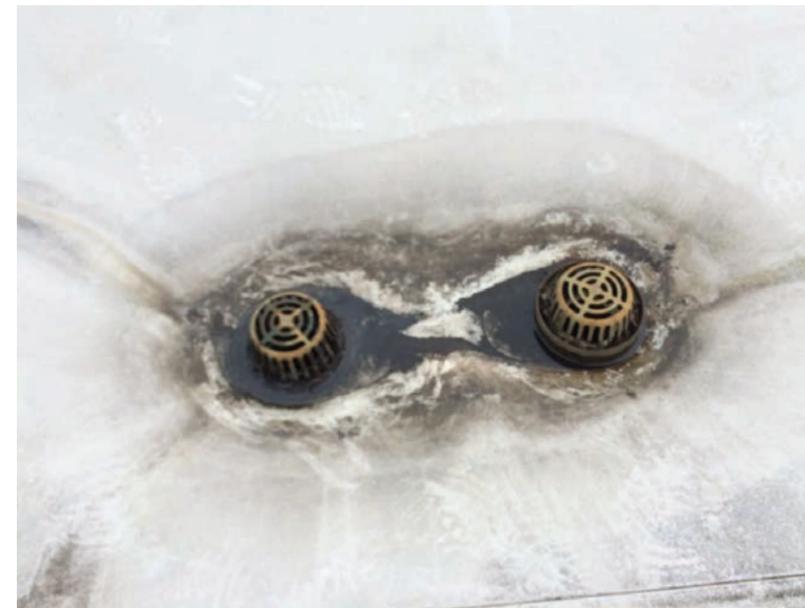
Figure B30.2 Typical roof drain and overflow drain conditions

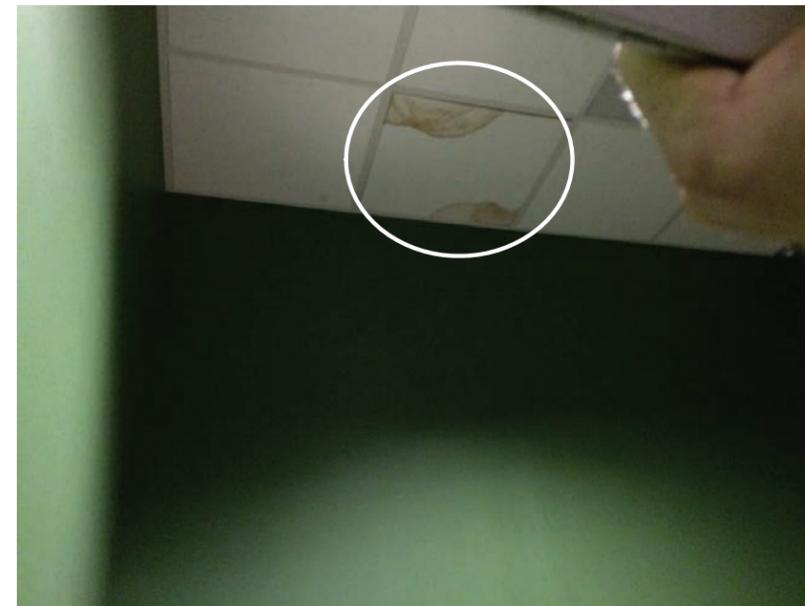
Figure C30.2 Evidence of leak visible in acoustic ceiling tile in Library

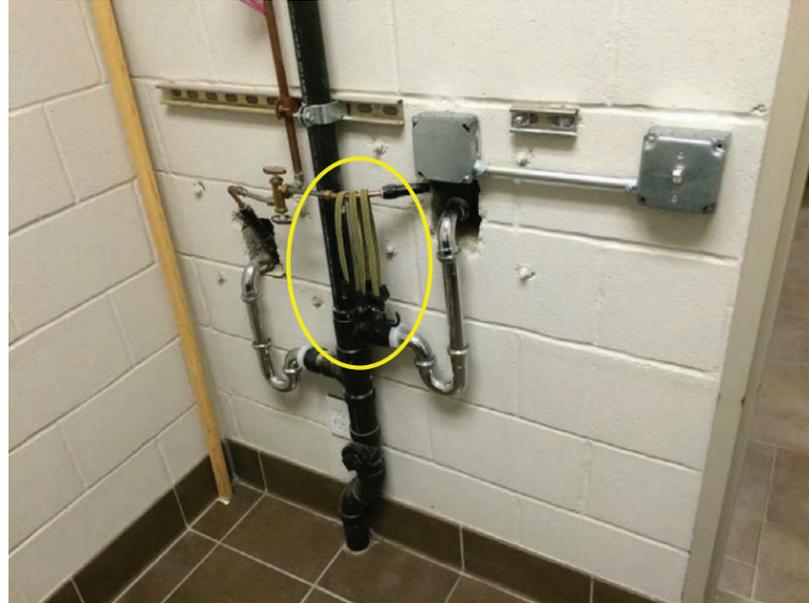
Figure D20.1/8 Copper water supply and PVC sanitary lines; note straps hung from plumbing

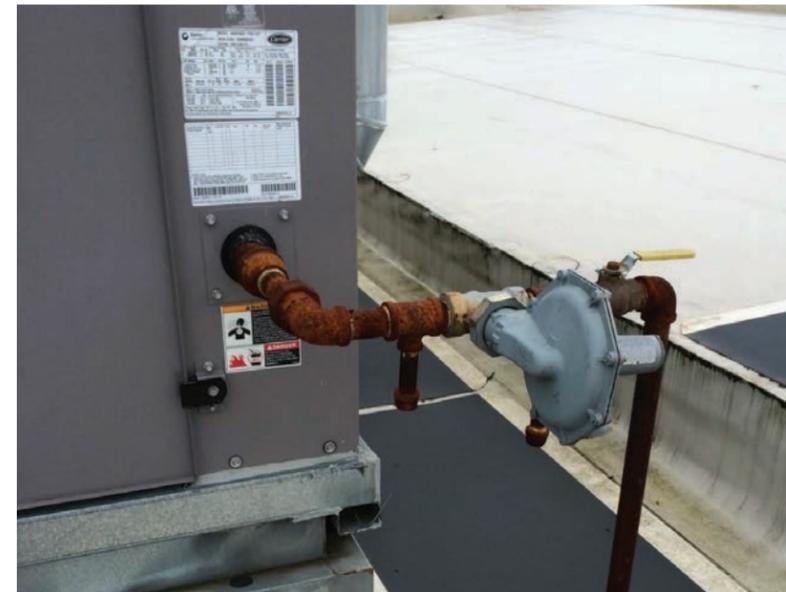
Figure D30.4A Rooftop mechanical units are gas-fired; typical gas line is unpainted pipe, corroded

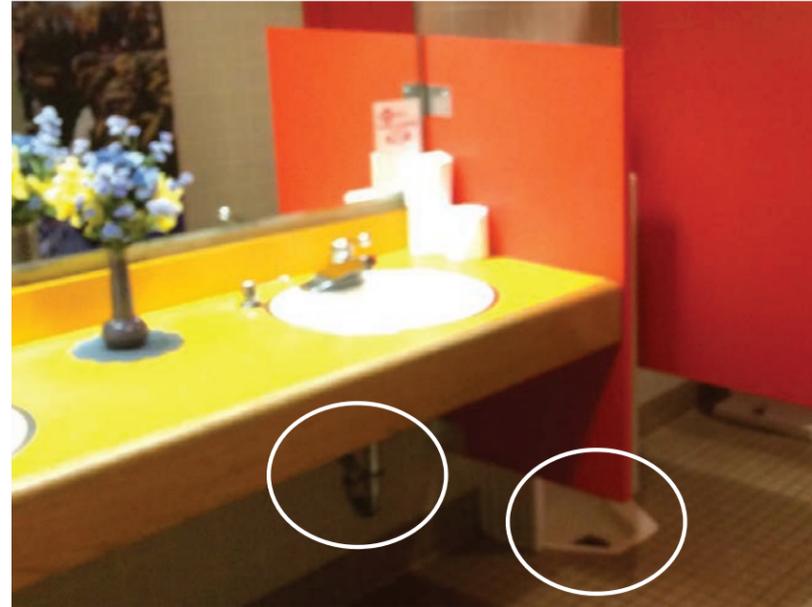
Figure C10.4 Sink and urinal are not accessible (Men's Room observed)

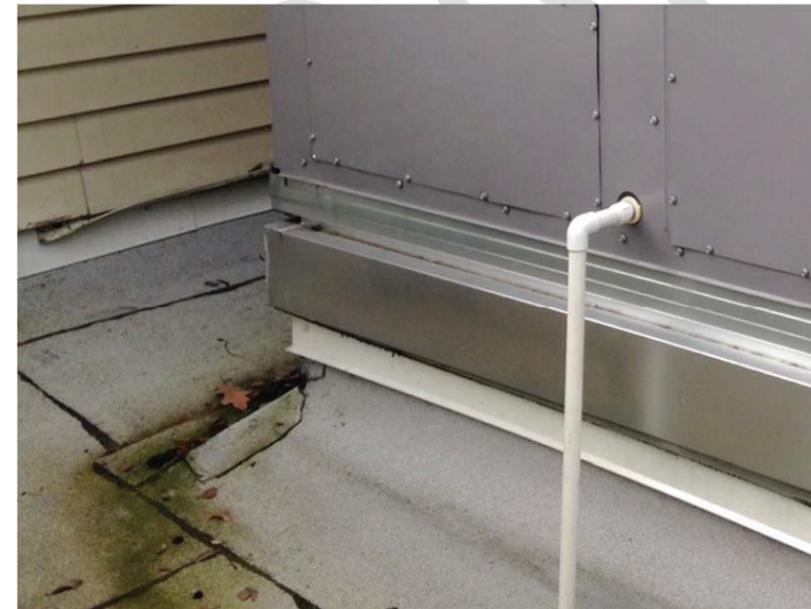
Figure B30.1 Staff photo of roof condition above Activity Room space

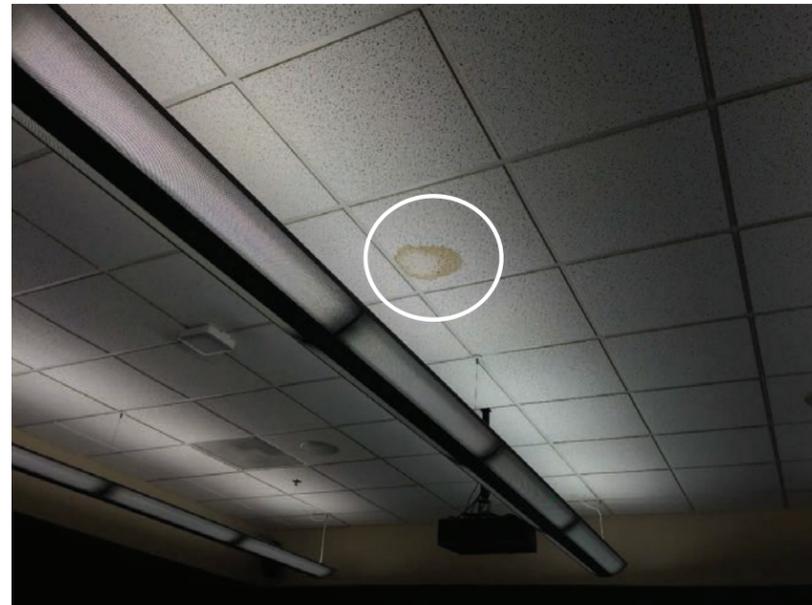
Figure C30.2 Evidence of past leak visible in acoustic ceiling tile; Staff noted that leak was repaired

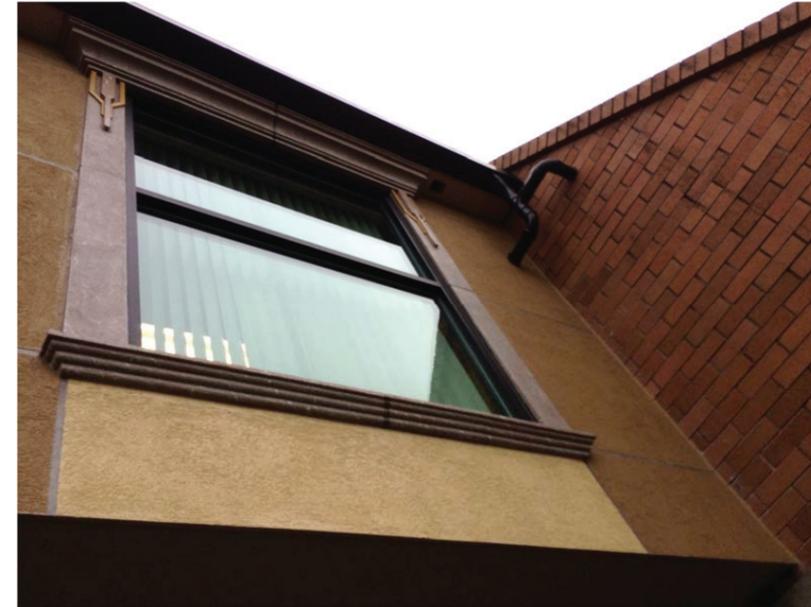
Figure B30.1 Metal roof edge, flashings and gutters appear to be in good condition

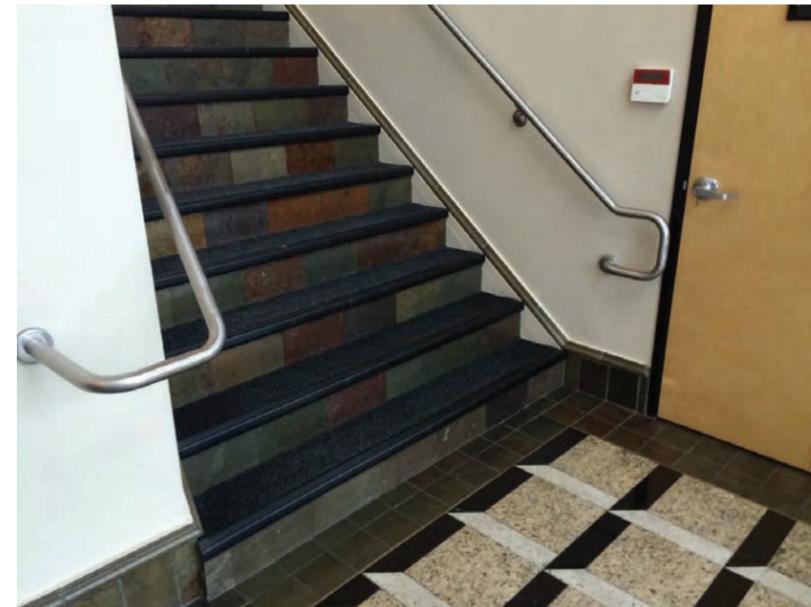
Figure C20.2 Stairs are steeper than code required, exceeding 7 inches at risers
