City of Tualatin

CITY FACILITIES STUDY

FACILITIES ASSESSMENTS *report*

YOST GRUBE HALL
ARCHITECTURE

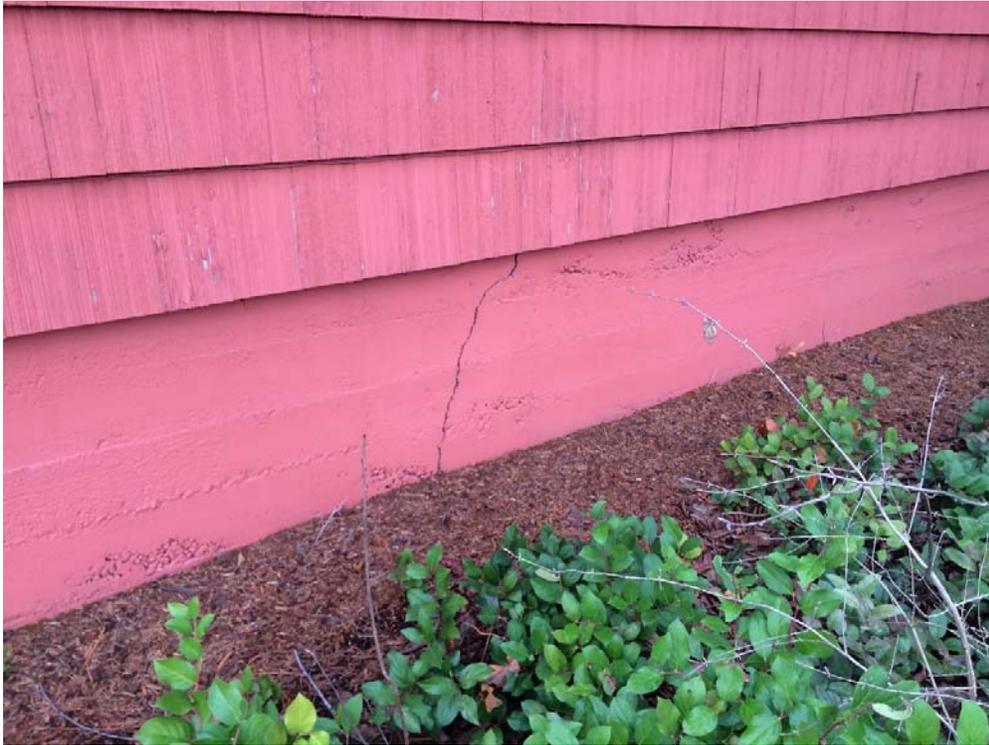
A10 – FOUNDATIONS (foundations, slab-on-grade, etc.)		
Item		Comments/Findings
A10.1	General condition	<ul style="list-style-type: none"> • CIP concrete foundation walls appeared to be in good shape • Some minor cracking was observed above grade at the south and west sides; refer to Figure A10.1; there was no apparent water intrusion observed in the basement at these same locations
Recommendations		
A10.1.1 Monitor basement walls for additional cracking, water intrusion, or other signs of settlement

Figure A10.1 Minor cracking observed at basement walls (this location at south side)

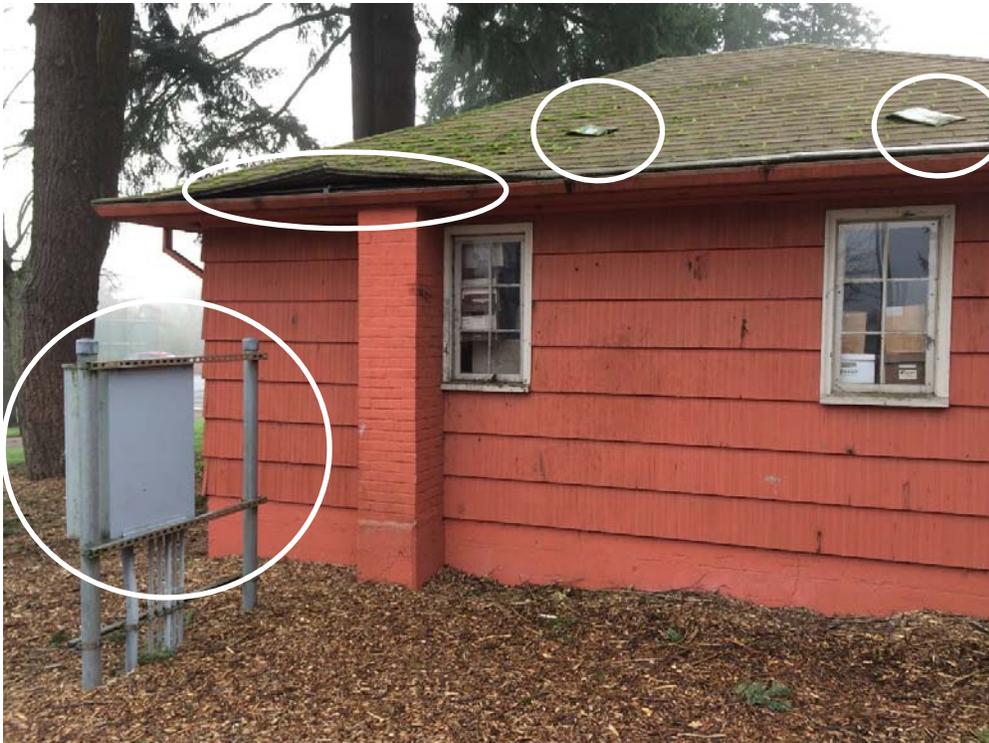
B30 – EXTERIOR HORIZONTAL ENCLOSURES (roofing, horizontal openings, etc.)		
Item		Comments/Findings
B30.1	Type and condition of roofing system	<ul style="list-style-type: none"> • Roofing is three-tab asphalt shingles, which may be near the end of its life-span (10-15 years) • It was observed that moss has grown on the east side. Refer to Figure B30.1
B30.2	Other issues	<ul style="list-style-type: none"> • Flashings, vents, etc. all appear in acceptable condition • Access to the roof was not available; observations were made from the ground level • The roof at the Garage north of the building appeared to have been recently damaged, possibly by the early December windstorm or from actions by users of the skateboard park adjacent; Staff reported that the damage had been repaired (skateboard park users have sometimes accessed the roof by climbing on the power meter stanchions adjacent to the garage); several old skateboard decks had been thrown onto the roof of the garage; refer to Figure B30.2

Figure B30.2 Damage at eave edge of Garage roof; Staff indicated that following the inspection, the observed damage at the Garage roof had been repaired; roof access may be possible by adjacent electrical equipment; abandoned skateboard decks on Garage roof

Recommendations		
B30.1.1	Confirm age and life-span remaining for existing roofing; replace if necessary, possibly adding a layer of plywood sheathing if required to improve the structure’s lateral force resistance (refer to B10.3). Replacement roofing with metal roofing system has been proposed in the City’s Capital Improvement Plan.	
B30.2.1	Monitor conditions of flashings, vents, gutters, downspouts, etc.; recommend investigation for replacement as necessary at next reroofing. Staff indicated that following the inspection, the observed damage at the Garage roof had been repaired.

Consider means to avoid access to the Garage roof, and inspect roof regularly for recurring damage.

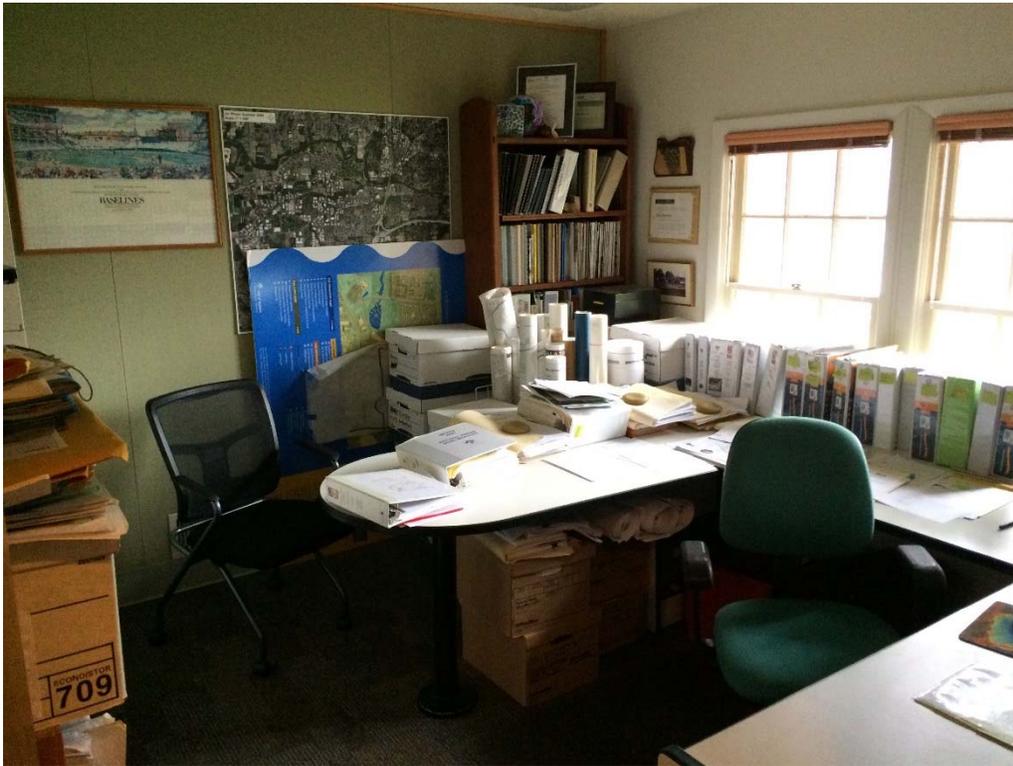
Figure B10.5A Office functions impose loads differently than residential use

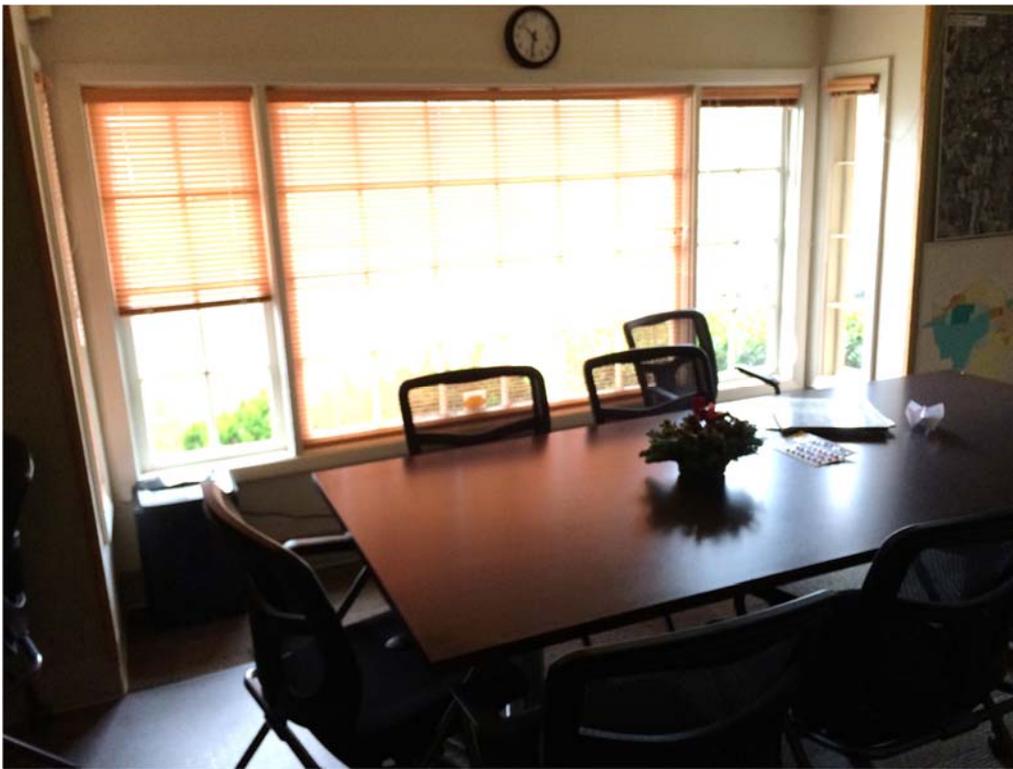
Figure B10.5B Office functions impose loads differently than residential use

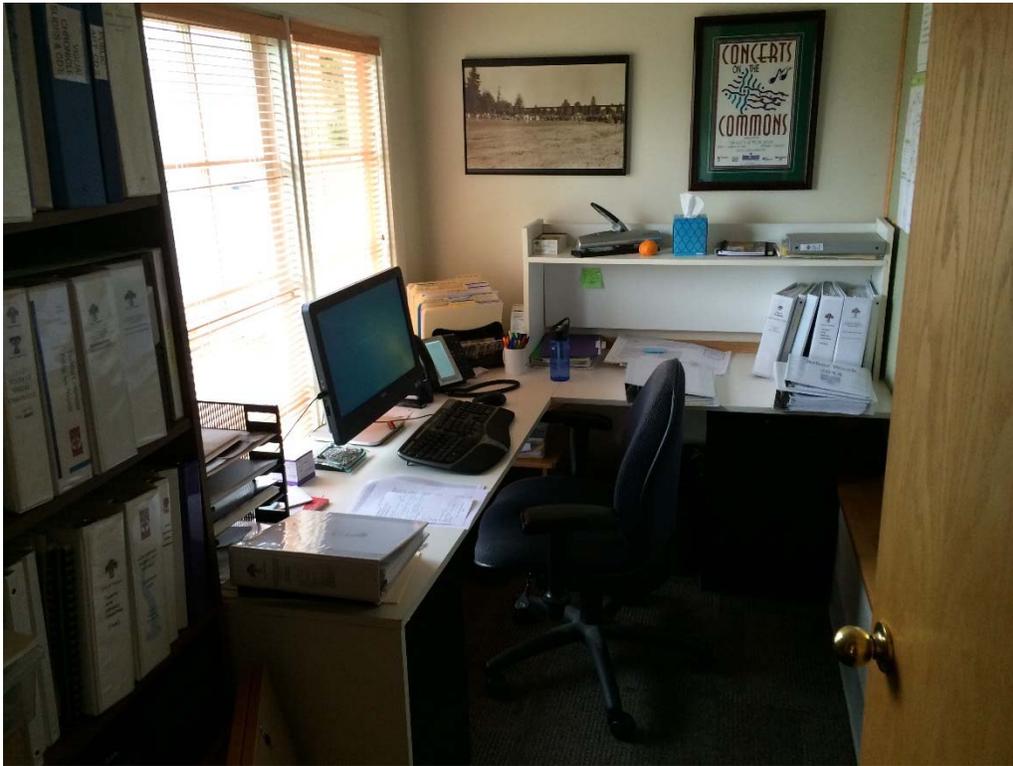
Figure B10.5C Office functions impose loads differently than residential use

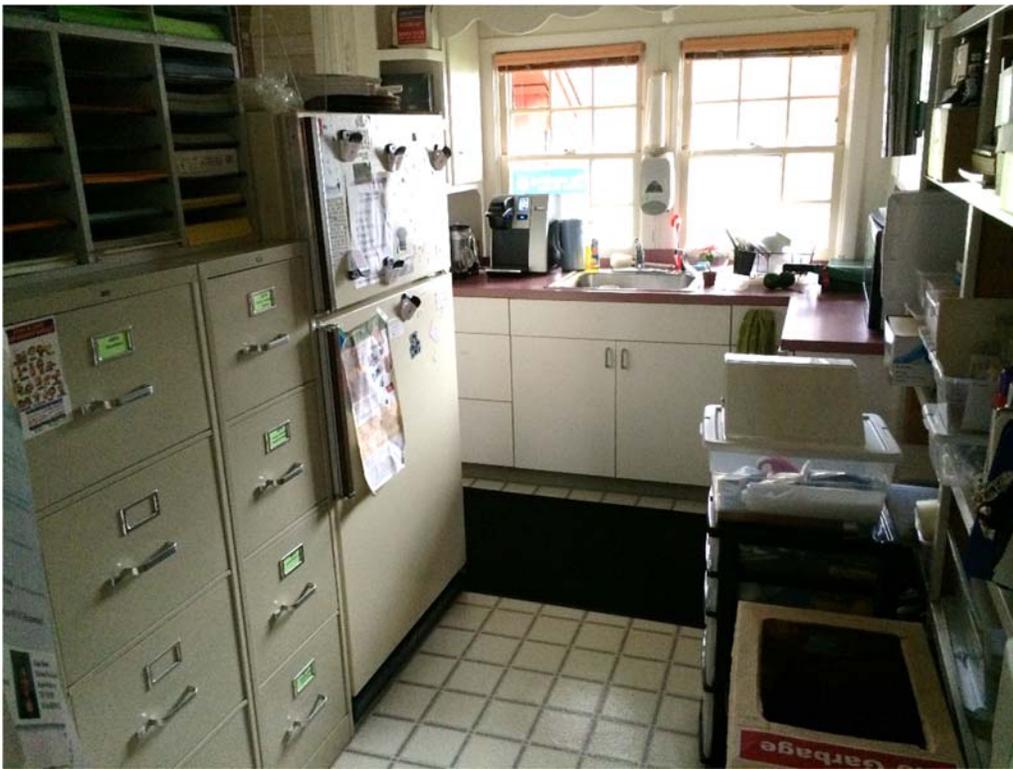
Figure B10.5D Office functions impose loads differently than residential use

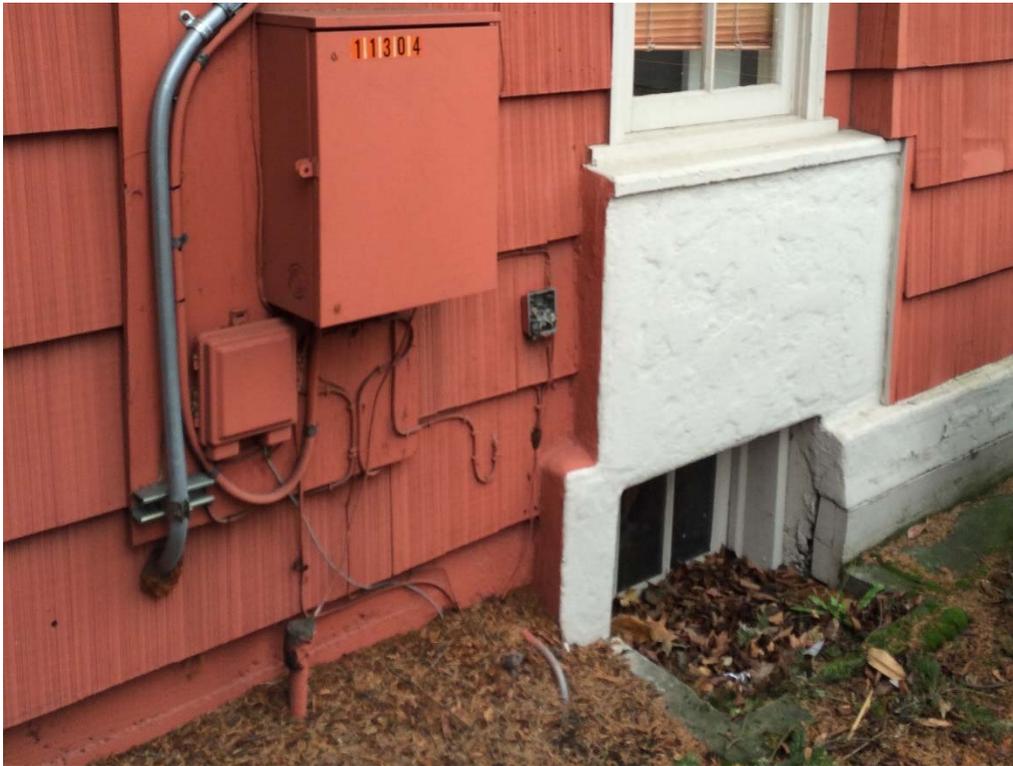
<ul style="list-style-type: none"> • The building’s original foundation drainage system, if it ever existed, is likely non-functional now • Leaves have collected within basement window wells; refer to Figure B20.3
Recommendations		
B20.1	None	
B20.2.1	Maintain proper cleaning and painting regimen to ensure wood windows remain operational and rot-free	
B20.3.1	It is recommended to add extensions to the ends of downspouts to transport stormwater away from the foundations.	
B20.3.2	Leaves and debris should be removed from basement window wells and adequate drainage confirmed

Figure B20.3 Window wells at Basement have collected leaves and debris at rear (east)

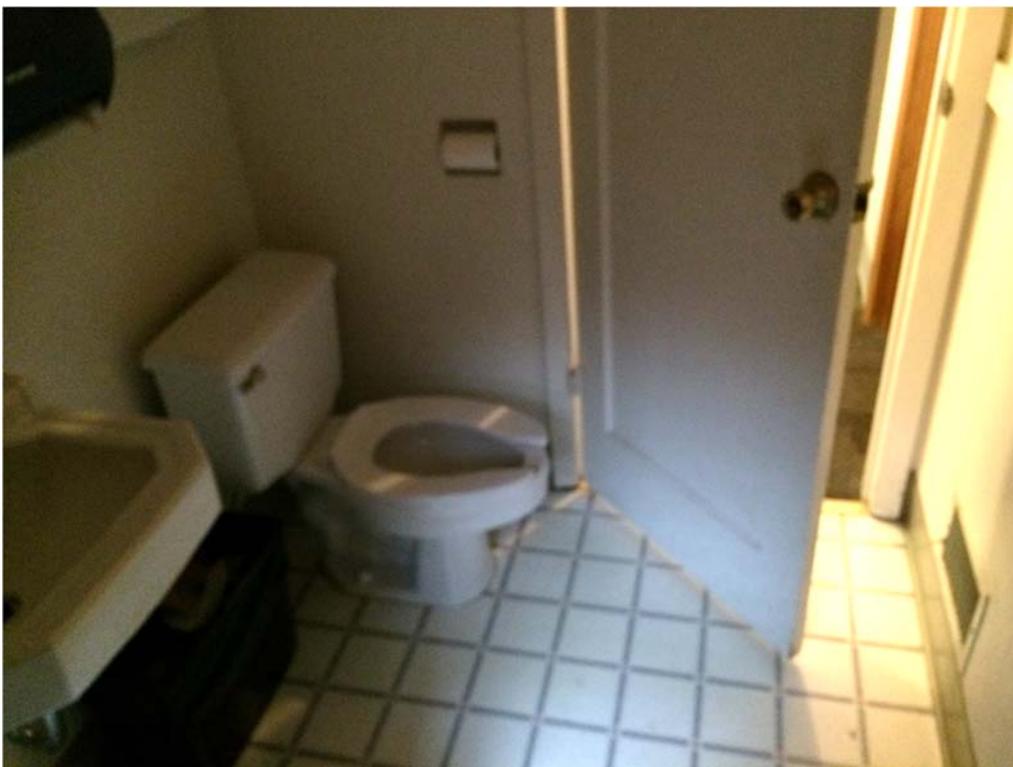
Figure C10.4B Restroom conversion from residential to commercial is not accessible

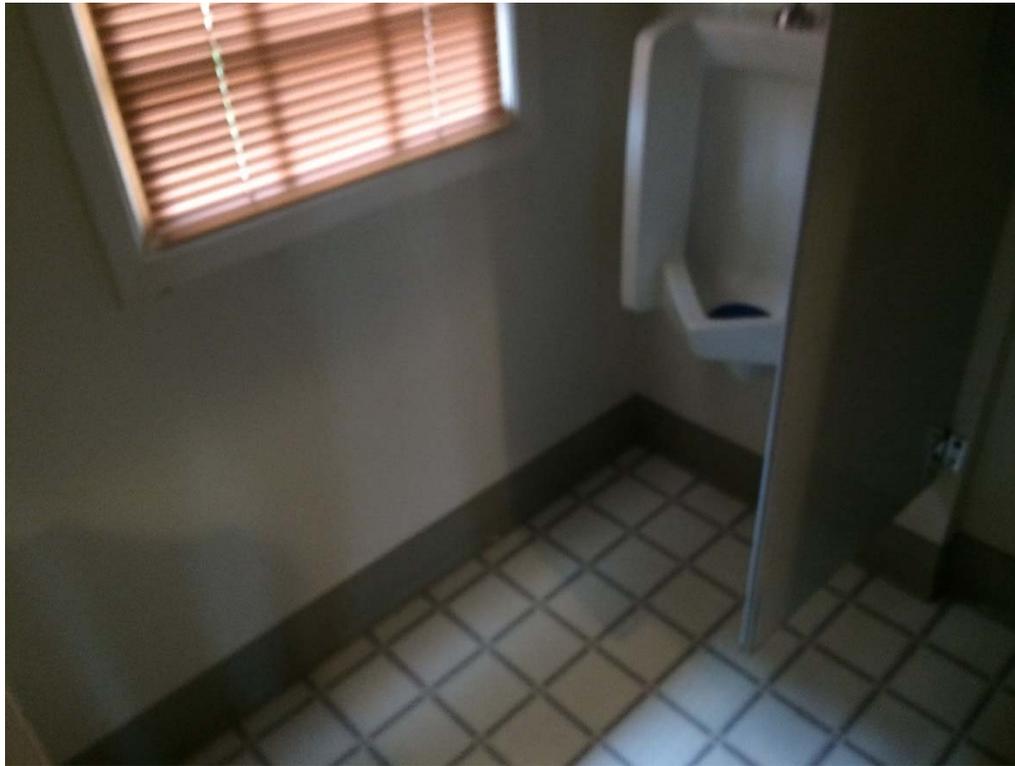
Figure C10.4C Restroom conversion from residential to commercial is not accessible

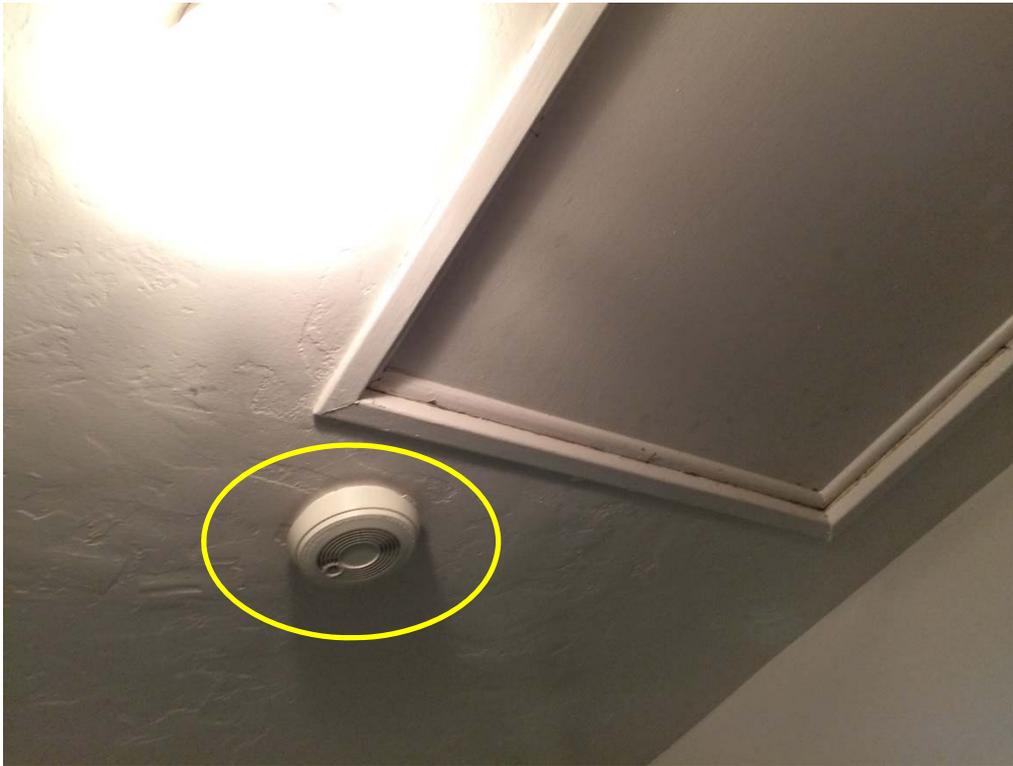
Figure D60.2 - Local, battery-operated residential type smoke detectors

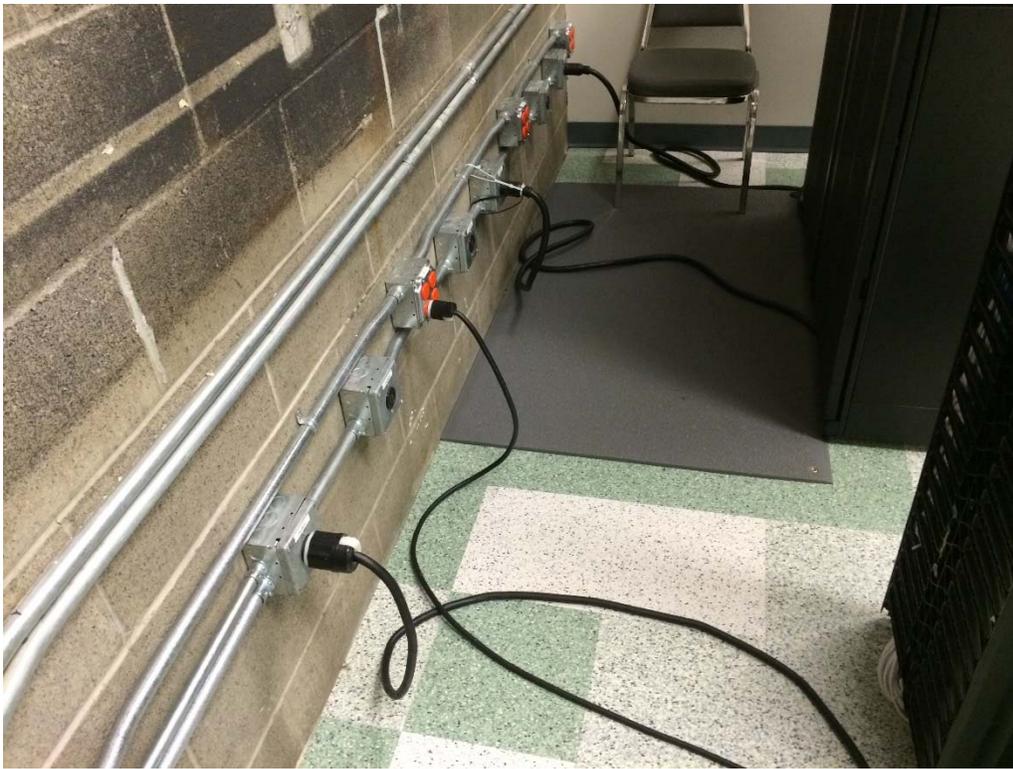
Figure D50.17 Potential trip hazard at power cords from server racks to wall outlets

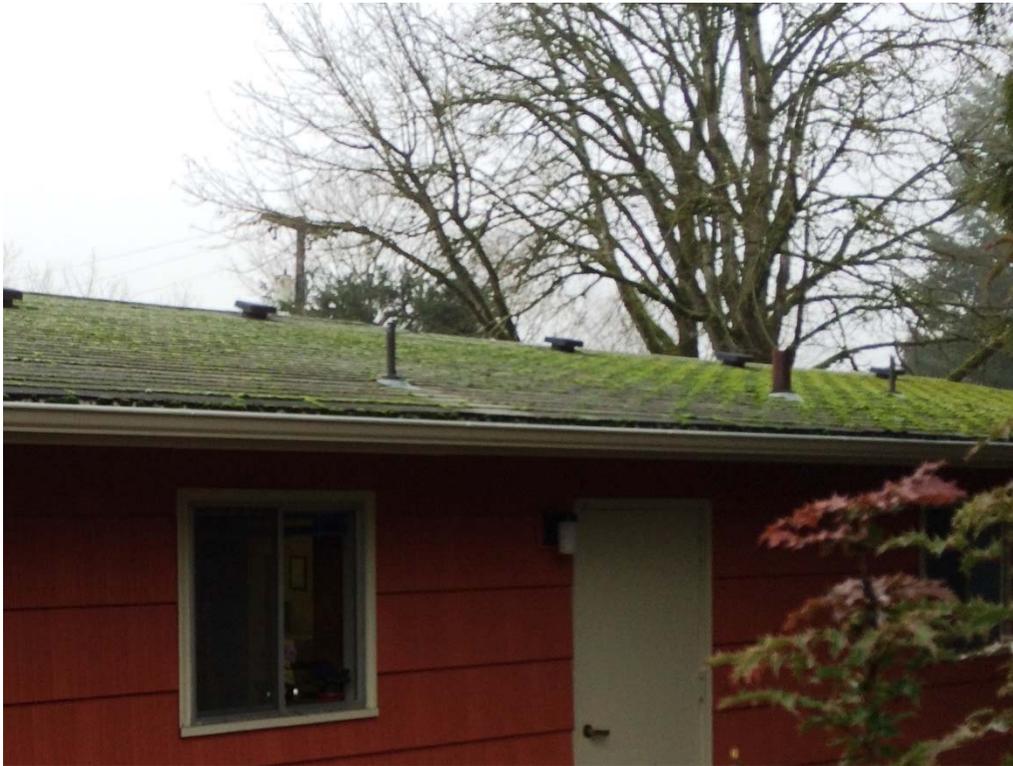
Figure B30.1 Moss at north roof

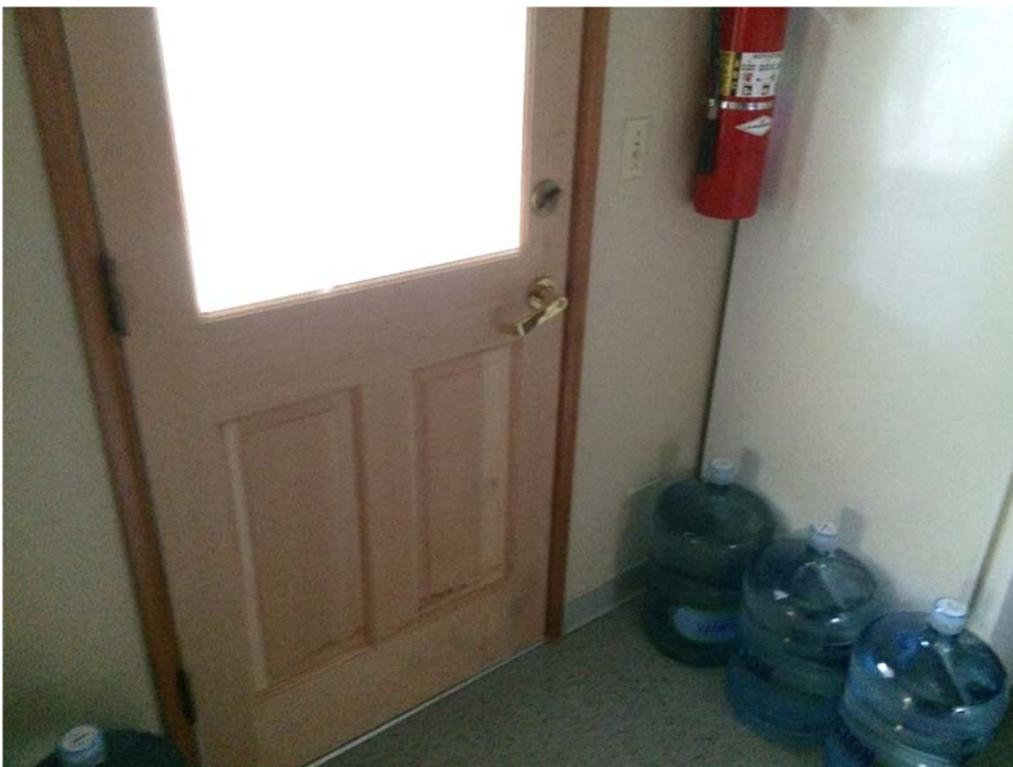
Figure C10.4A Storage of water bottles adjacent to accessible rear entry

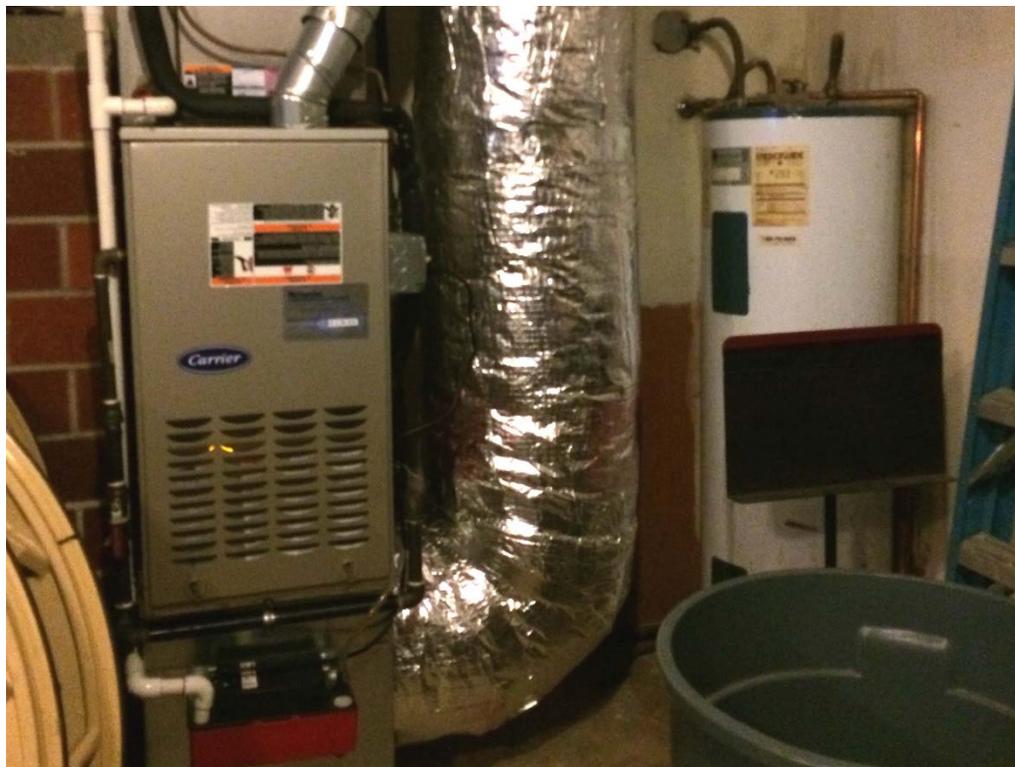
Figure D30.6 Air handler configuration; access compromised by storage

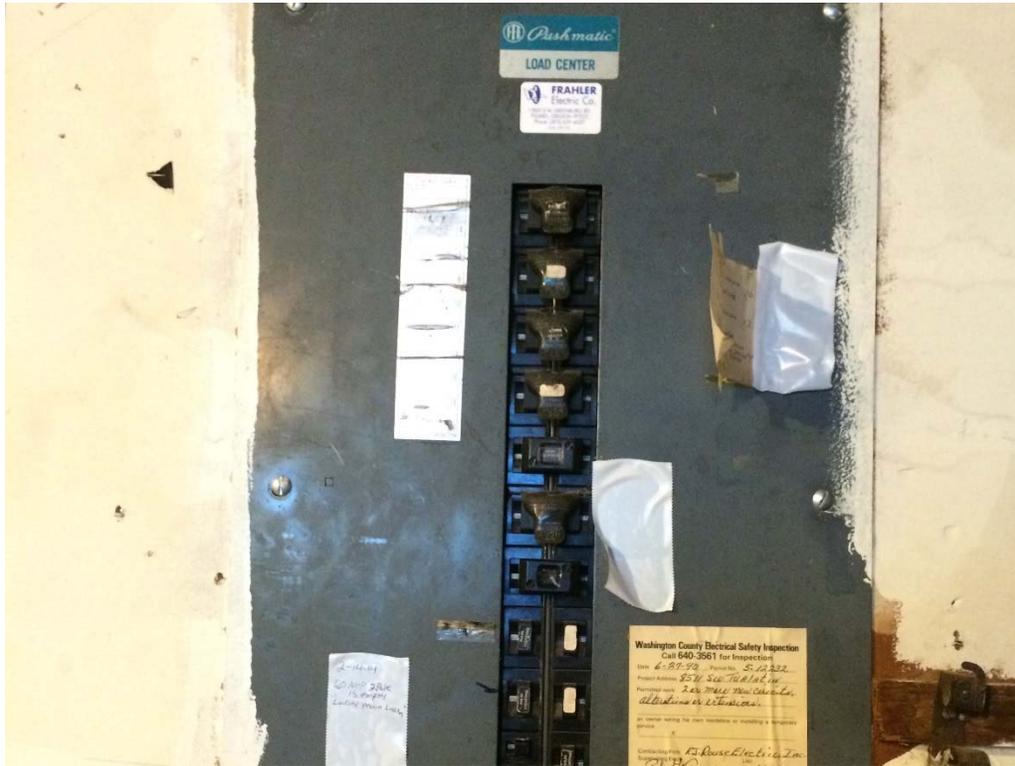
Figure D50.6 Original electrical panel with push button-type circuit breakers

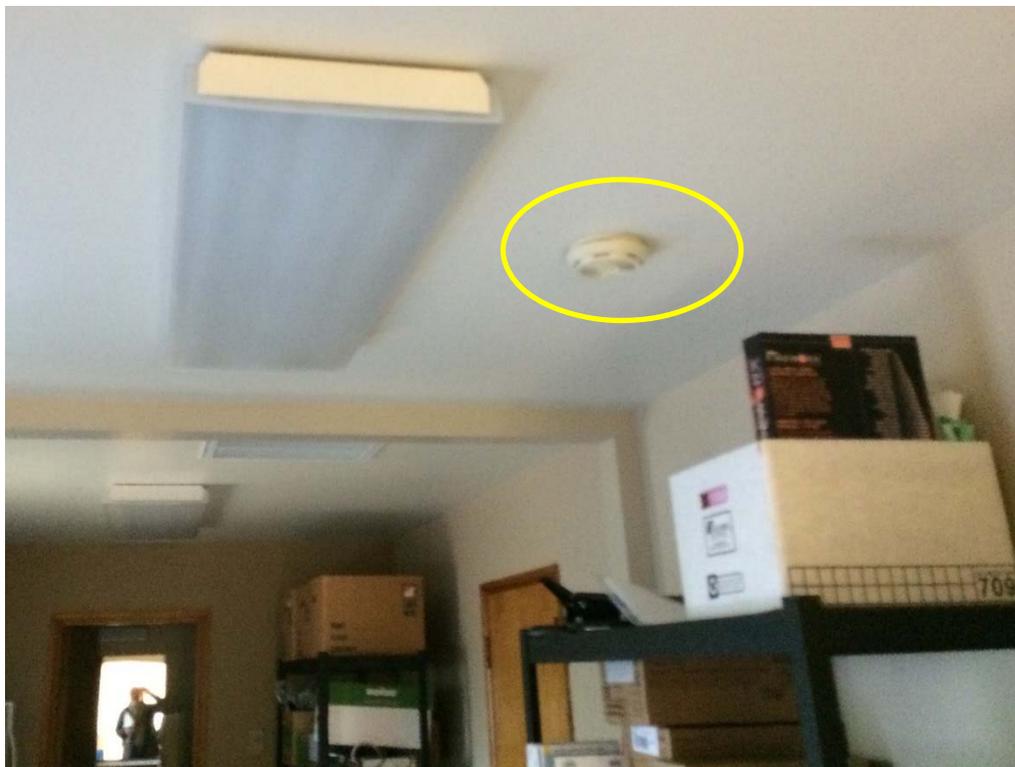
Figure D60.2 - Local, battery-operated residential type smoke detectors

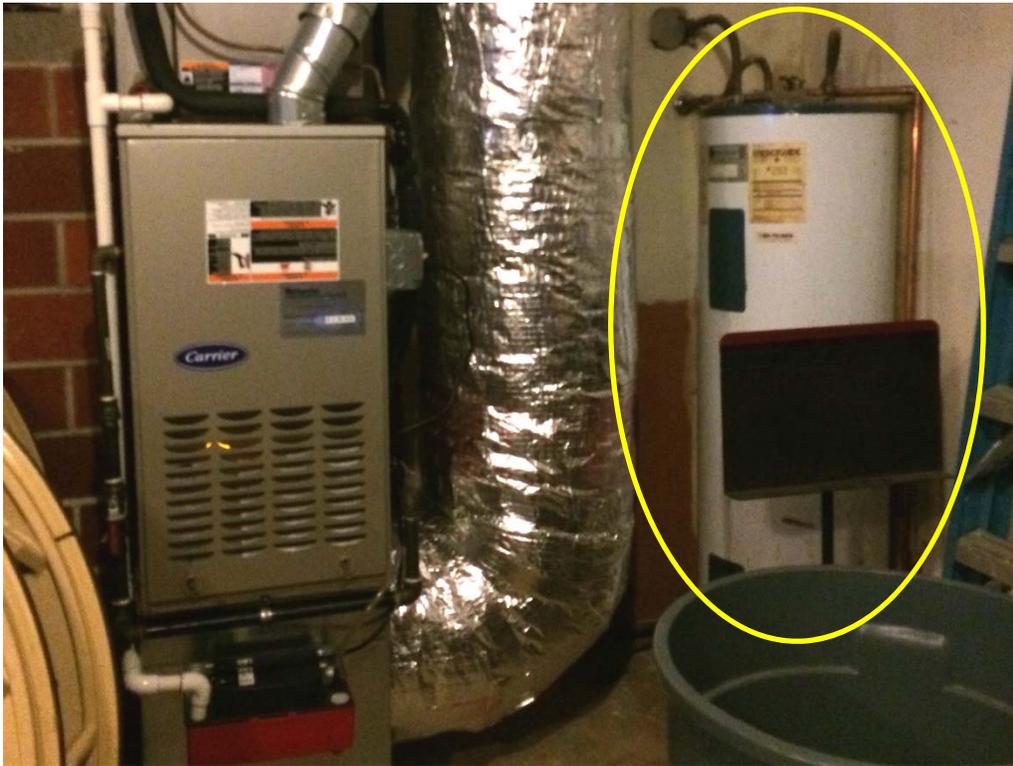
Figure E10.1 Water heater is not restrained for seismic forces

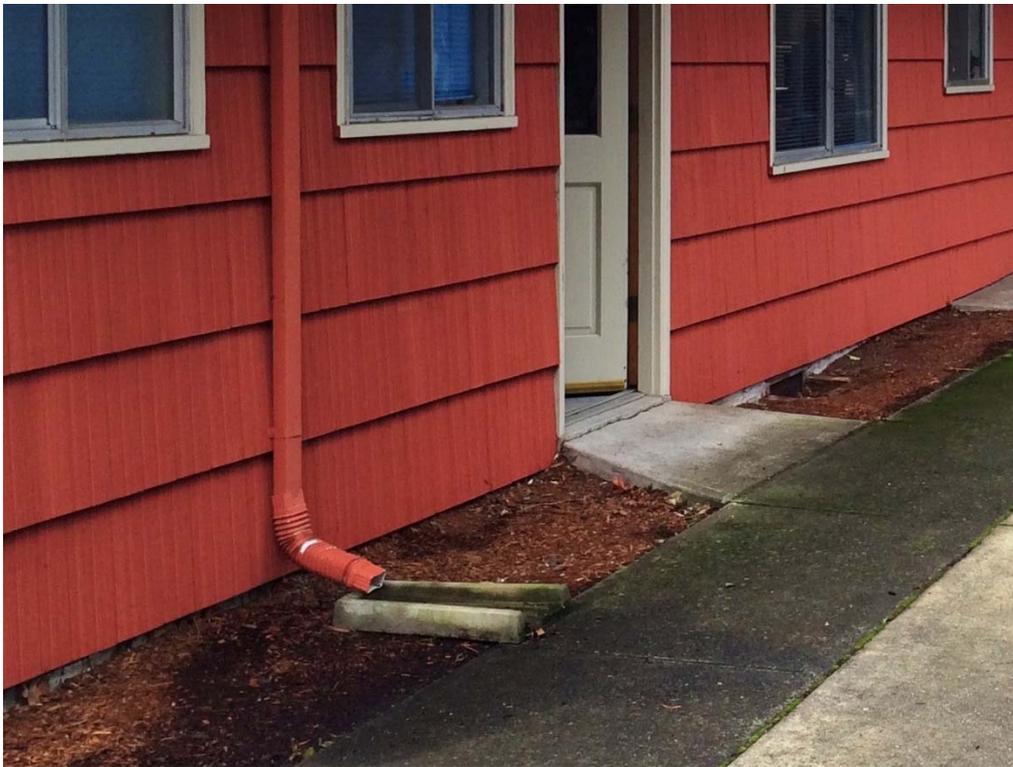
Figure G20.8 Soil and topping in contact with siding at rear (north)

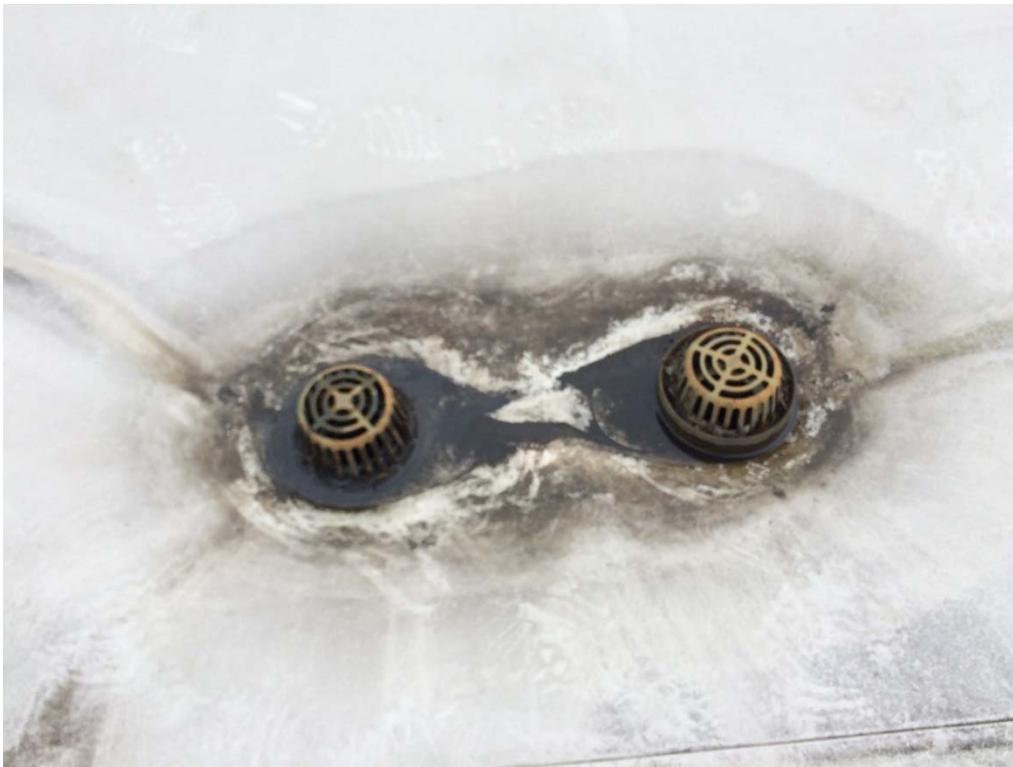
Figure B30.2 Typical roof drain and overflow drain conditions

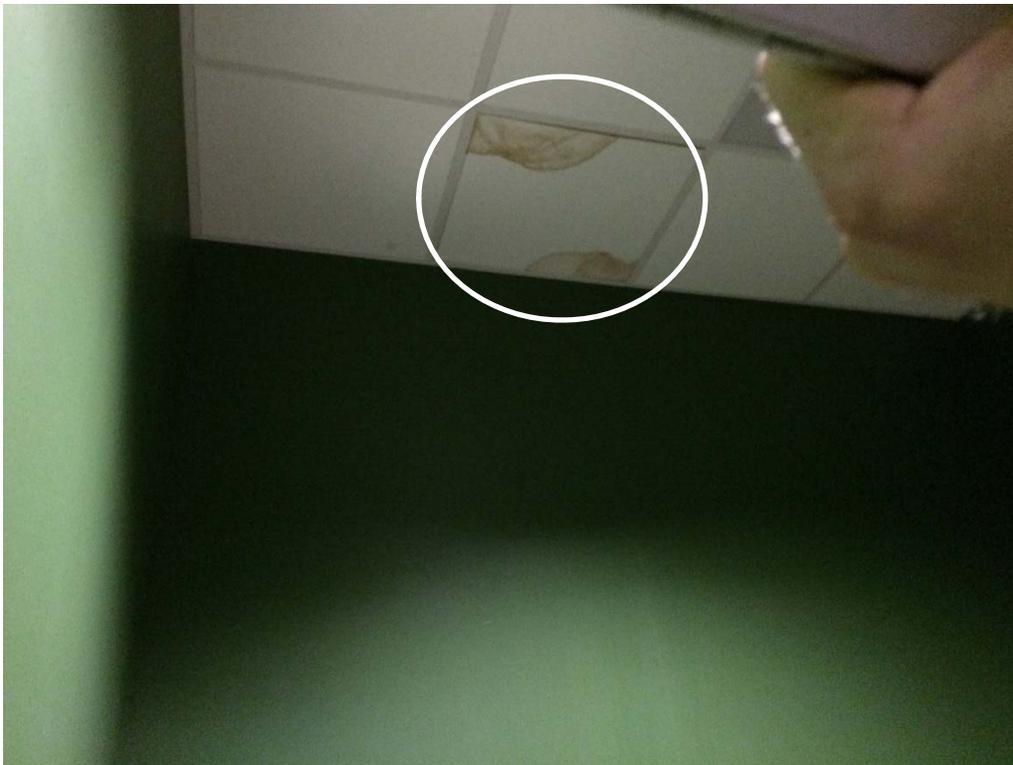
Figure C30.2 Evidence of leak visible in acoustic ceiling tile in Library

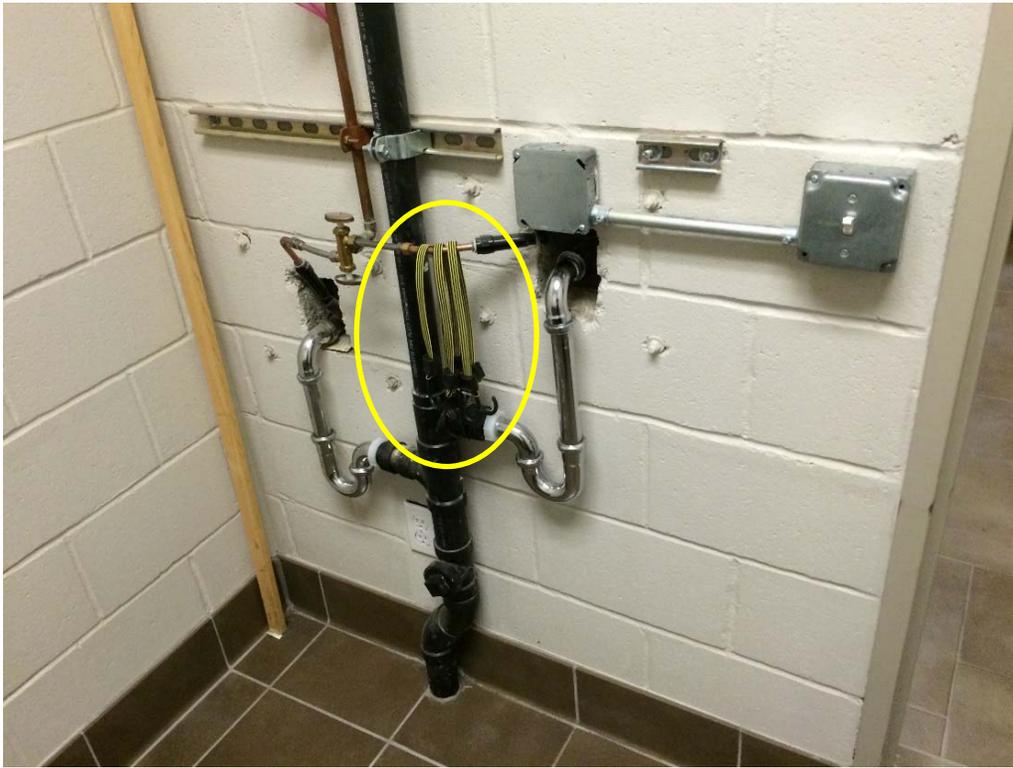
Figure D20.1/8 Copper water supply and PVC sanitary lines; note straps hung from plumbing

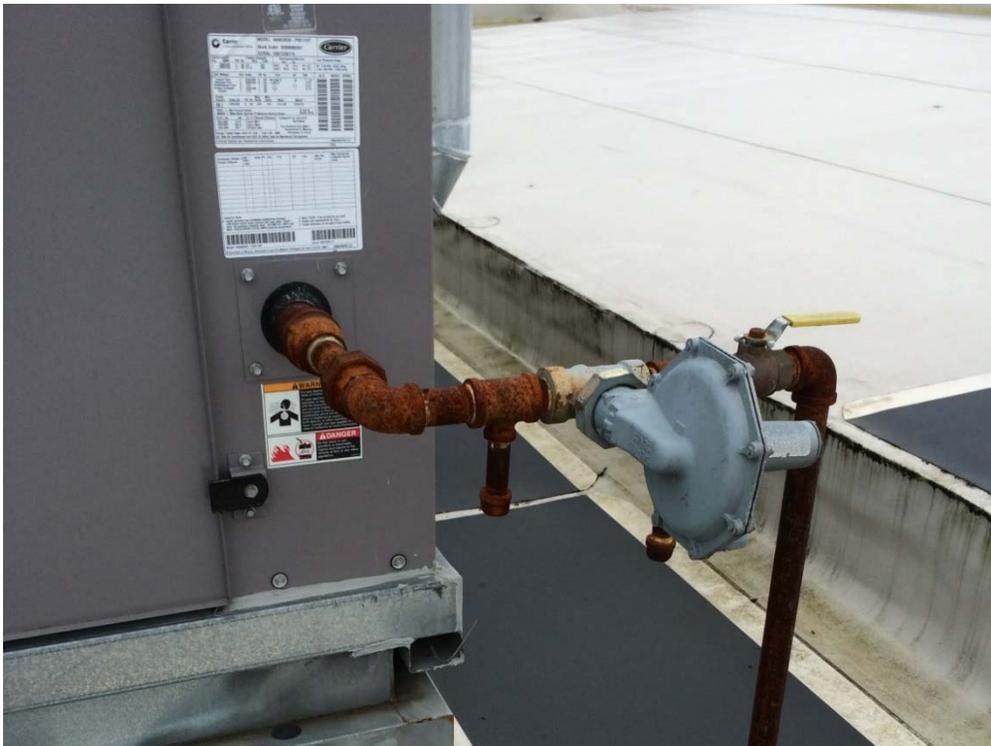
Figure D30.4A Rooftop mechanical units are gas-fired; typical gas line is unpainted pipe, corroded

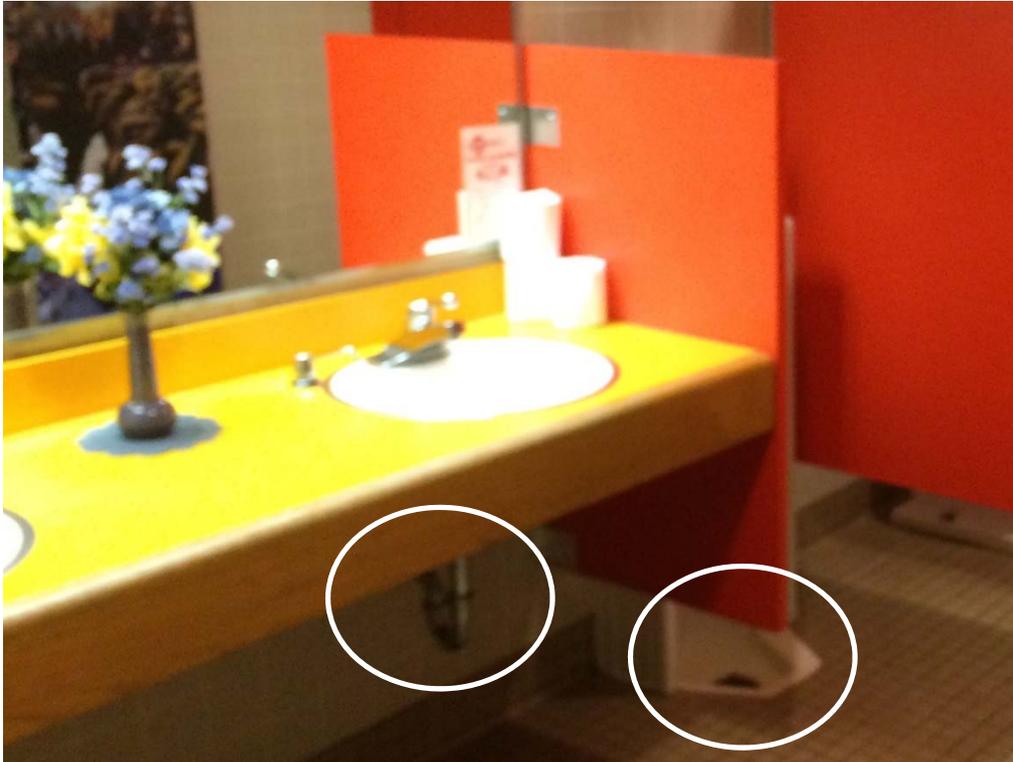
Figure C10.4 Sink and urinal are not accessible (Men's Room observed)

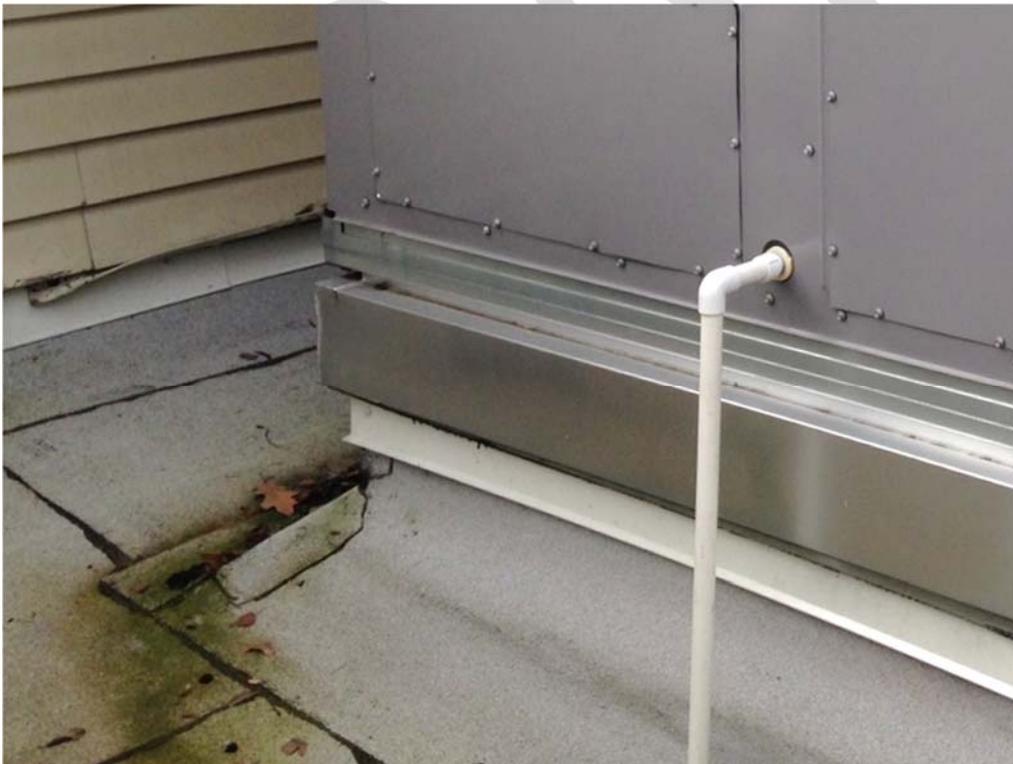
Figure B30.1 Staff photo of roof condition above Activity Room space

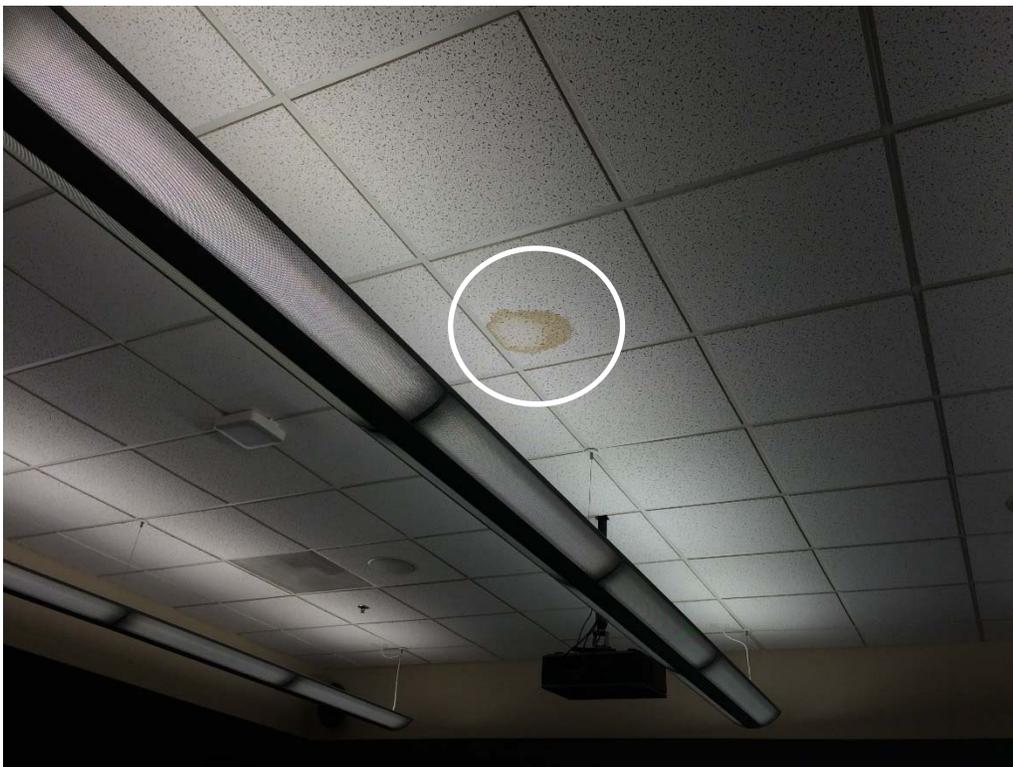
Figure C30.2 Evidence of past leak visible in acoustic ceiling tile; Staff noted that leak was repaired

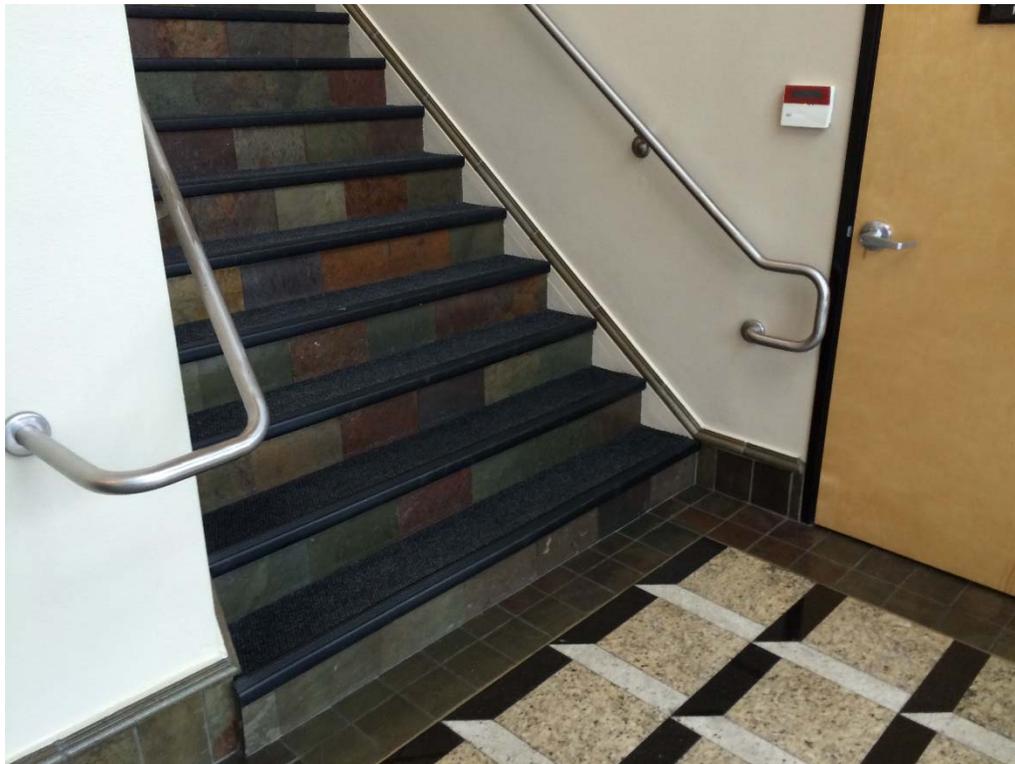
Figure C20.2 Stairs are steeper than code required, exceeding 7 inches at risers
