May 31, 2016

**Re: Significant Natural Resource Area reconnaissance for
9440 SW Sagert Street, Tualatin**

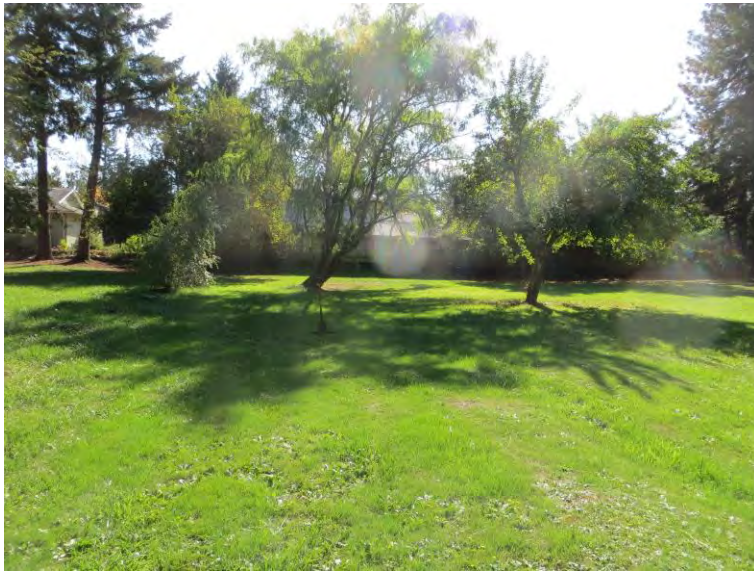
Our initial investigation occurred on October 13, 2015. The previous few days had been dry but some rain had fallen over the weekend. The property slopes gently from southwest to northeast. The area just south of the house has more intensive landscaping with small trees, shrubs, and lawn grass. The majority is expansive lawn with several mature trees, including Norway maple, Douglas fir, fruit trees, and weeping willow.

Figure 1. Looking south toward upper end of property

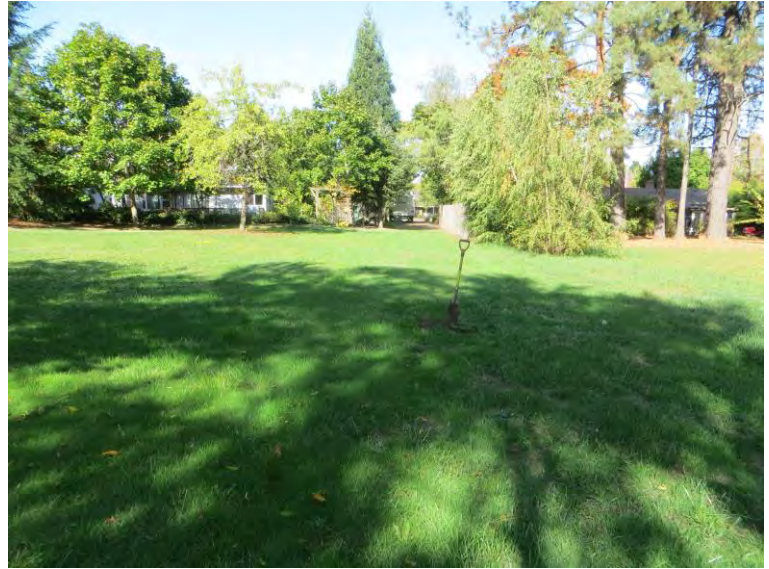
We sampled the soil in two locations. One was south of the southeast corner of the house, just beyond the intensively landscaped area, and the other in a low spot on the eastern property line. Both locations exhibited weakly hydric soil, based upon redoximorphic features in the top 12 inches that met the F3 (Depleted Matrix) criterion. The soil matrices were 10YR 4/2 with redoximorphic concentrations of 10YR 4/4. The location along the eastern property line just barely met the criterion, with redox beginning around 9 inches. The other location closer to the house exhibited redox features closer to the surface. However, neither plot was strongly hydric.

Figure 2. Looking north at sample plot on western property boundary

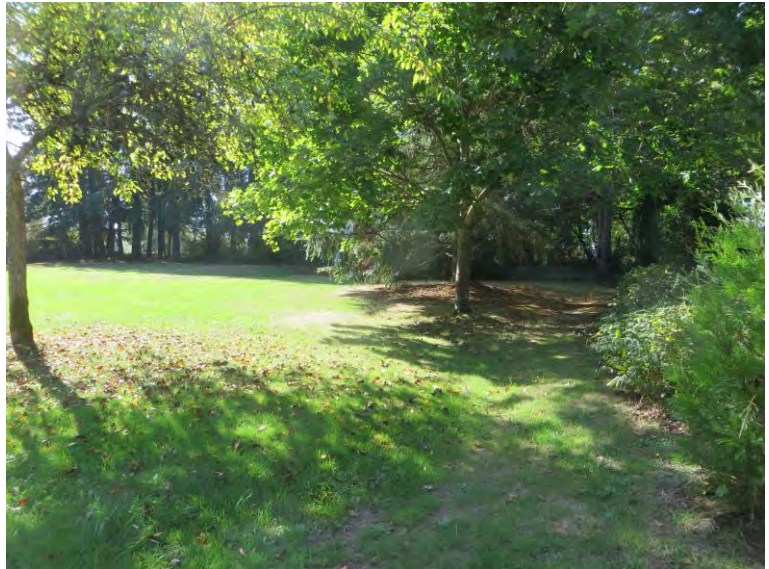
Figure 3. Looking west along edge of intense landscaped area, at sample plot in slight swale.

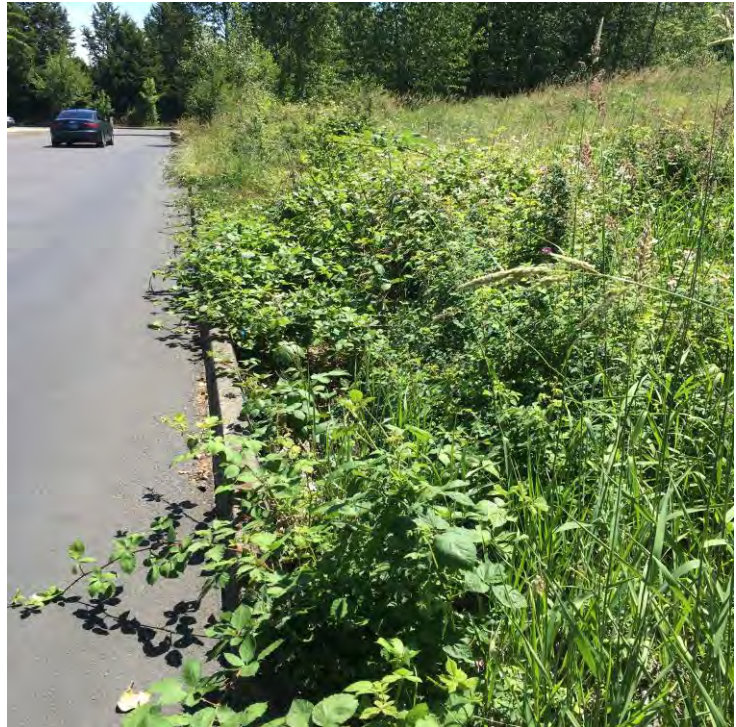
There is a ditch present along the edge of the parking lot of the industrial uses in the northwest quadrant of the SW 95th Street / NW Sagert Street intersection. Near the intersection of SW Sagert Street and SW 95th Avenue, the ditch is very shallow and flat, with no indication of standing water and vegetation community similar to the grasses present on adjacent higher ground. The grade descends and the ditch deepens and widens to the west, away from the intersection and toward the center of the property line, and the ditch developed evidence of standing water with increasing depth.

Hydrophytic trees and shrubs were present where the surface hydrology indicators were also observed. Because of its status as a stormwater facility that did not appear to be created in a natural Sensitive Area, a vegetated corridor is not applicable to this resource.

Additionally, any associated vegetated corridor would be severed by SW 95th Street, which is nearly 50 feet wide itself, including all the impervious surface.

Figure 4. Looking east toward SW 95th Avenue along south side of drive aisle

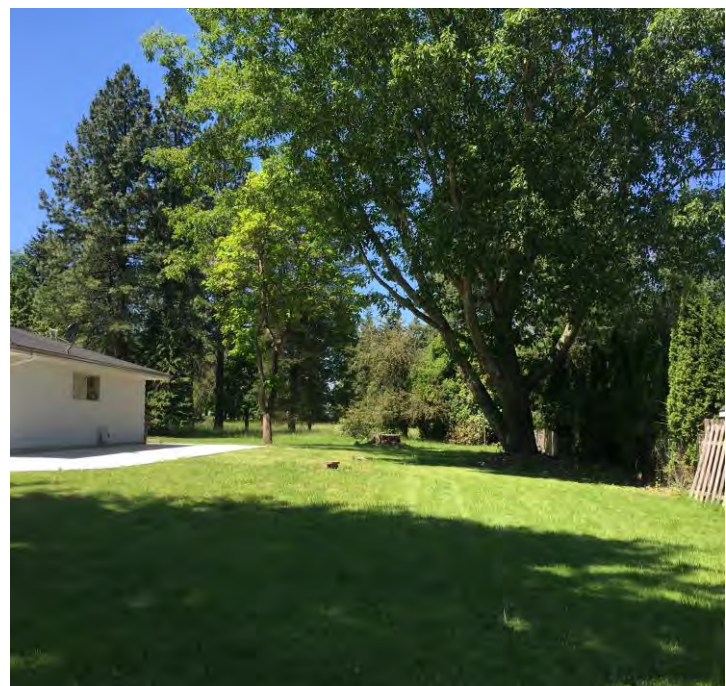
Ponderosa pines are the dominant tree. From the right-of-way, the lawn does not exhibit indications of wetness such as stunted growth or stress. The vegetation present consists of Norway maple, non-native oak, and other species that favor drier conditions. We observed no surface alterations indicating surface water management challenges to the routine use of the property during the wet season, such as ditching.

Figure 5. Looking west from SW 93rd toward the subject property. No indication of wet conditions entering from offsite.

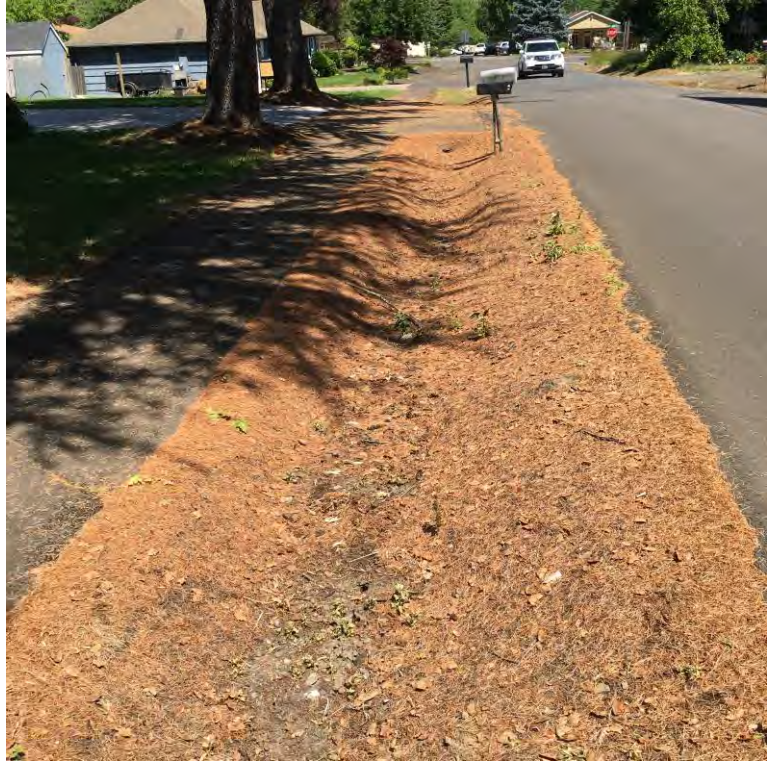
Viewing the site from SW 93rd Avenue, we did not see any evidence that water flows from the subject or adjacent property onto properties fronting on SW 93rd Avenue. We did not observe evidence that sheet flow crosses the sidewalk into the roadside ditch serving SW 93rd Avenue, or any other connection allowing potential surface flow to connect to the ditch (area drain, small pipes). This ditch appears to only carry roadway runoff; it is not connected to natural streams or wetlands.

Figure 6. Looking north along east side of SW 93th Avenue. If the subject property or the adjacent property to the south were wet, it would likely drain into this ditch.
