ARBORIST REPORT **(Tualatin Development Code 33.110)**

For: Mutual Materials Site, Tualatin, Oregon

DATE April 23rd, 2019, Revised 8.3.19

PROJECT DESCRIPTION: Tree survey and assessment required by Tualatin Development Code

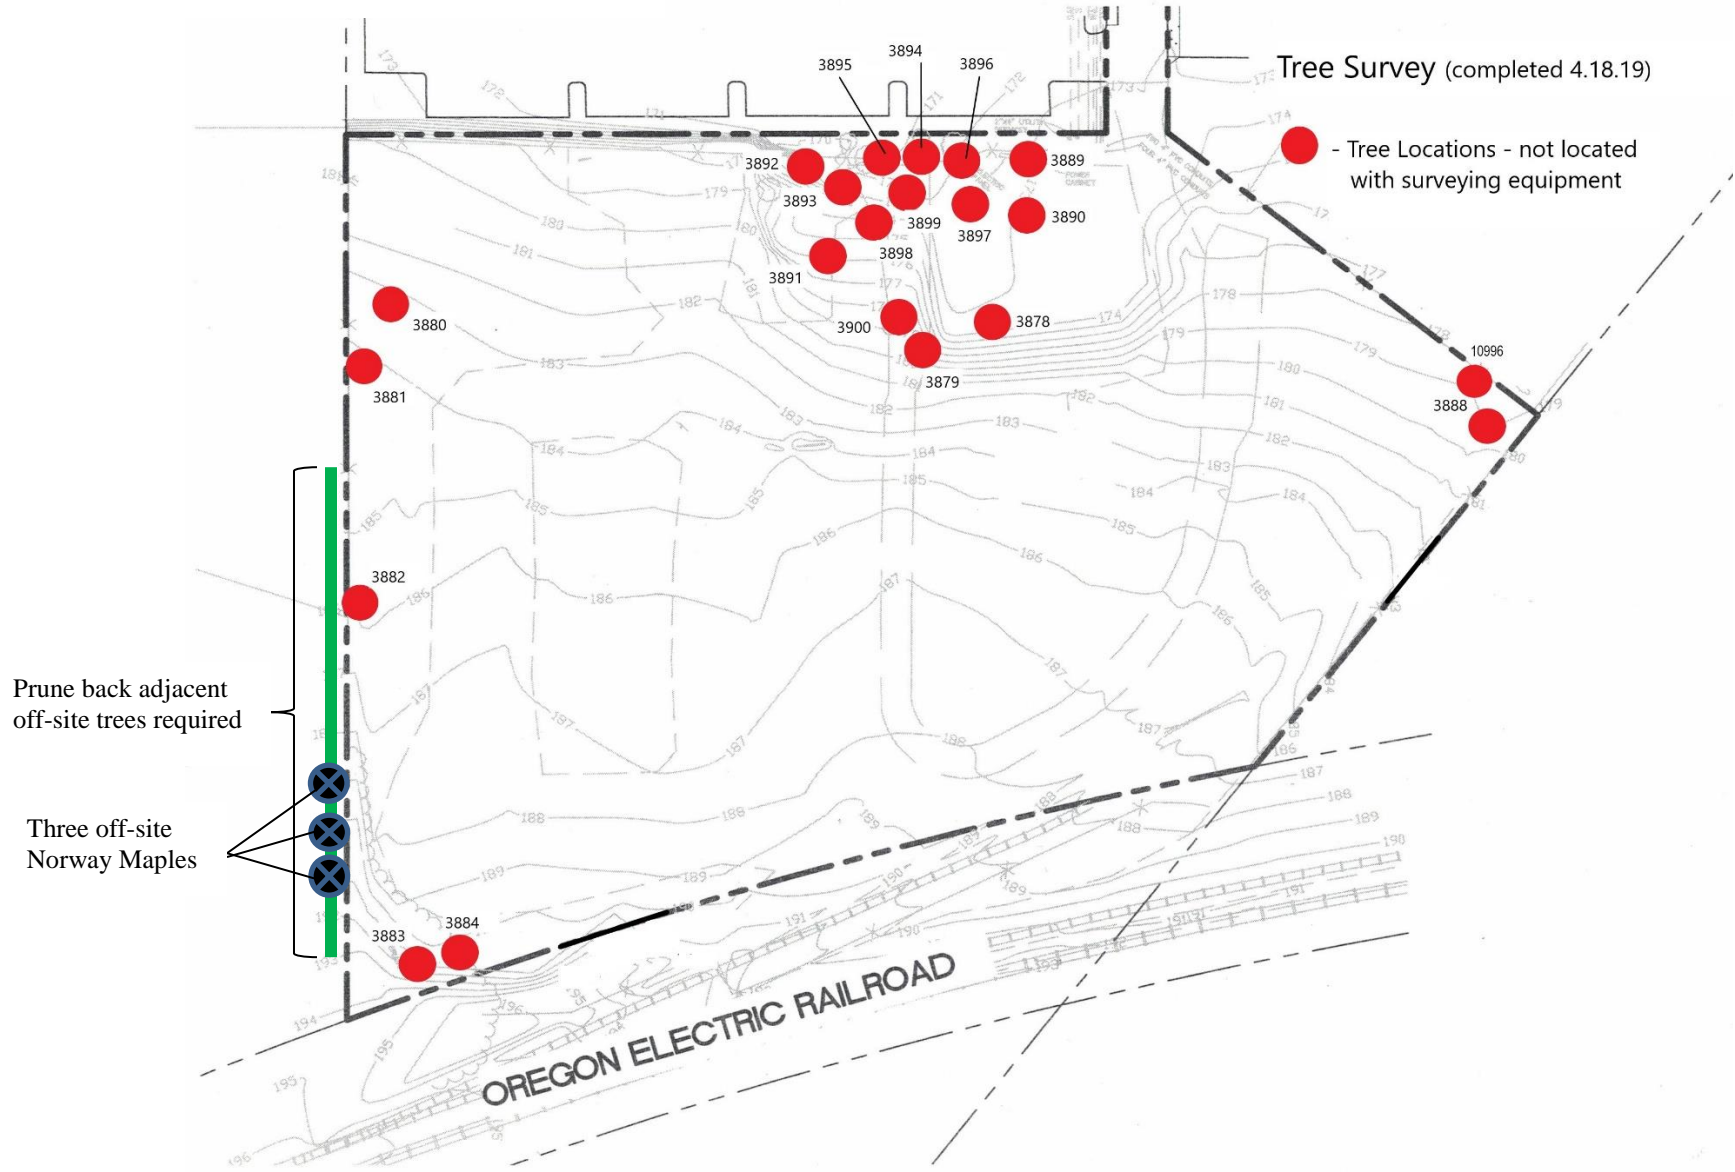
Figure 1 Existing Tree Survey

Tree cover is confined to the periphery and less disturbed areas of the site. The majority of trees are Western cottonwoods, a pioneer species frequently found on disturbed land. All of the cottonwood trees are young or semi-mature and are within the 10 to 30-year age range. These trees are generally in fair to good condition. There are a few Sweet cherry and English hawthorn trees. These are naturalized species and are considered invasive and undesirable within the region. These trees were generally multi-stem trees and all of them were unmaintained/ managed. The two young willow trees noted are also pioneer species common on disturbed land – these have sprouted within the last 10-years. The sweet chestnut along the west fence line is unusual and appears to be self-seeded. The tree consists of four stems fused together in linear fashion. Unfortunately, this tree is growing directly on the fence line and is starting to bulge and damage the fence itself. No trees with high value as landscape specimens exist on the parcel.

1. Adjacent to the west fence line are three planted Norway maples and some other ornamental trees with branches stretching over the property line (see area marked in Figure 1). These trees should be carefully pruned back by an ISA Certified Arborist before any construction takes place. The three Norway maples in particular should be protected from root disturbance as much as possible: the trees are only 3-ft from the existing property line fence so the soil surface within the proposed development setback should be protected to the fullest extent possible. A radius of 10-ft from the base of the trees to any ground excavation should be adequate to protect the health of these trees.
