Portland Tree Consultancy

ARBORIST REPORT **(Tualatin Development Code 33.110)**

For: Mutual Materials Site, Tualatin, Oregon

DATE April 23rd, 2019

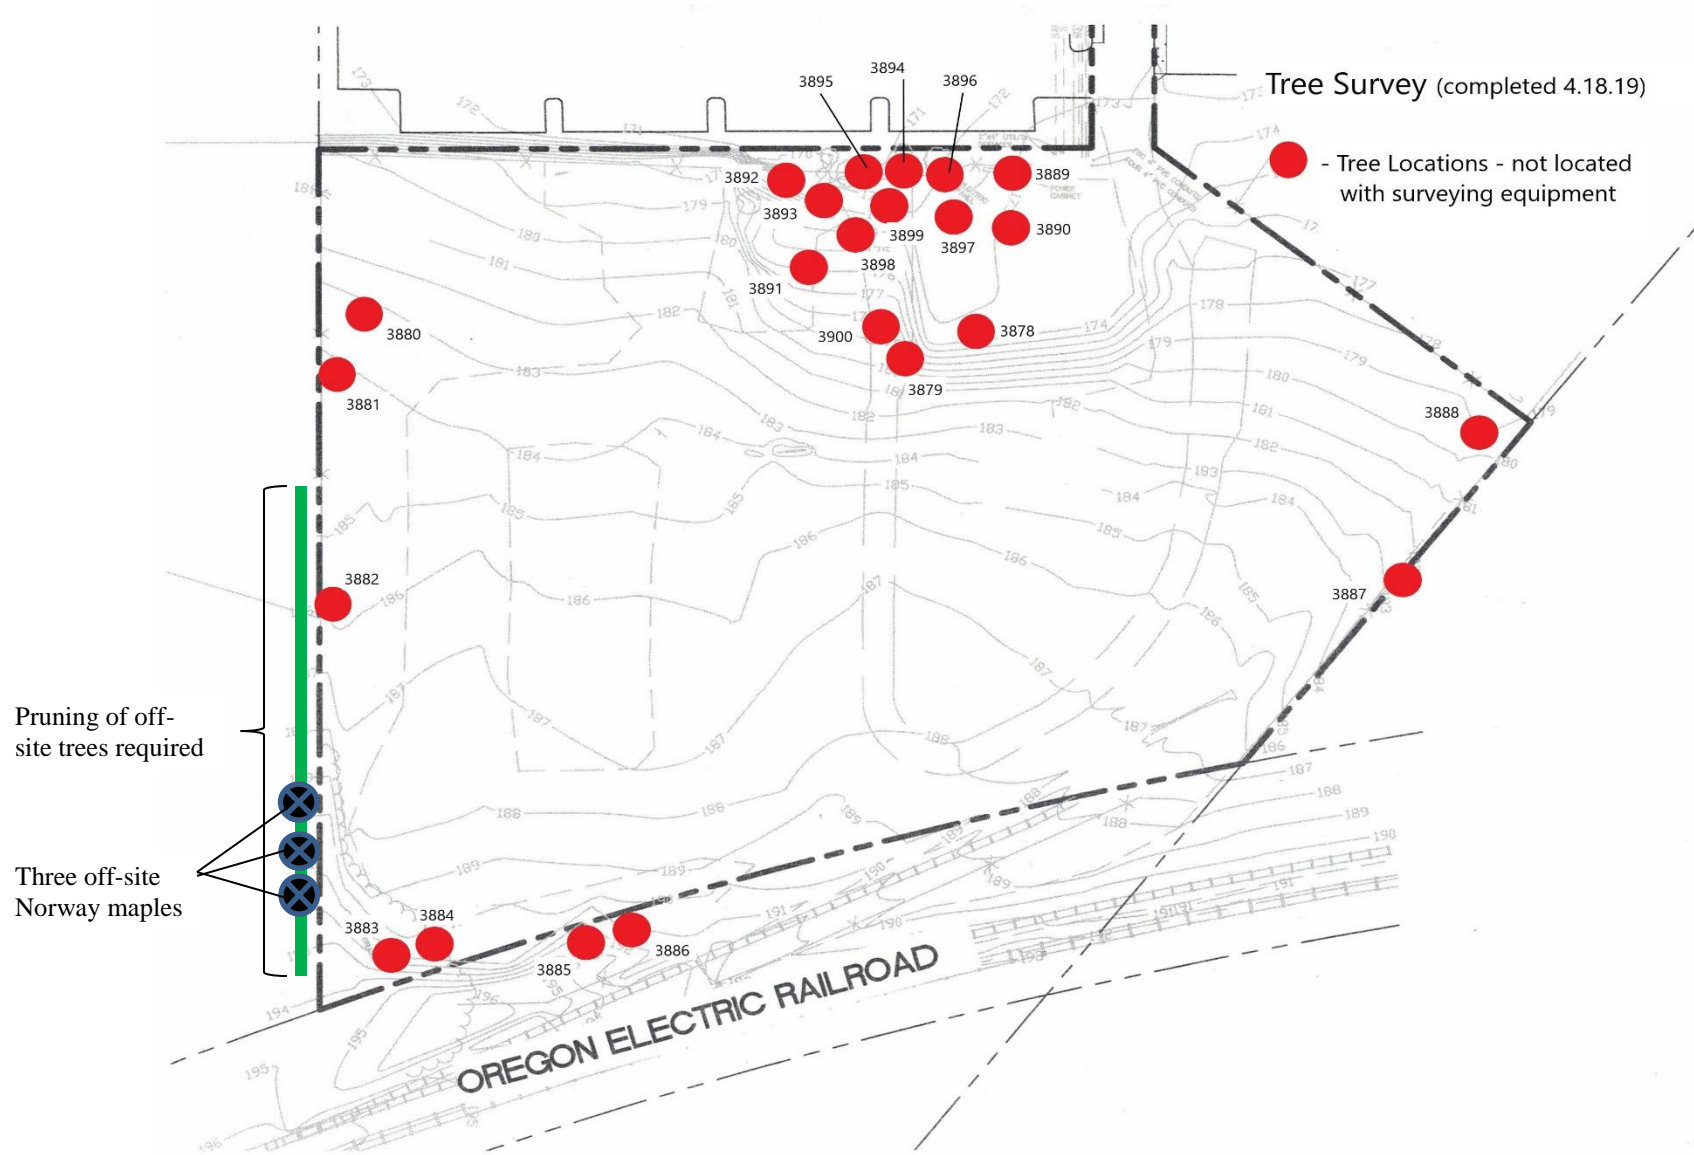
Figure 1. Existing Tree Survey

Tree cover is confined to the periphery and less disturbed areas of the site. The majority of trees are Western cottonwoods, a pioneer species frequently found on disturbed land. All of the cottonwood trees are young or semi-mature and are within the 10 to 30-year age range. These trees are generally in fair to good condition. There are a few Sweet cherry and English hawthorn trees. These are naturalized species and are considered invasive and undesirable within the region. These trees were generally multi-stem trees and all of them were unmaintained/ managed. The two young willow trees noted are also pioneer species common on disturbed land – these have sprouted within the last 10-years. The sweet chestnut along the west fence line is unusual and appears to be self-seeded. The tree consists of four stems fused together in linear fashion. Unfortunately, this tree is growing directly on the fence line and is starting to bulge and damage the fence itself. No trees with high value as landscape specimens exist on the parcel.

1. Adjacent to the west fence line are three planted Norway maples and some other ornamental trees with branches stretching over the property line (see area marked in Figure 1). These trees should be carefully pruned back by an ISA Certified Arborist before any construction takes place. The three Norway maples in particular should be protected from root disturbance as much as possible: the trees are only 3-ft from the existing property line fence so the soil surface within the proposed development setback should be protected to the fullest extent possible. A radius of 10-ft from the base of the trees to any ground excavation should be adequate to protect the health of these trees.
