TREE PRESERVATION & ASSESSMENT REPORT **(Tualatin Development Code 33.110)**

For: Moore Project Site, Tualatin, Oregon

DATE April 5th, 2021

PROPERTY ADDRESS: 20865 SW 105th Ave., Tualatin, OR 97062

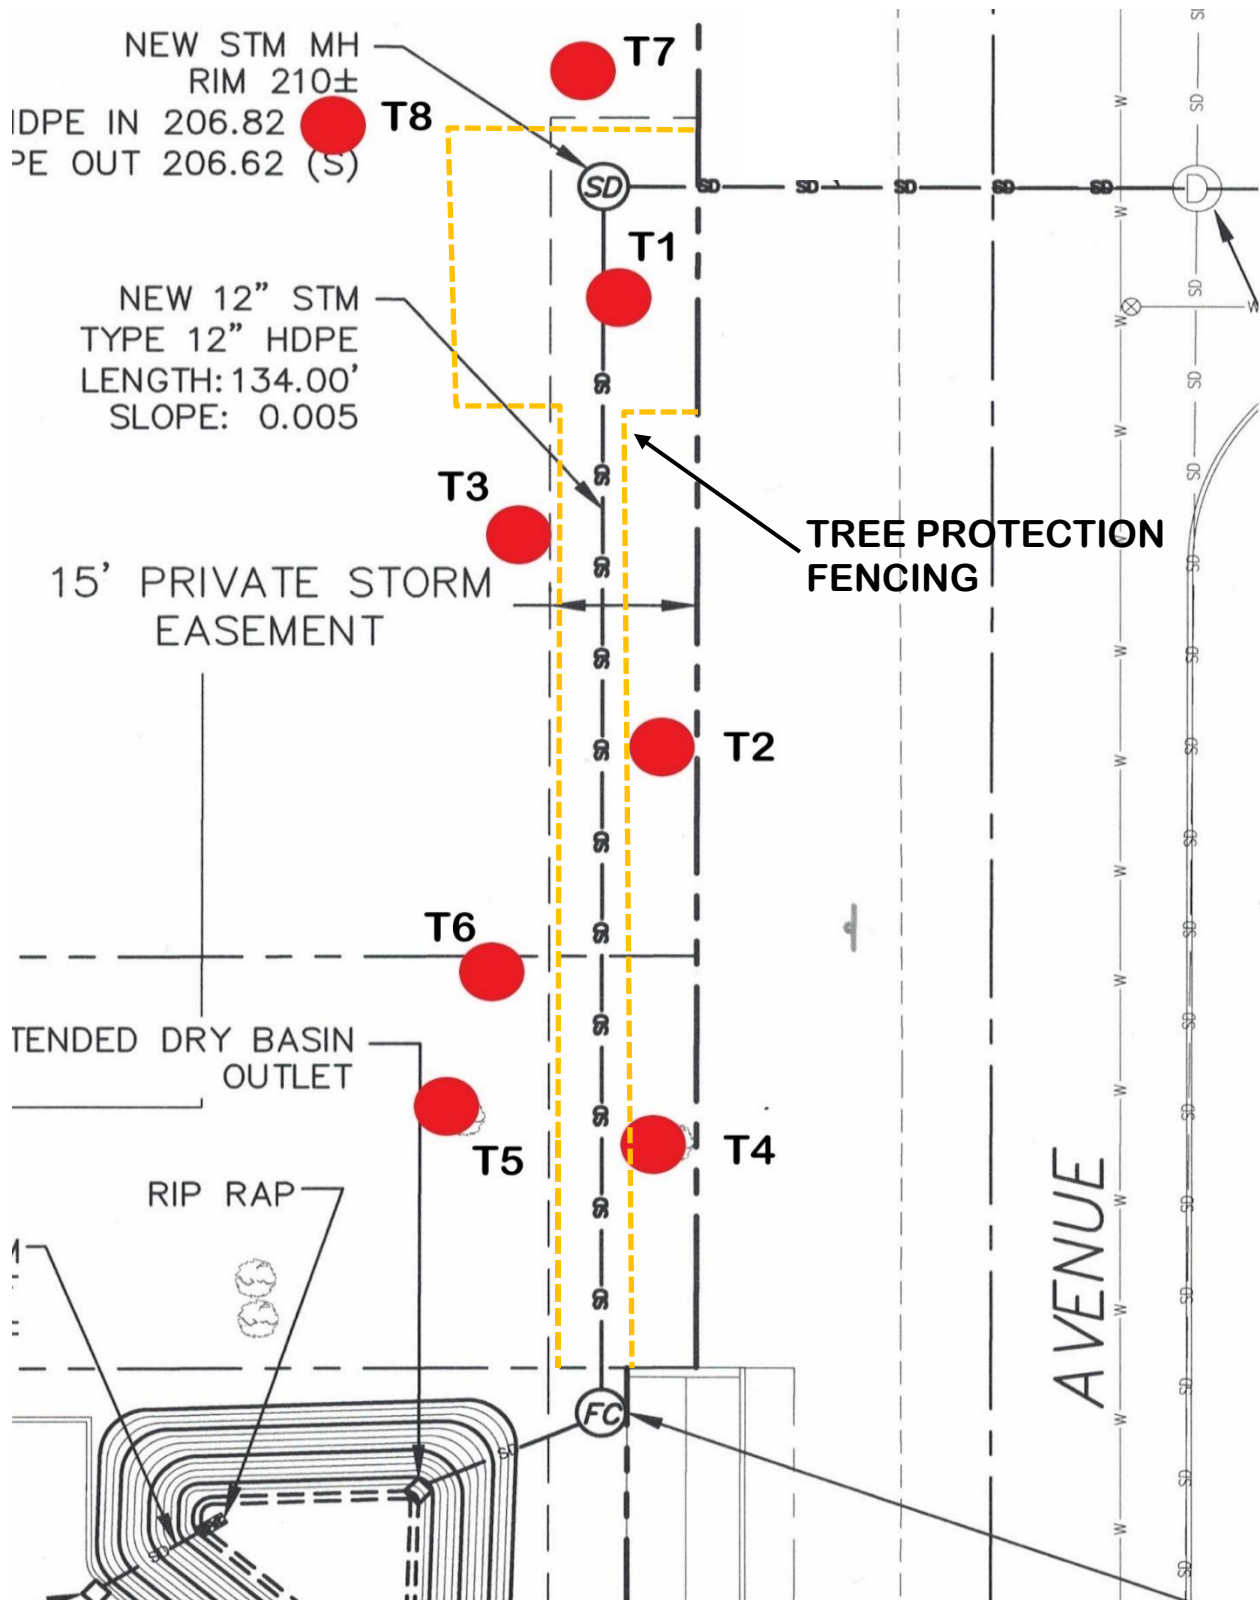
FIGURE 3. Inventory of Utility Easement Trees, Locations are approximate & not surveyed (Refer to Table 2)

All the trees adjacent to the proposed line are in good condition and can survive a significant amount of root loss. The trees are semi-mature at present and not significant as landmark trees. Figure 3 shows the location of the trees. The second column of Table 2 shows the distance of each tree from the center-line of the stormwater line which was field marked at time of inspection.

2. Assuming a 3-ft wide trenching centered on the proposed alignment show below and full open trench excavation, then Trees 1, 2, and 4 should be removed and the other trees can be protected with fencing.

3. If the alignment can be moved 3.5-ft west then it may be possible to save all of the trees if a tracked mini-excavator can be specified for the work. Tree 1 would still remain a possibility for removal. An arborist should be on-site during the initial stages of the excavation to make a final determination on tree removal and retention.

5. Because these trees are very low branched it is recommended that Tree Protection Fencing is orange safety web fencing is used secured in the ground by heavy duty T-posts. General fence locations are shown in Figure 3 but will be adjusted dependent on the size of the excavation equipment and the exact alignment of the utility pipe.

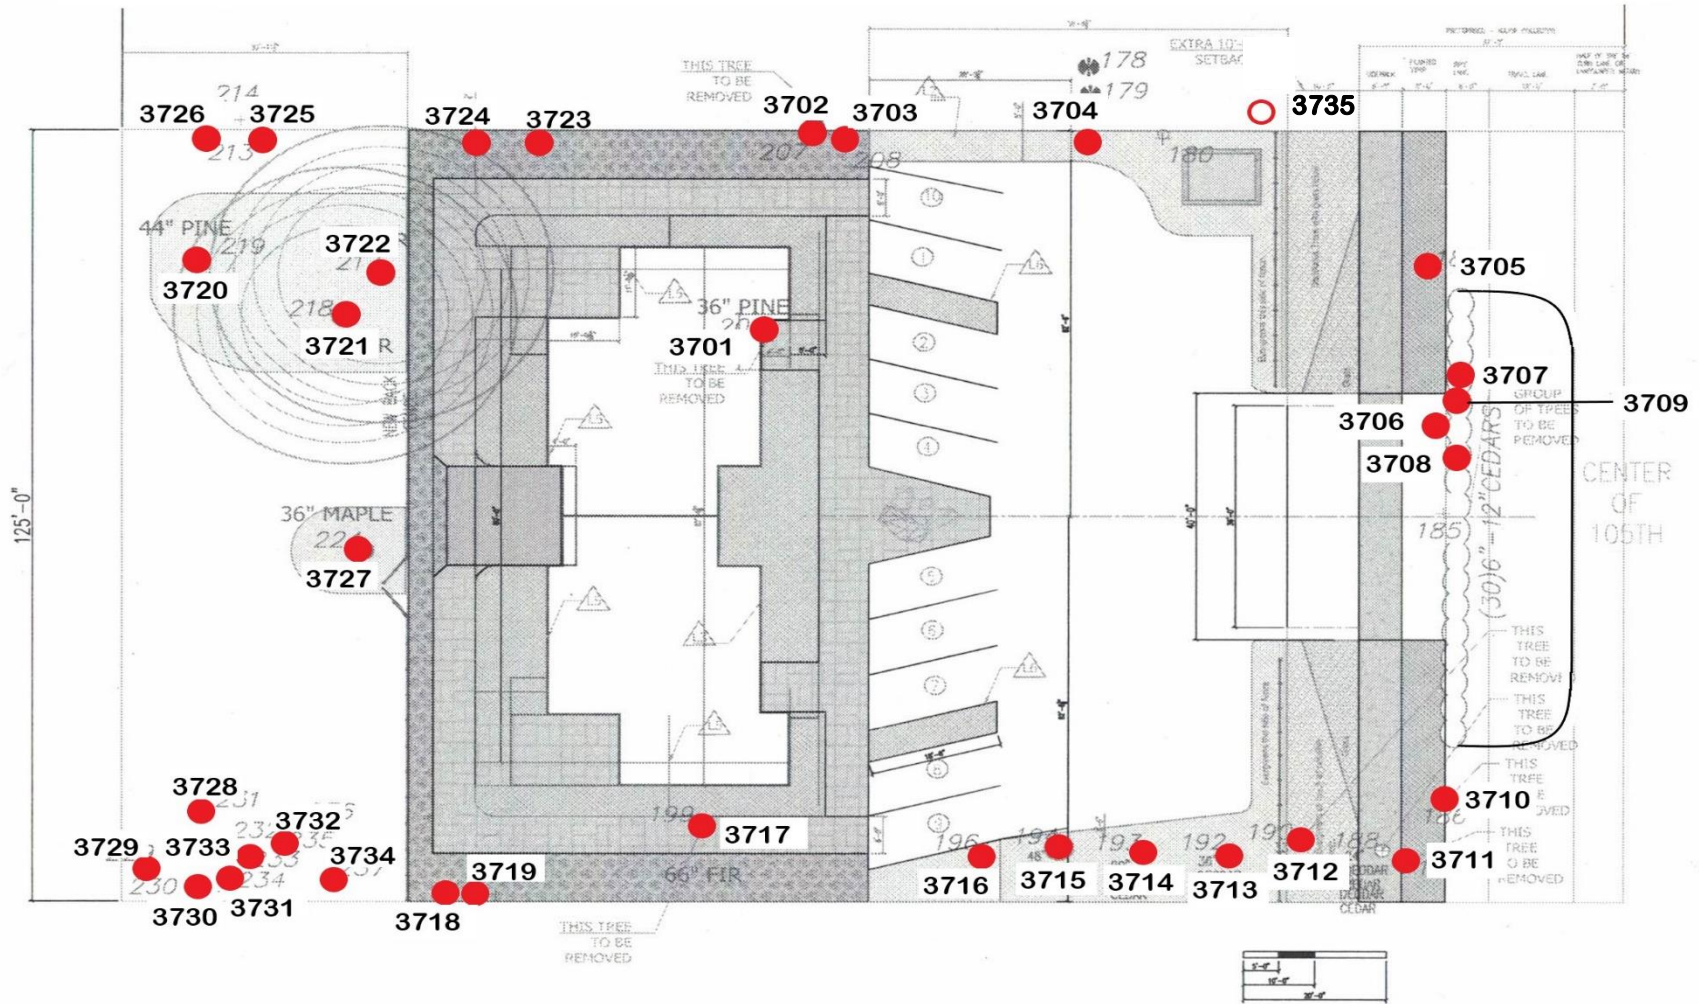
FIGURE 1. Inventory of Site Trees (Site layout has been superseded)

A tree inventory, site inspection and tree preservation/ assessment, was completed on June 18, 2019 and again on December 18th, 2020. All trees at, above, or just below, 8-inches DBH were tagged with metal discs as required by the Tualatin Development Code. TABLE 1 & FIGURE 1 show the result of this inventory.

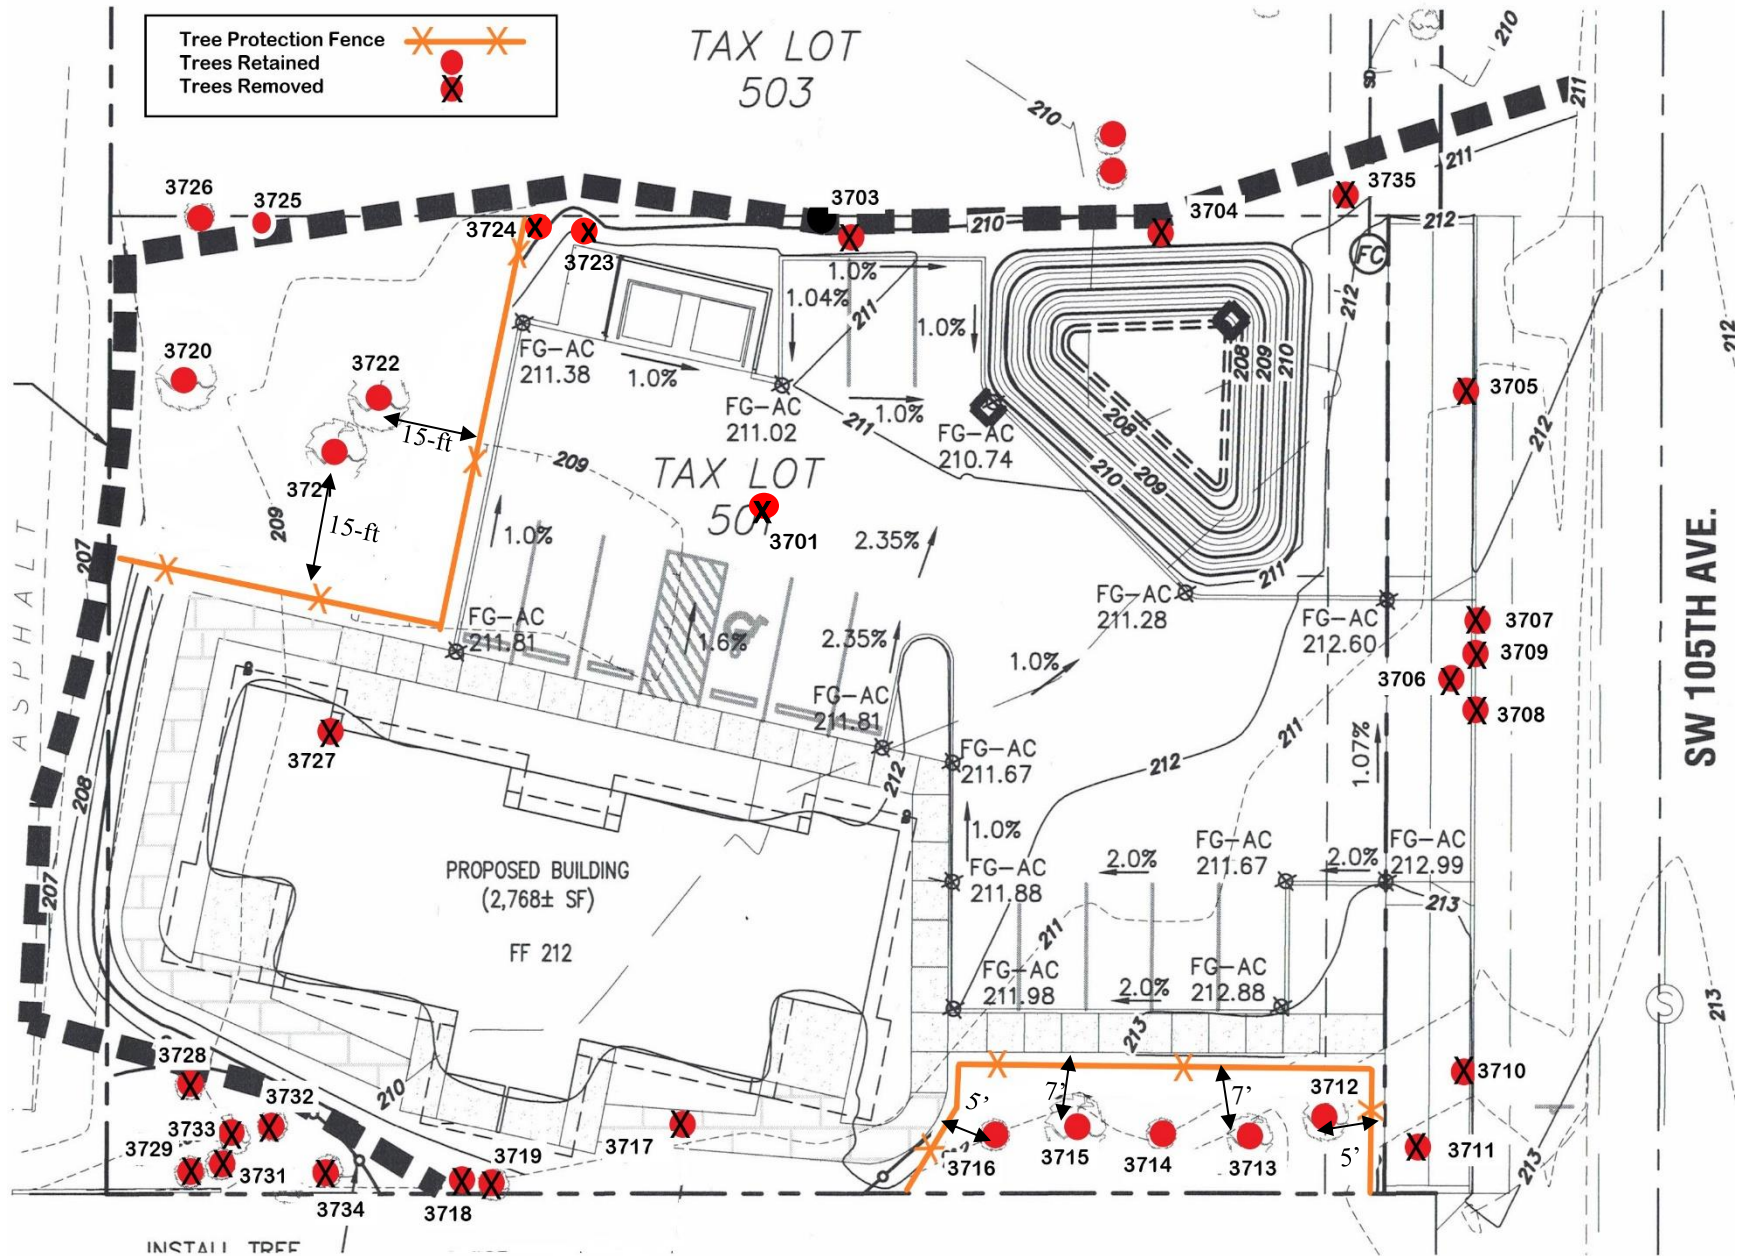
FIGURE 2. Tree Plan & Tree Protection Plan (Site)

The following trees 23 are proposed to be removed (see Figure 2): Trees 3711, 3710, 3708, 3706, 3709, 3707, 3705 (all to be removed due to their location within or adjacent to the public right-of-way. Trees 3735, 3704, 3703, 3723, 3724 are all along the west property line and are either too near excavation or fill for parking lot curbs, stormwater structures. These trees are generally in poor condition (see Table 1). Trees 3701, 3717 and 3727 are within the footprint of the proposed building. It is also recommended that the following non-native invasive trees are removed: Trees 3718, 3719, 3734, 3732, 3731, 3728 and 3729. A crabapple (T3733) in poor condition with shared root space within this grouping of invasive trees will not likely survive and is also recommended for removal.

- a) Trees 3720, 3721, and 3722 are very large trees in good to fair condition. The trees have shared root space and have some large surface roots to a radius of 12-ft or so. Fill will be placed within a significant portion of their expected root zone. Keeping fill to 15-ft min. distance will provide sufficient rooting space for the trees to maintain their condition. Tree Protection Fence locations as per Figure 2 will allow this separation. Trees 3725 and 3726 will also be protected by the proposed fence locations. (see Tree Protection Standards 2 & 6)

- b) Five large trees (3712 through 3716) are being preserved at the southeast corner of the property. No excavation of the existing surface will take place adjacent to the trees, but fill will be placed to support the parking area location. It will be important to maintain at least five feet of the existing grade adjacent to the base of the trees in order for the inner root systems of these trees to be aerated. Figure 2 shows the minimum distances for placing the Tree Protection Fence. This fencing will be moved after construction of the parking lot sidewalk to allow placement of large diameter rock over permeable geotextile fabric to allow for an appropriate slope angle. A retaining structure may be constructed in place of the rock fill. (see Tree Protection Standard 6)

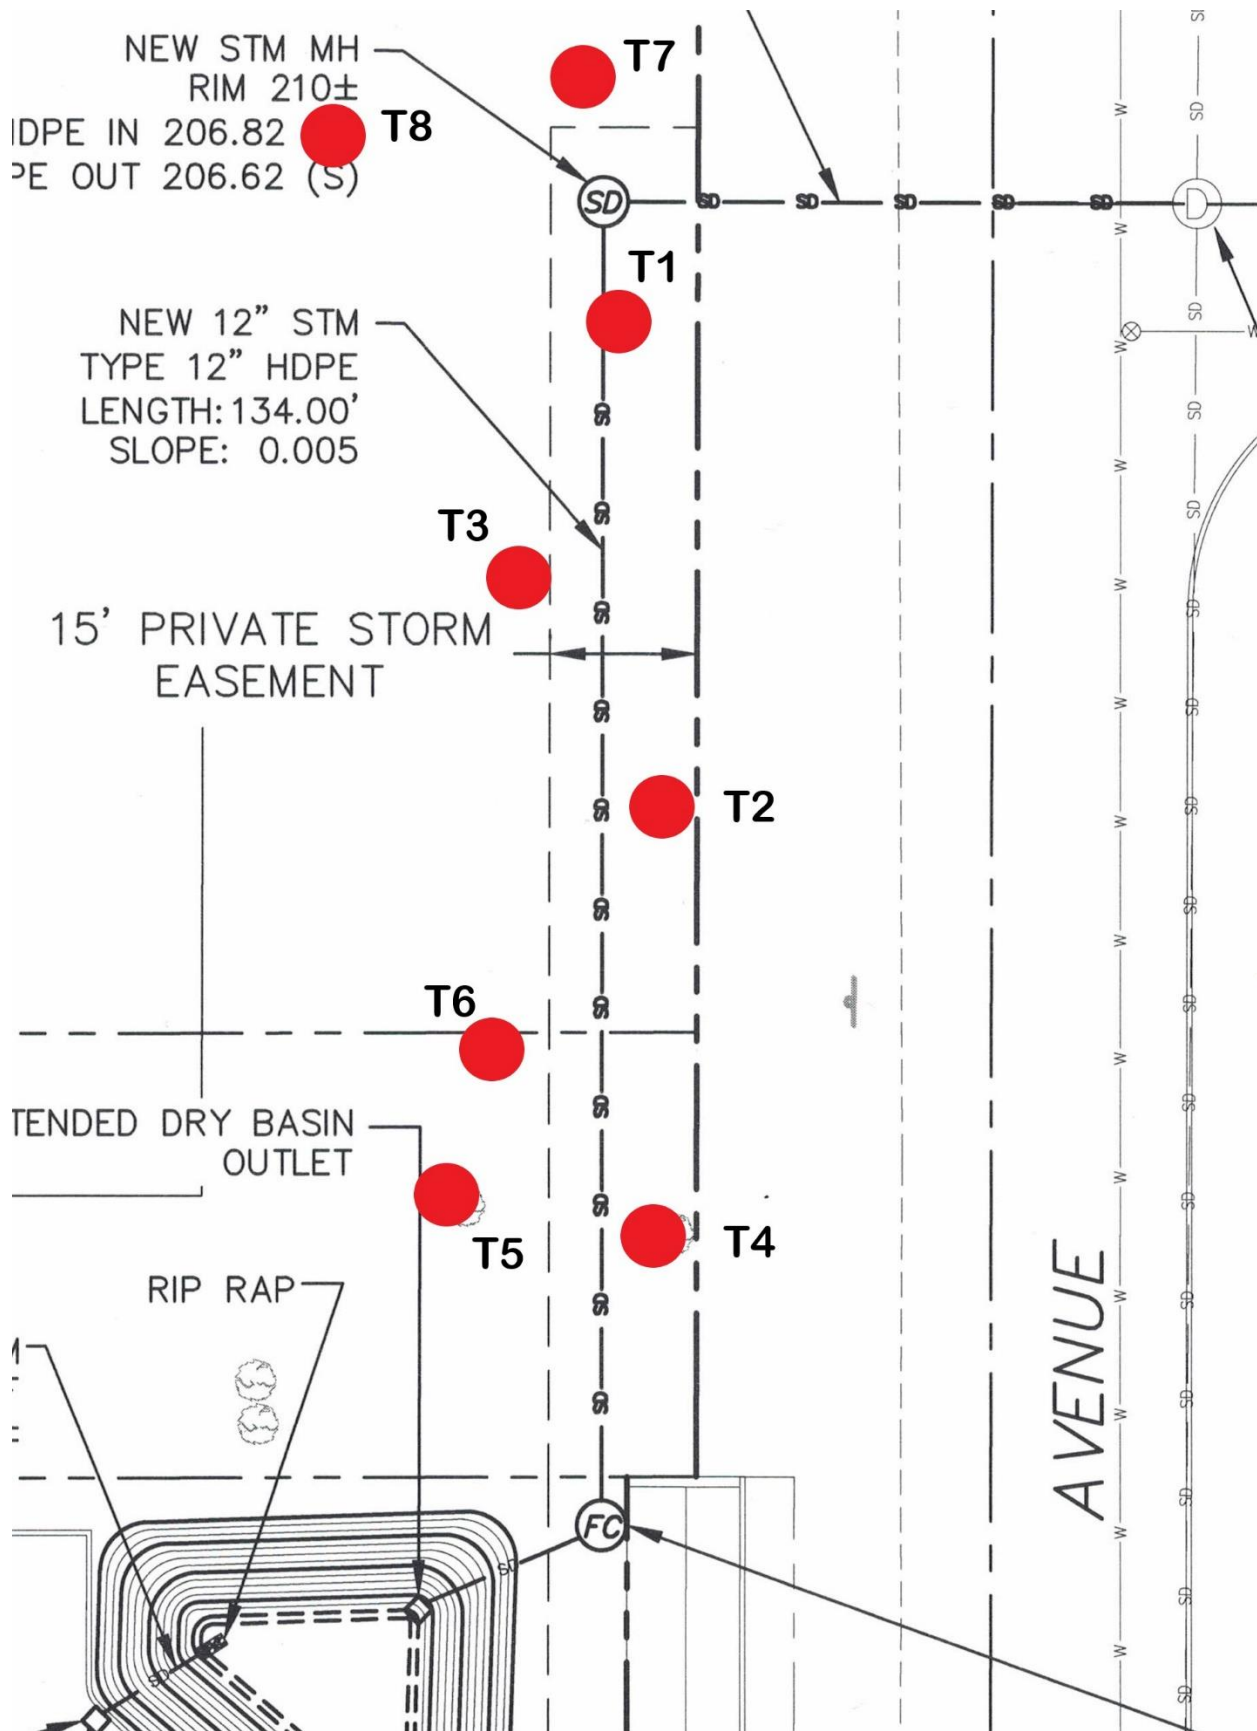
FIGURE 1. Inventory of Trees, Locations are approximate & not surveyed (Refer to Table 1)

All the trees adjacent to the proposed line are in good condition and can survive a significant amount of root loss. The trees are medium size at present and not significant landmark trees. The second column of Table 1 shows the distance of each tree from the field marked center-line of the stormwater line.

1. Further information is needed on the width of the trench required and the size of the equipment needed to complete the work.
2. Assuming a 3-ft wide trenching on the proposed alignment and full mechanical trench excavation, then Trees 1, 2, and 4 should be removed and the other trees can be protected with fencing. If possible the trench should be moved 2-ft to the east for further protection of the remaining trees.
3. If the alignment can be moved 3.5-ft west then it may be possible to save all of the trees if a tracked mini-excavator can be specified for the work. An arborist should probably be on-site during this excavation to prune roots and oversee the work.
4. Assume subsurface directional drilling will not be possible because of the size of the stormwater line.
