Pre-Construction Tree Inventory & Tree Protection Plan

Inventoried July 2021

Plan Proposed March 2022

Community Partners for Affordable Housing
Plambeck Gardens Multifamily Housing Project
Site Address: 23500 SW Boones Ferry Road
Tualatin, OR 97062

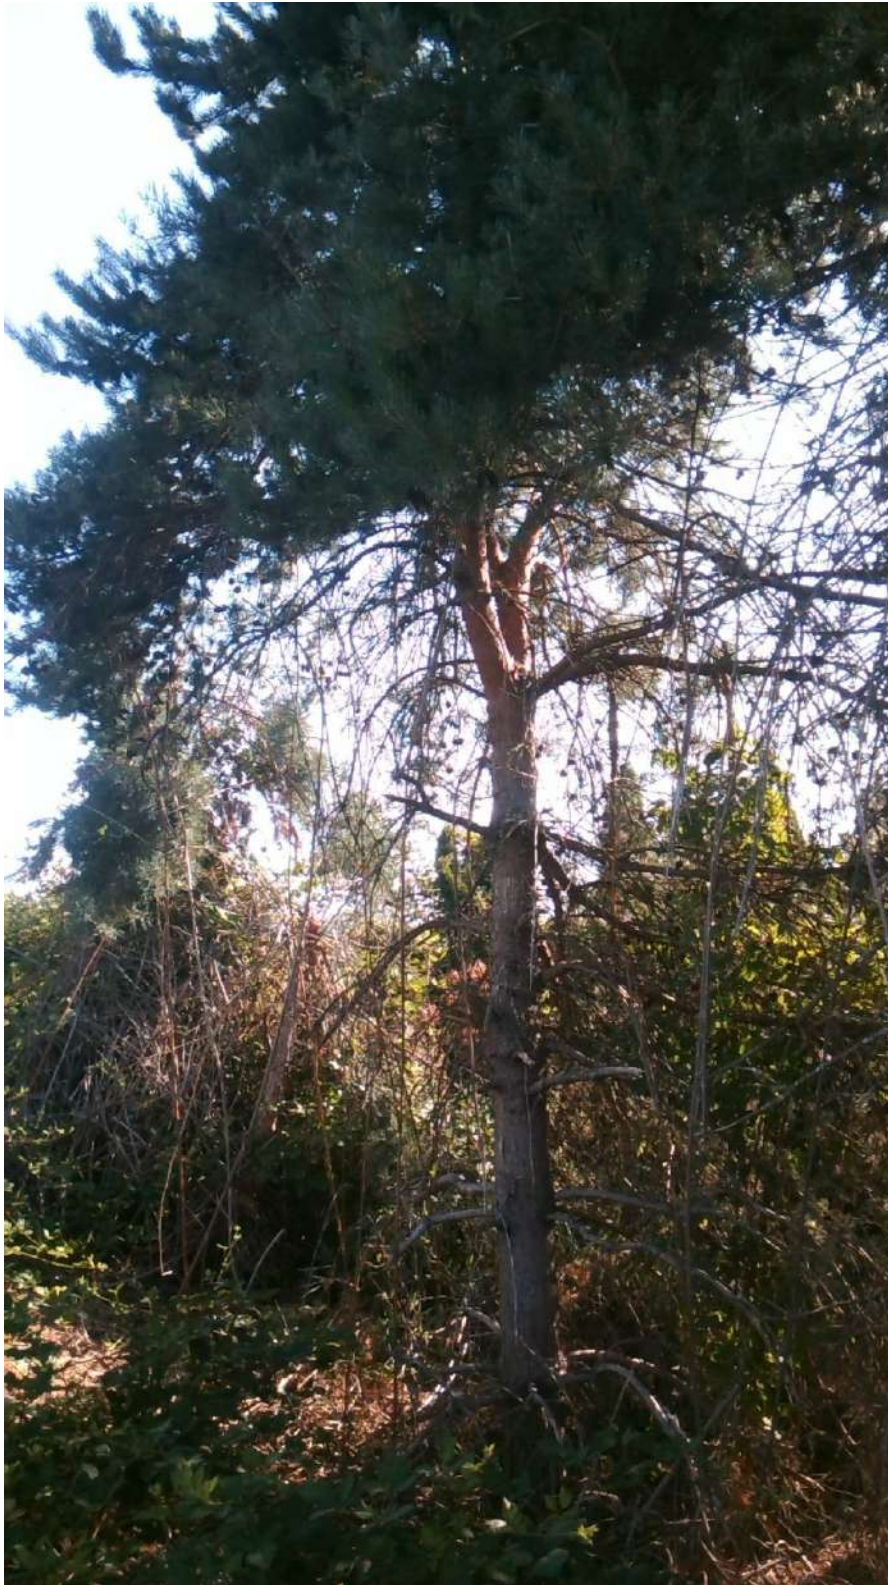
Many of the Scotch pines had prior pruning resulting in co-dominant stems, and have been grown on 5' centers, creating uneven crowns, with low live crown ratios or self-pruning/dieback of most of the lower branches due to competition. Subsequently, many have had branches broken or ripped off, rather than pruned. They meet the conditions of TDC 33.110 (5)(b)(i)(B); evergreens which are unbalanced and lacking a full crown.

Photo 1. Typical Scotch pine with low live crown ratio, poor pruning, meets the conditions of TDC 33.110 (5)(b)(i)(B); evergreens which are unbalanced and lacking a full crown.

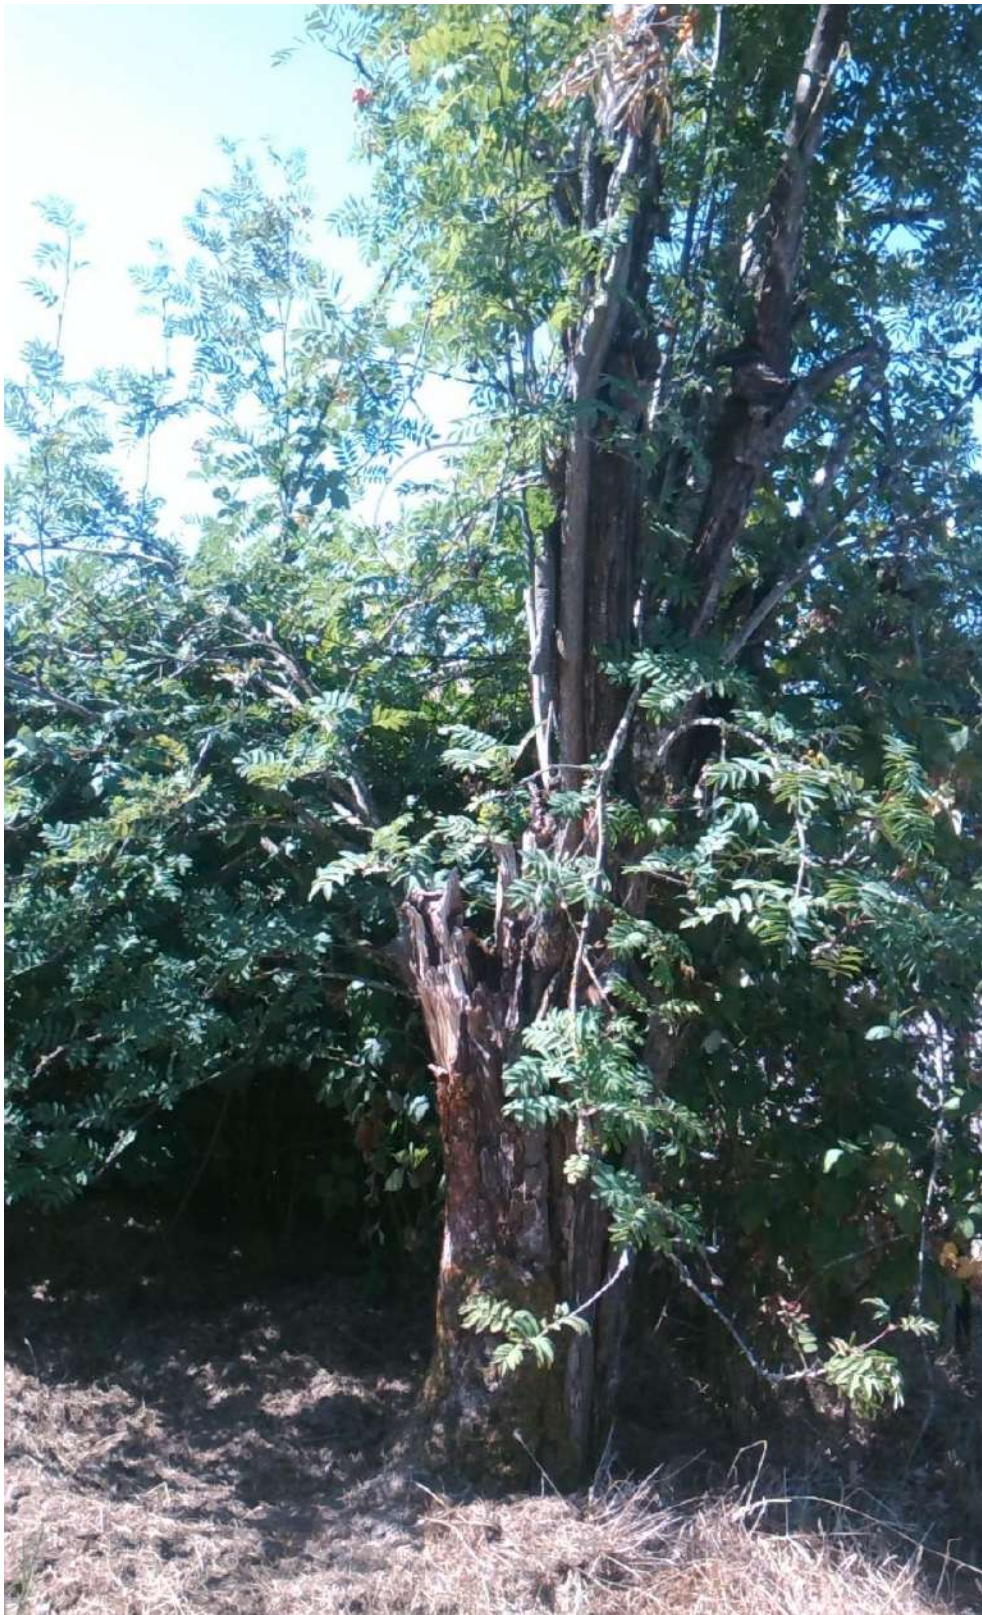
- The trees are primarily in good (40) to fair (56) condition. Six (6) are in poor condition and two (2) are dead. Tree #34 meets the conditions of TDC 33.110 (5)(a)(ii)(B); the tree is hazardous and parts are in danger of falling.

Photo 2. Tree #34 is a mountain ash that is hazardous to preserve due to previous failure, crack, and weakly attached epicormic shoots. It meets the conditions of TDC 33.110 (5)(a)(ii)(B); substantial portions of the tree are in danger of falling.

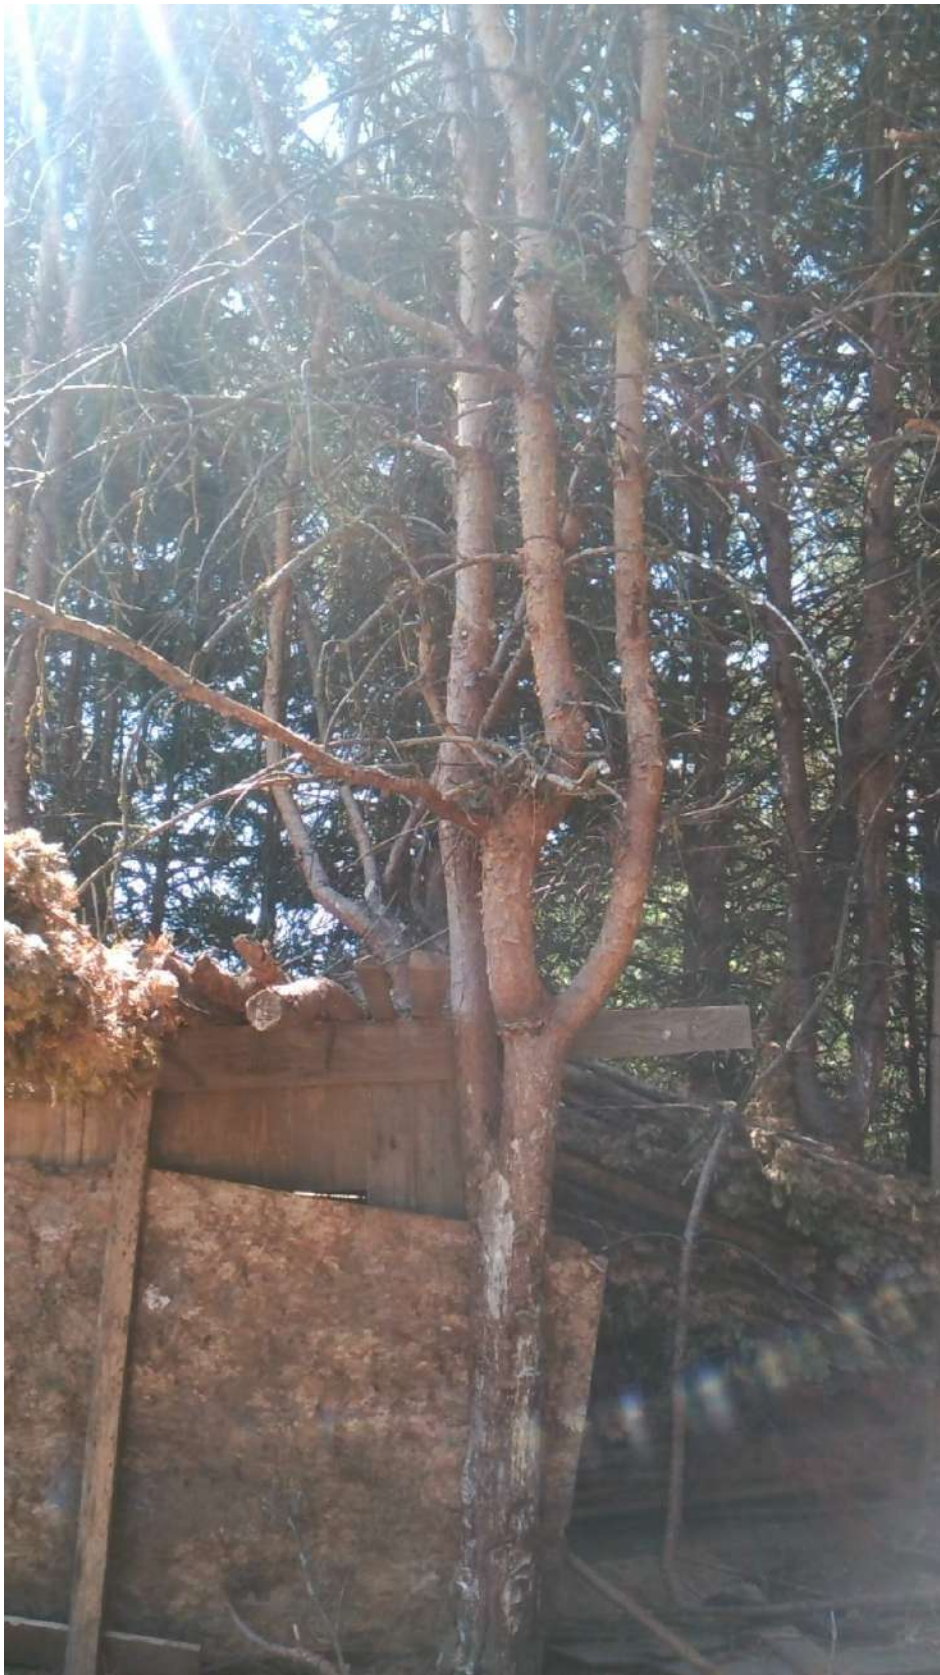
Photo 3. Tree #59 is a dead Scotch pine with multiple leaders. It meets the conditions of TDC 33.110 (5)(b)(i)(B); evergreens which are unbalanced and lacking a full crown.

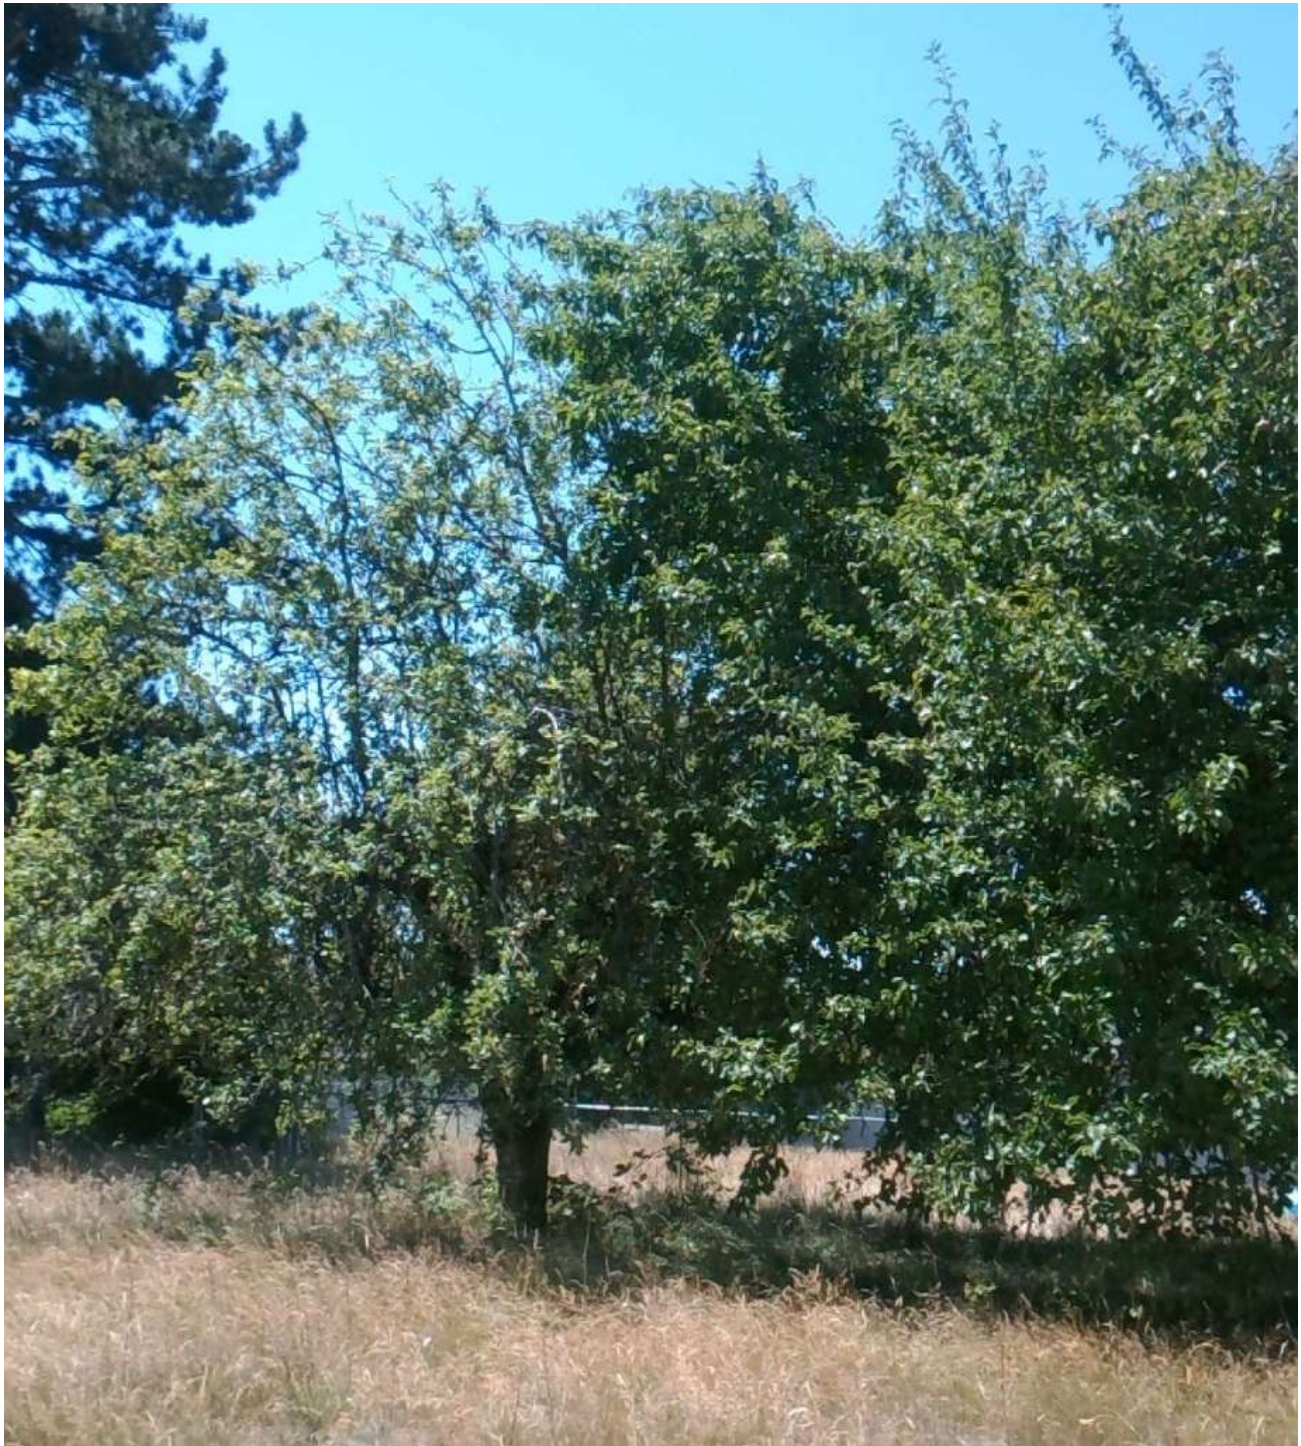
Photo 4. Tree #79 is a fair condition apple tree with a broken limb.

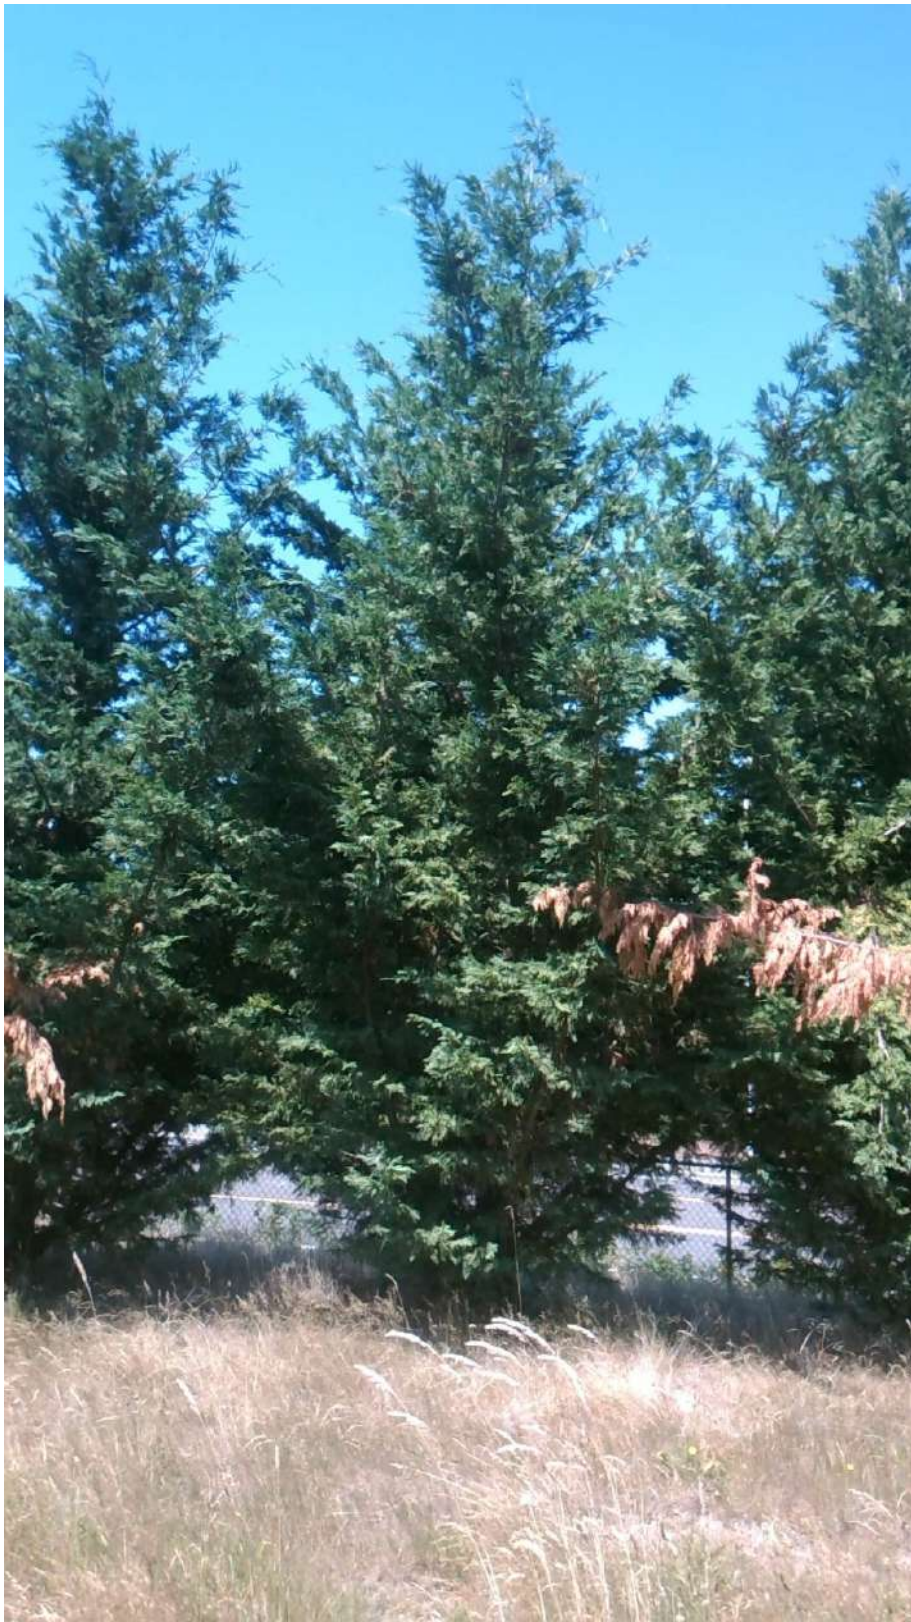
Photo 5. Trees 39-42 and several untagged smaller DBH trees in a row are good condition Leyland cypress.

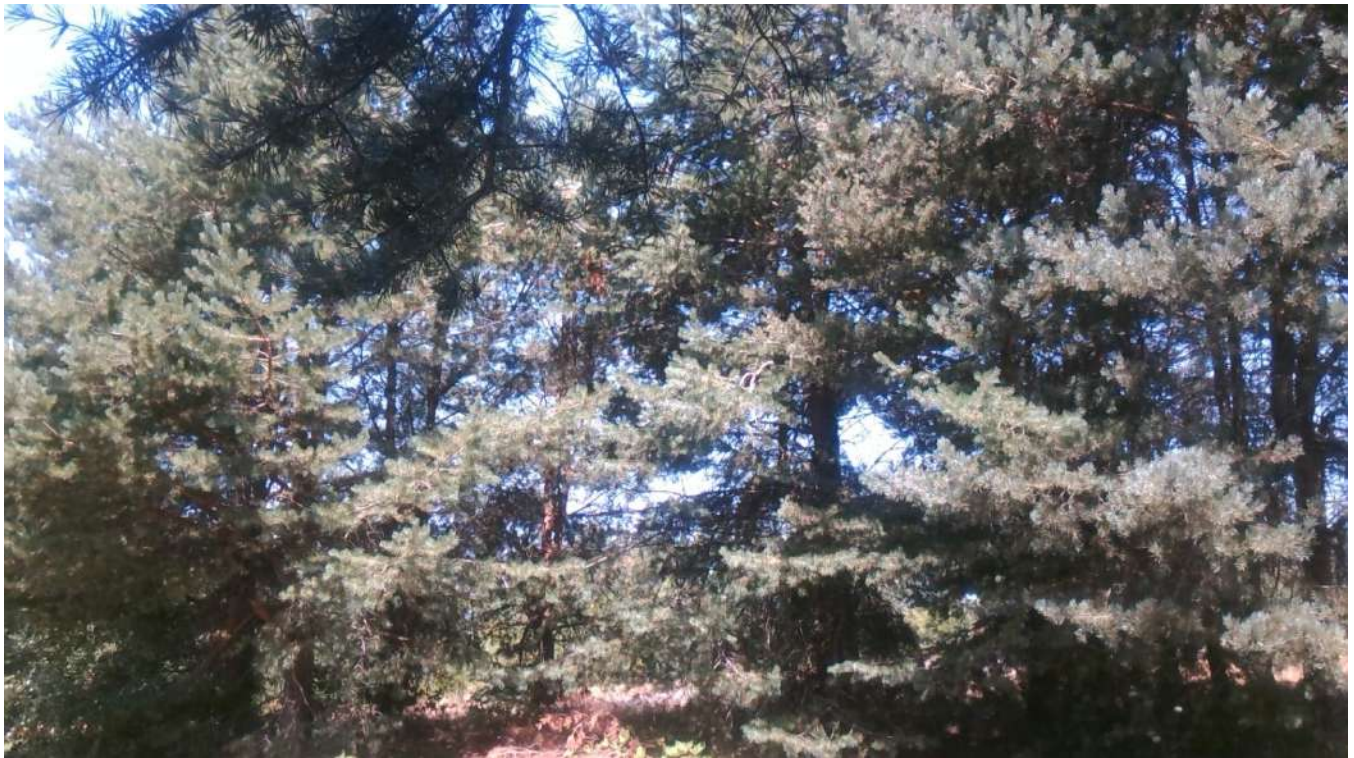
Photo 6. Nine untagged scotch pine on adjacent property near trees #80-82 should be fenced and protected in construction.

1. Fifteen (15) trees on adjacent property are required to be preserved unless alternative agreements are made with adjacent property owners. Provide tree protection fencing for any trees on adjacent property and schedule arborist supervision of any excavation within 12' of adjacent property trees.
2. Eighty nine (89) trees are identified for removal. These trees would be directly impacted by site grading within the structural root zones, and therefore meet approval criteria TDC 33.110 (5)(a)(iii).
3. Slightly modify grading plan to preserve tree #29 and provide tree protection fencing at the furthest possible extent to facilitate grading, but no closer than 12' from the tree trunk. The fence must be a

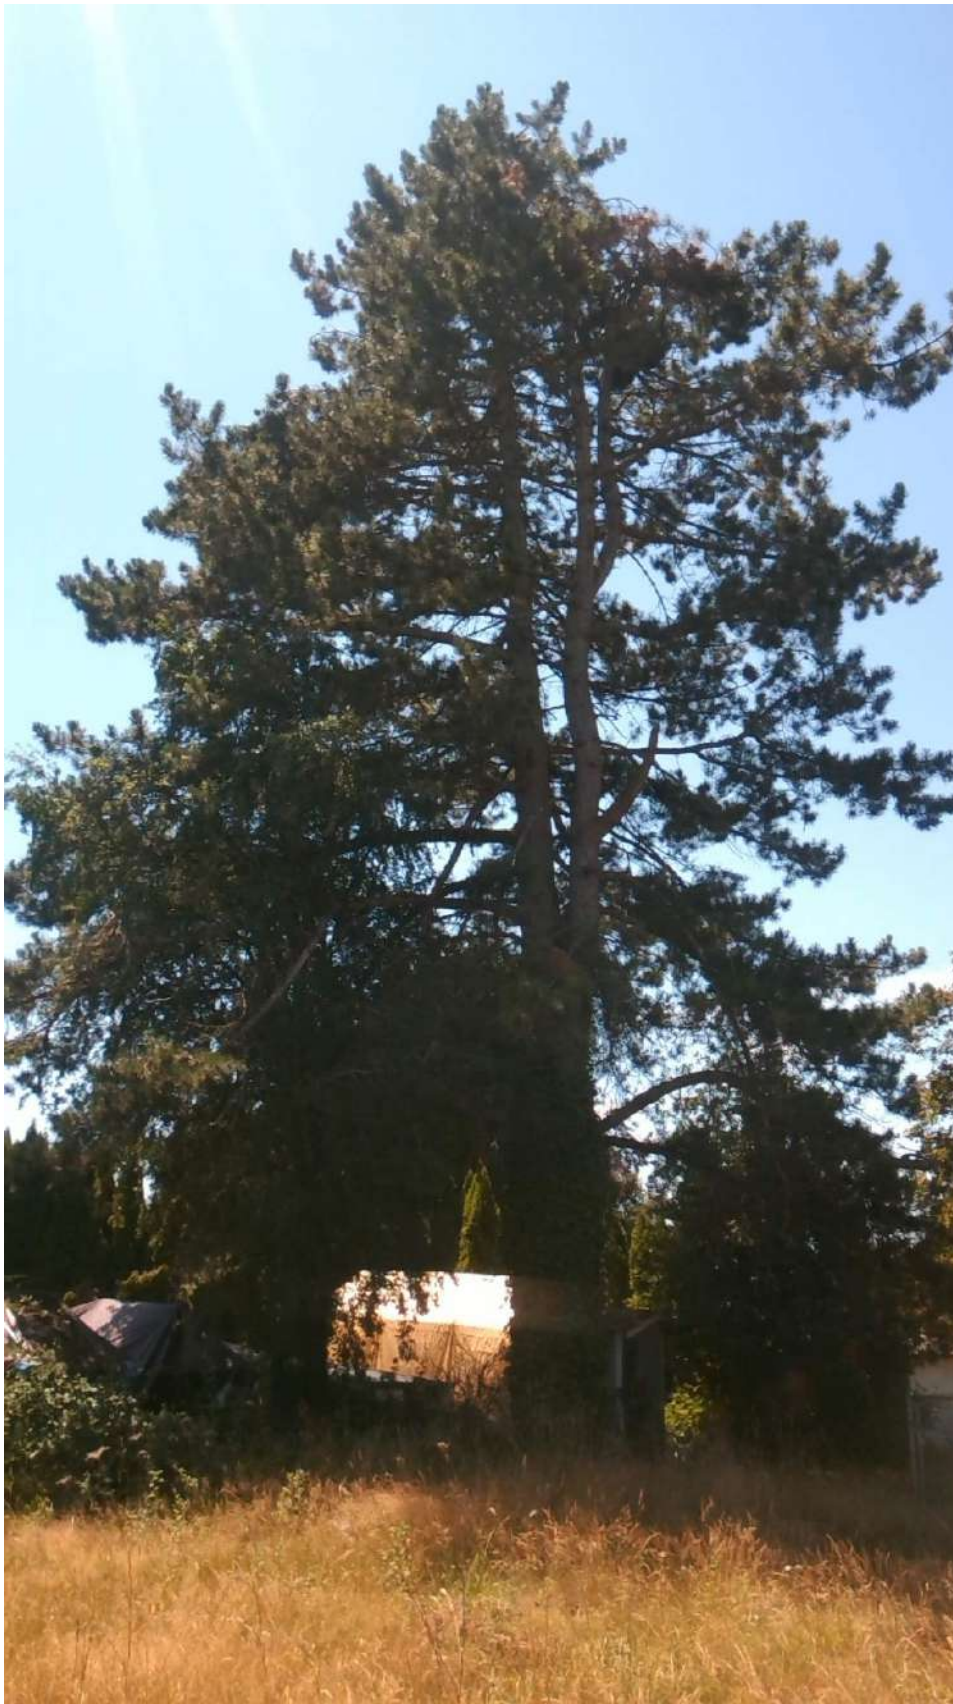
Due to extensive site grading, shown in the Architectural Review submitted drawings March 4, 2022, eighty nine (89) trees have grading impacts in the structural root zone and cannot be preserved. Tree #29 is close to the proposed grade and a minor grade adjustment is possible, according to the civil engineer.

Photo 9. Tree #29 is a co-dominant pine in fair condition.

4. Prior to plan finalization, consider ivy removal and an aerial inspection of tree #29 to determine maintenance recommendations such as pruning or cabling. Hidden defects are possible in its current ivy-covered state.

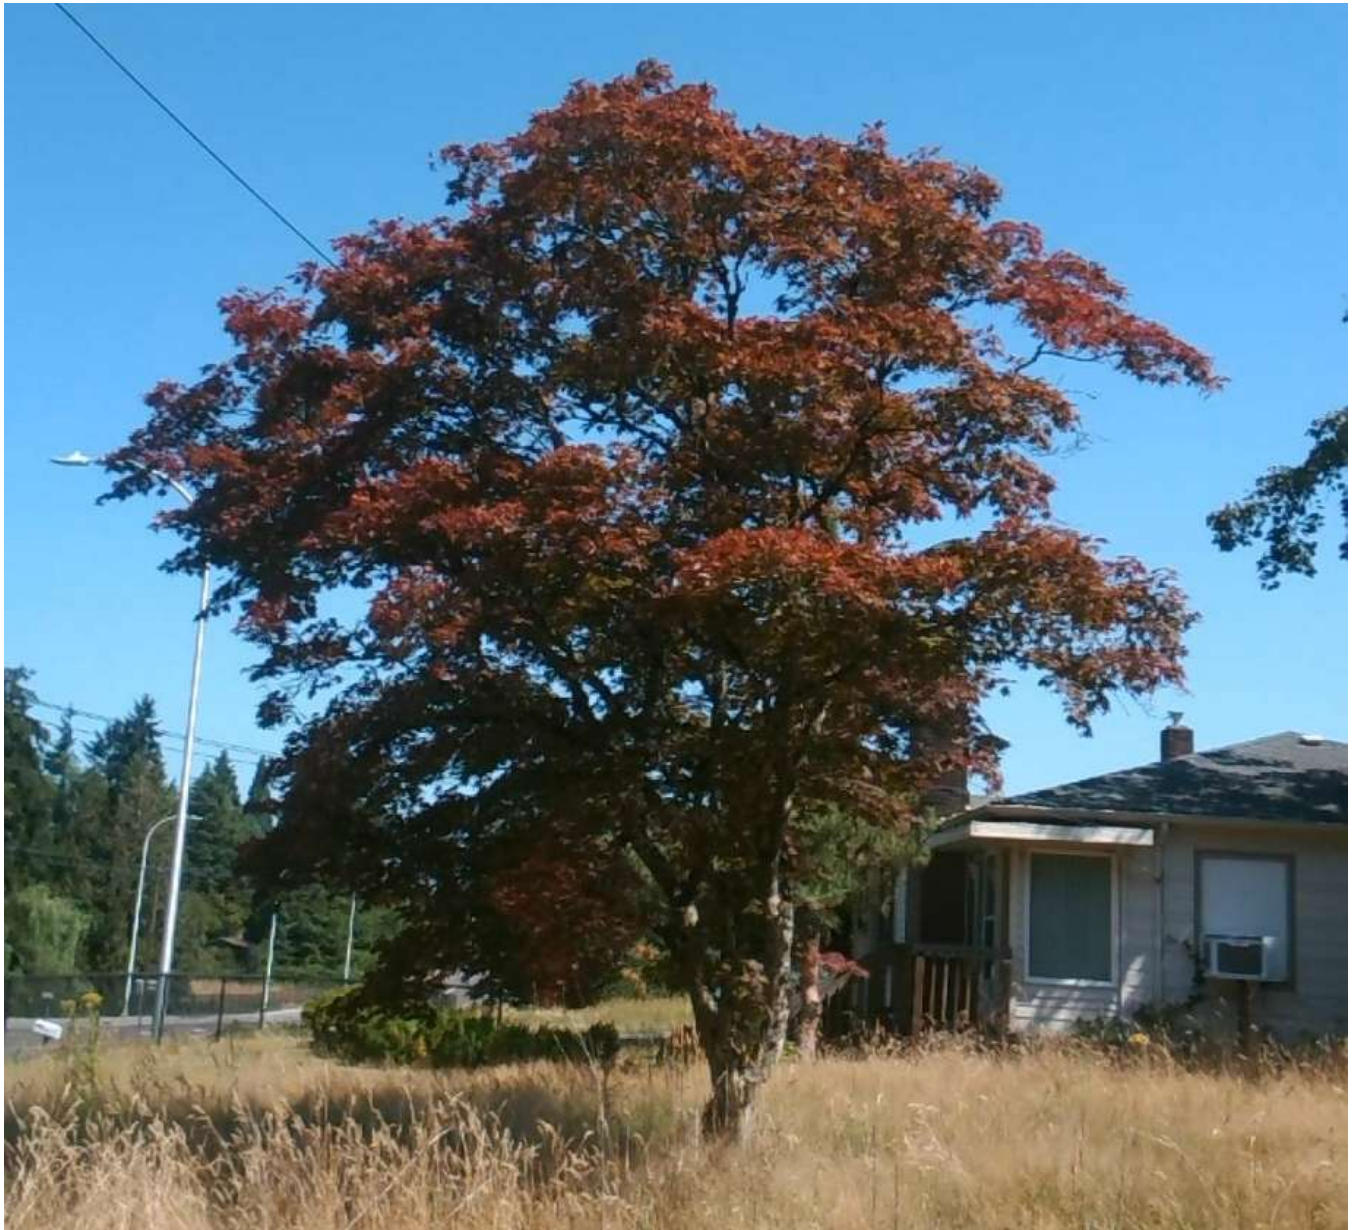
Photo 10. Tree #32 is a good condition Japanese maple

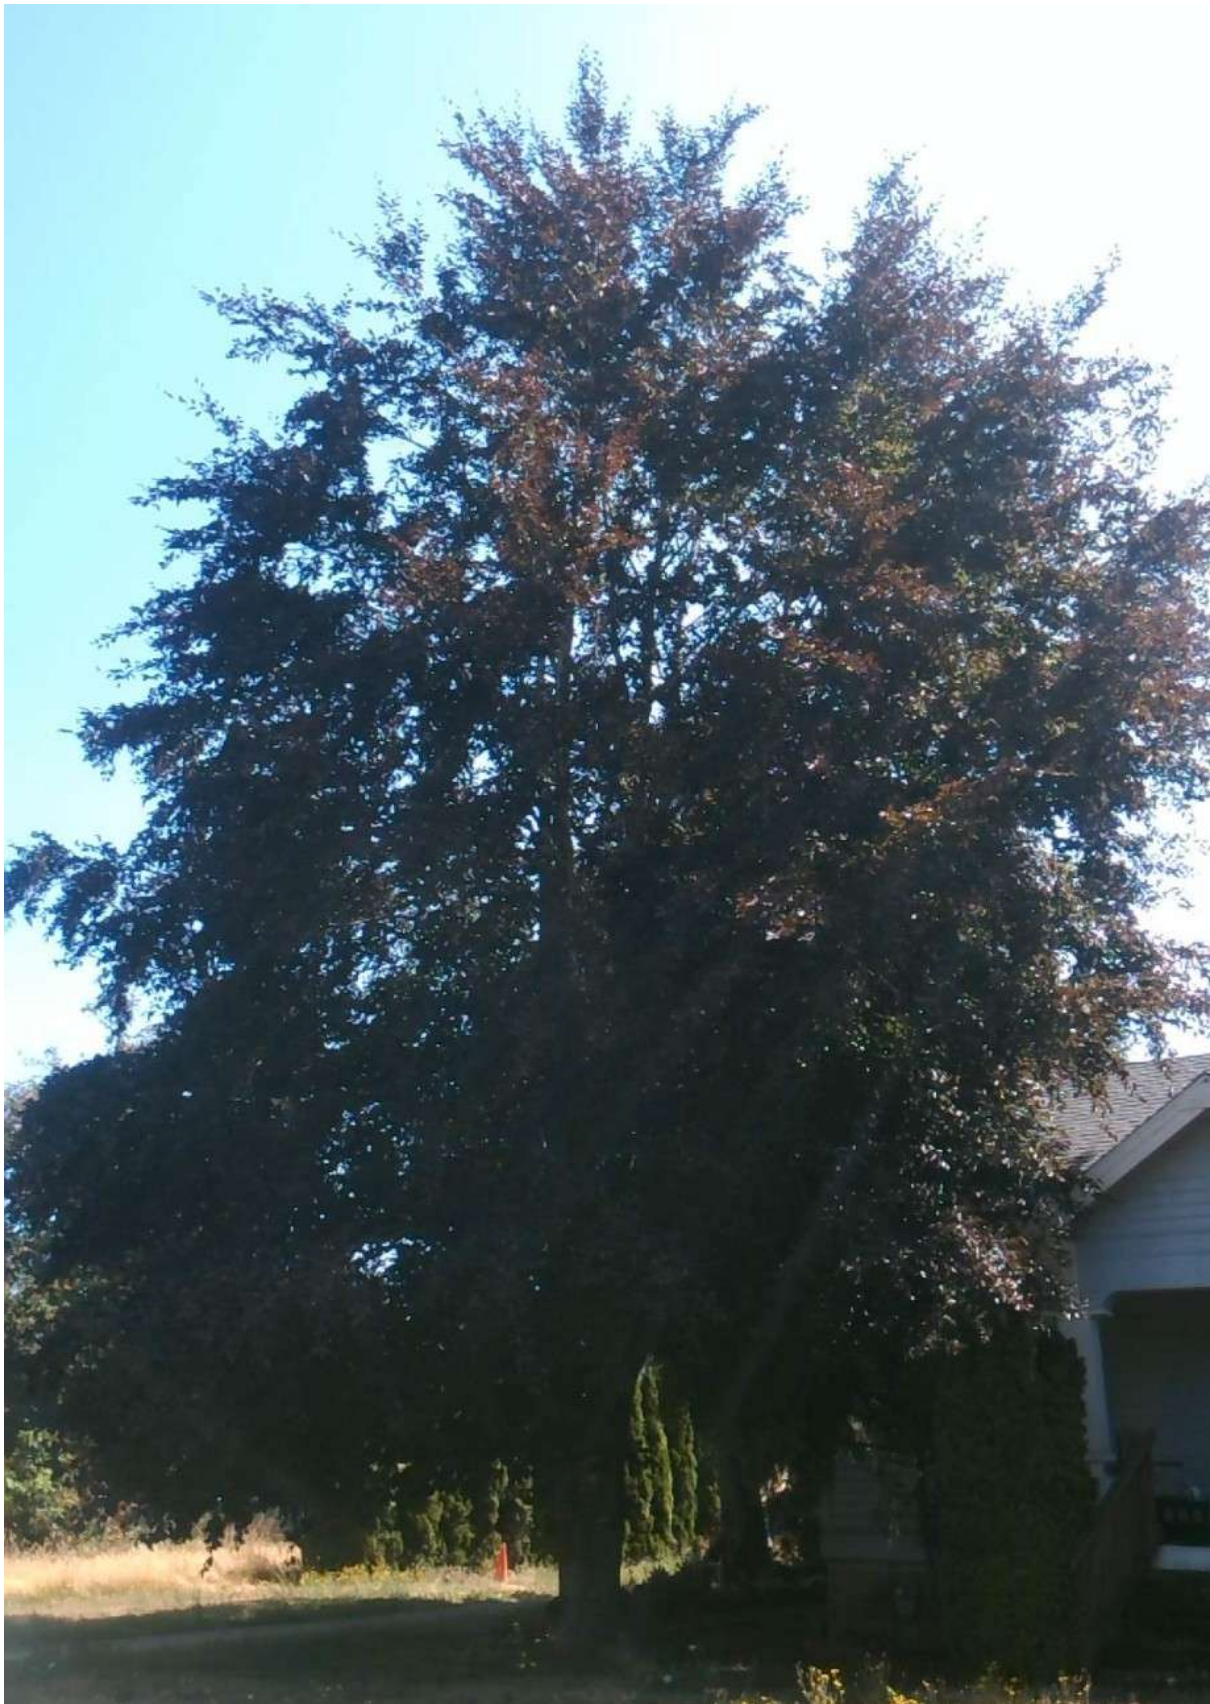
Photo 11. Tree #33 is a good condition Purple beech.
