## Todd Prager & Associates<sub>LLC</sub>

### MEMORANDUM

**DATE:** April 12, 2023

**RE:** Tree Inventory and Preliminary Assessment for Road Improvements associated with the Norwood Multi-Family Project in Tualatin

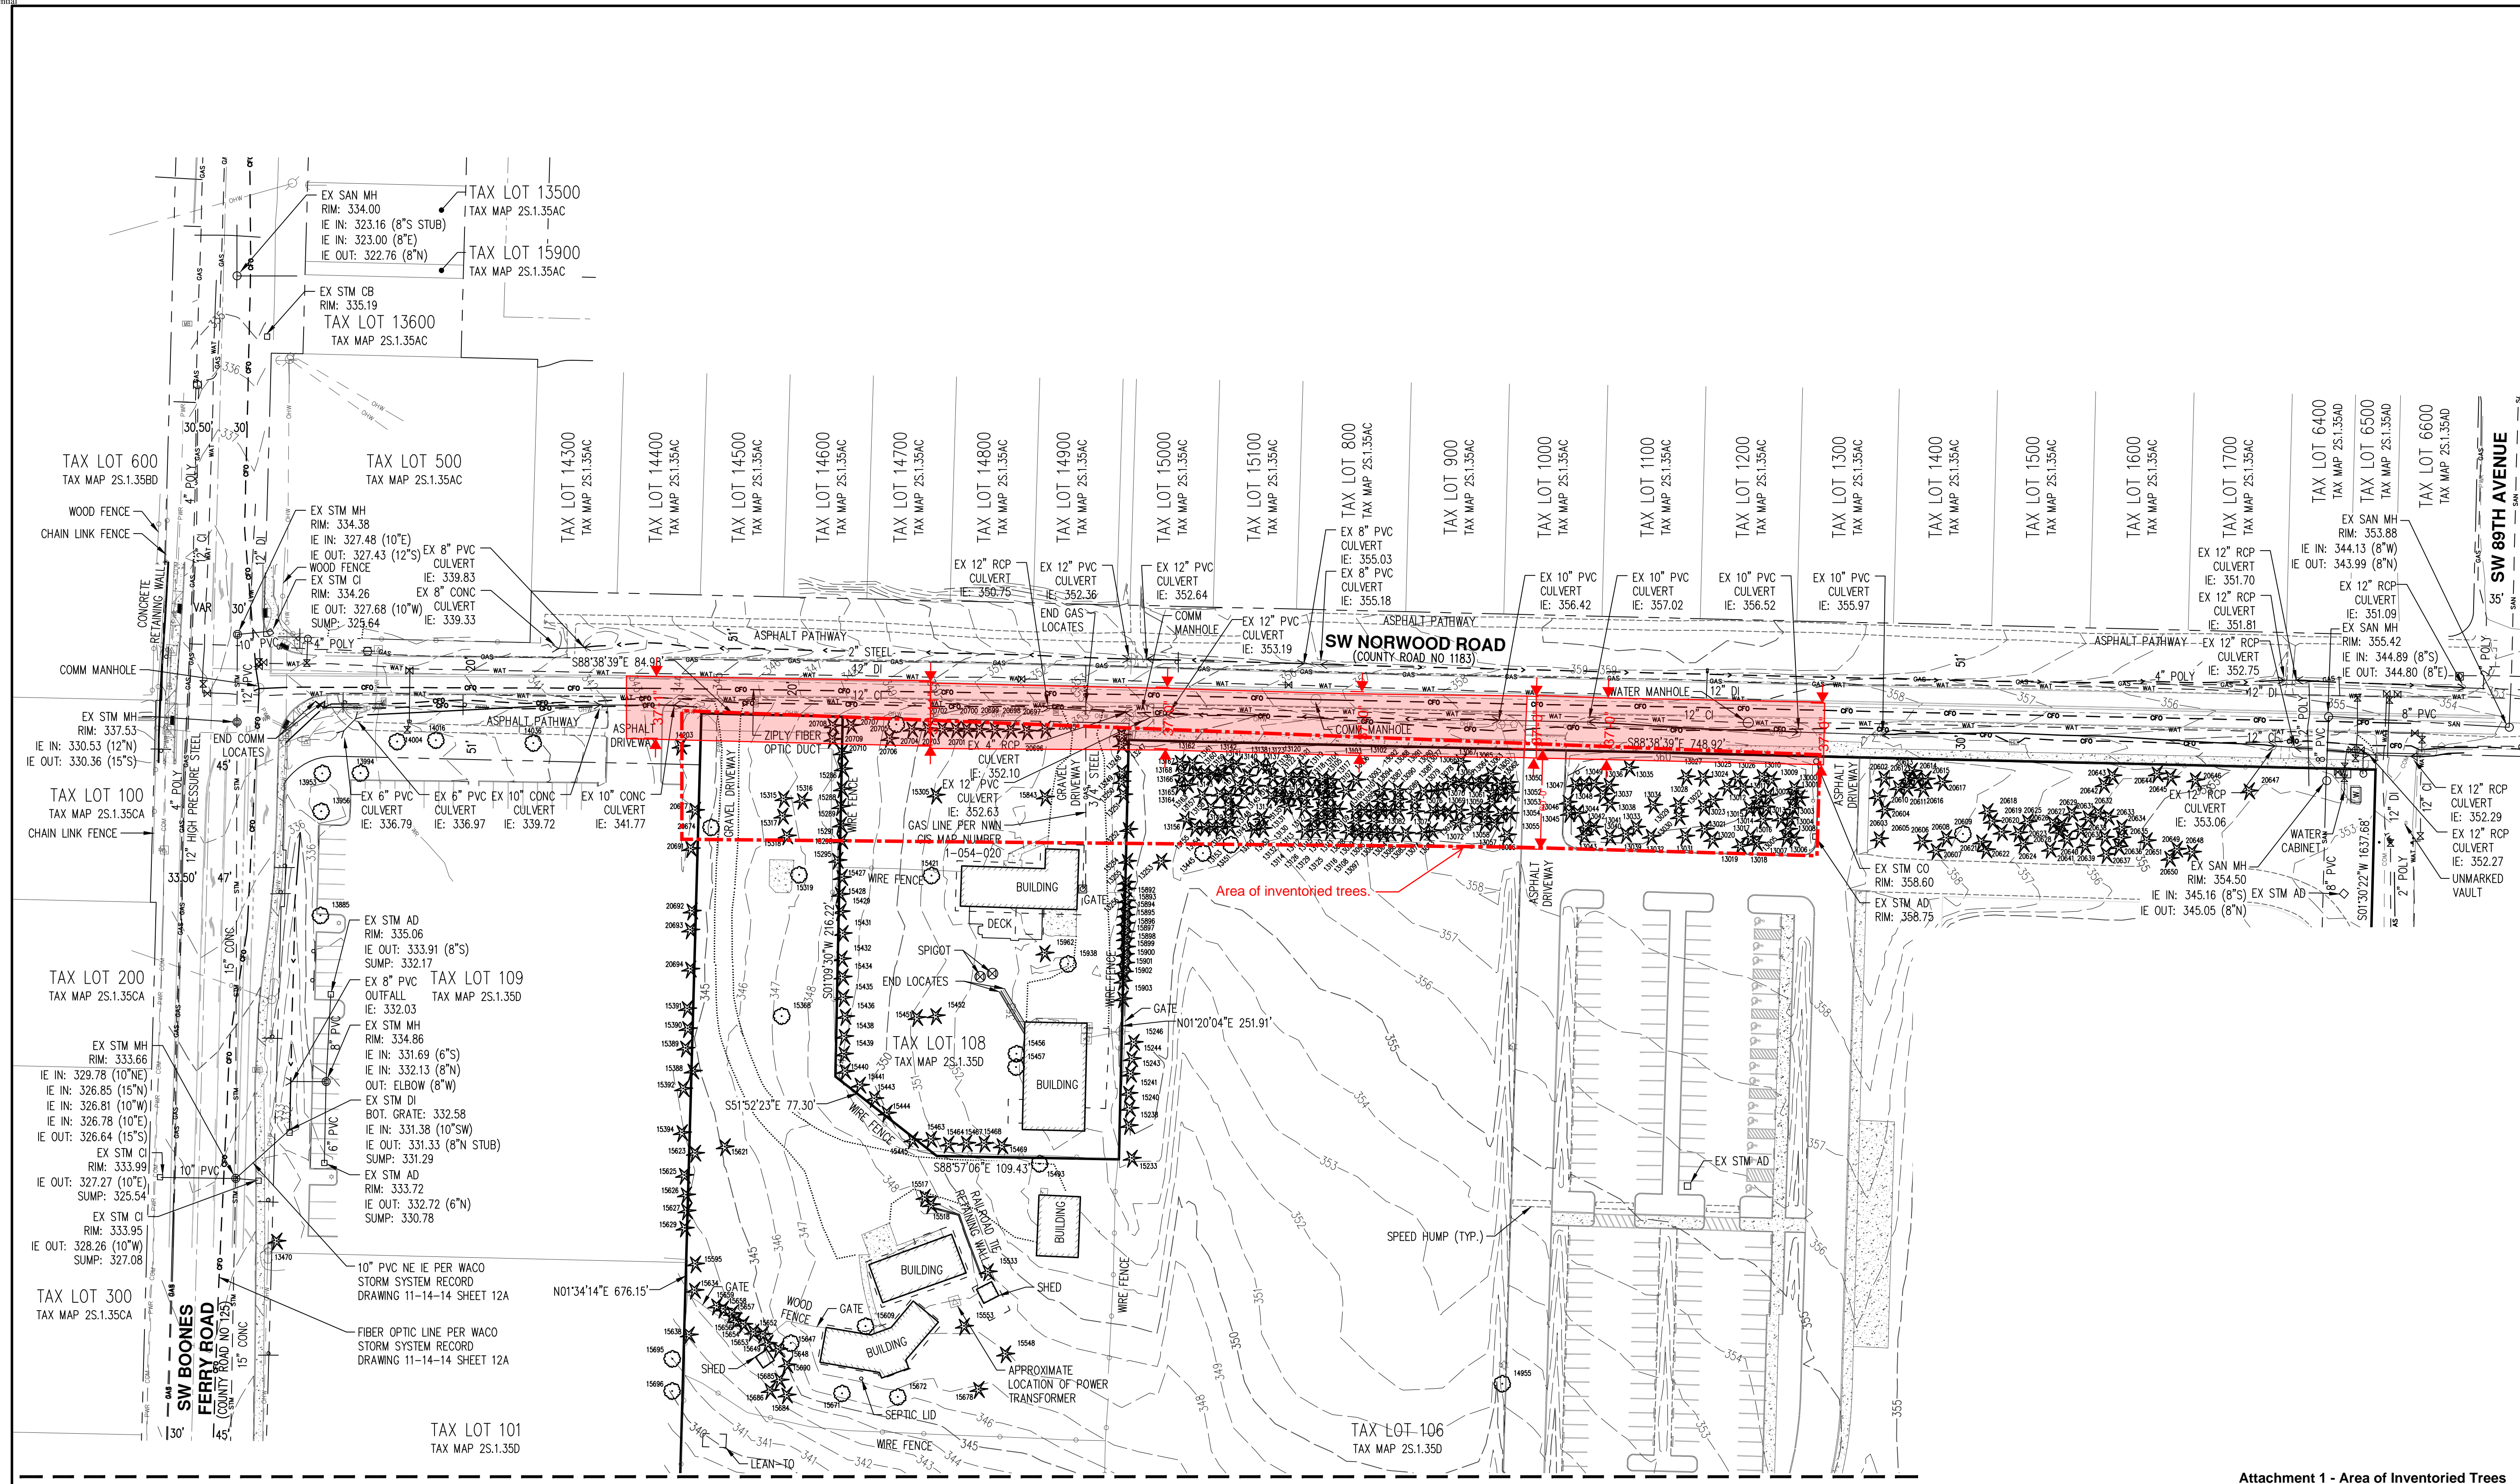
Attachment 1 - Area of Inventoried Trees

Our firm visited the site on March 17 and March 20, 2023, and inventoried 199 trees within the designated area from Norwood Road to 60 feet south of Norwood Road. The existing conditions map with tree locations is provided in Attachment 1 and the preliminary grading exhibit with tree locations is provided in Attachment 2. The following information was recorded for each tree:

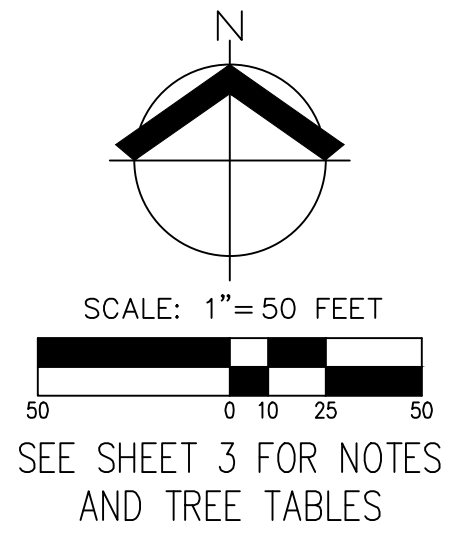
### Attachment 2 - Preliminary Arborist Exhibit

Existing curb to be removed and replaced with 6-inch curb. No root cracked curbs or lifted pavement were observed.

Alternative sidewalk route to retain tree frontage.

Recommended limit of disturbance to the north is the existing sidewalk. No construction, paving, grading or right of way improvements beyond this point.

Recommended corridor to bore underground utilities between the sidewalk and 7-foot-wide dedication.

Recommended limit of disturbance. No construction, paving, grading or right of way improvements beyond this point.

Existing curb and pavement to the south to be removed and converted to landscape.

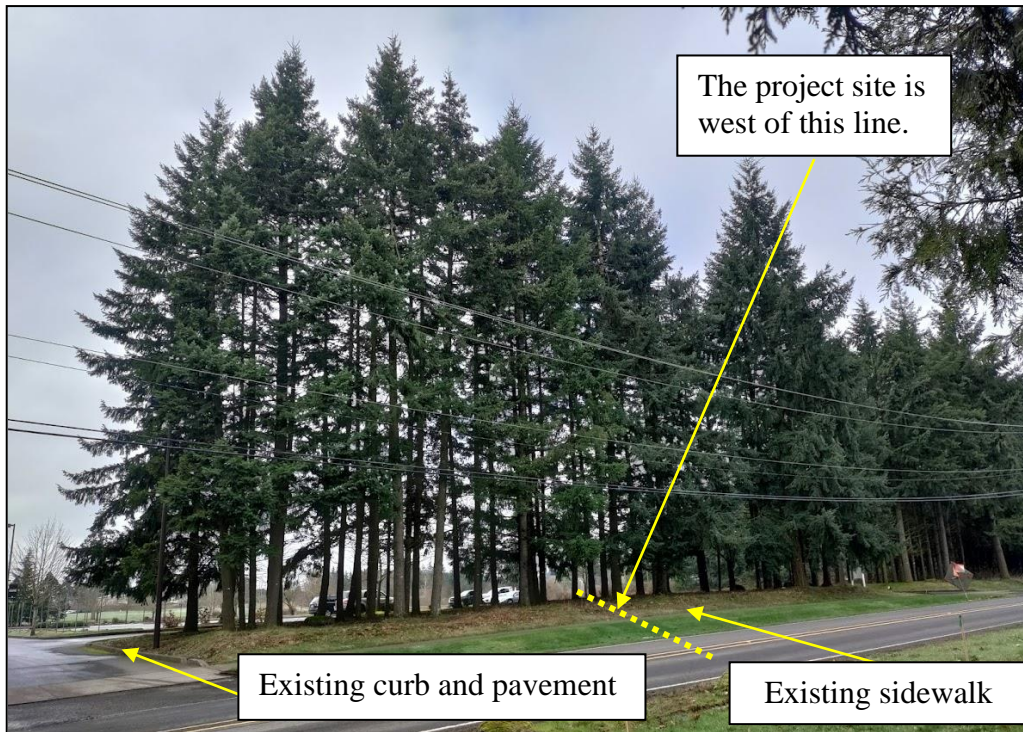
**Figure 2** Existing grove of Douglas-fir, east side. Notice the existing sidewalk and curbs around the trees. Photograph taken looking southwest. 3/21/2023.

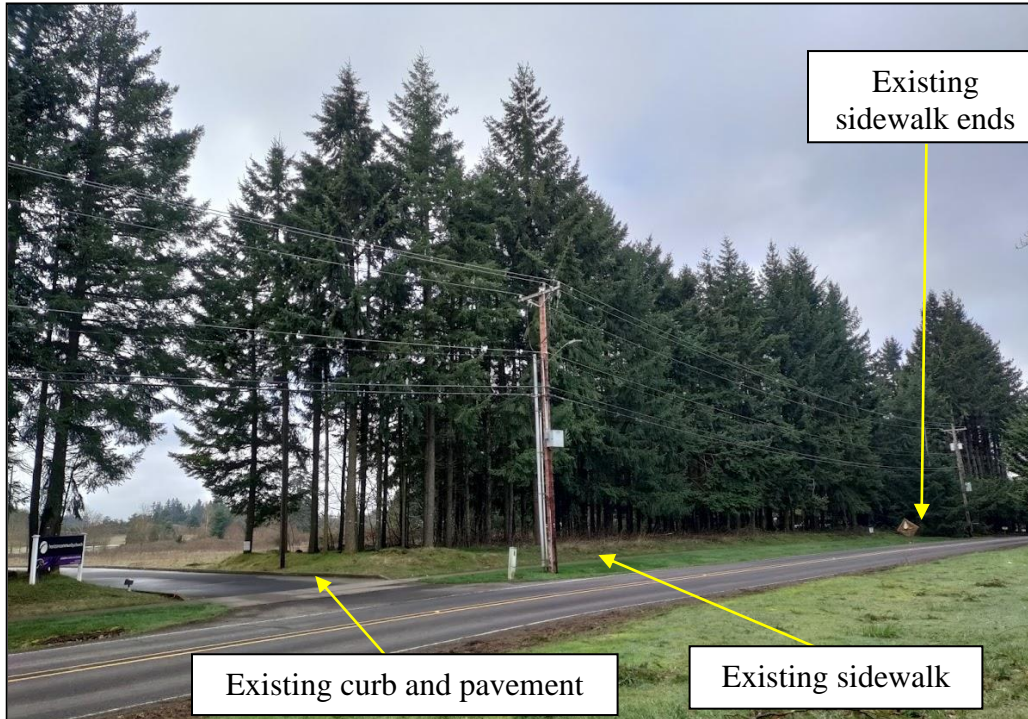
**Figure 3** Existing grove of Douglas-fir, west side. Notice the existing sidewalk and partial curb line. The sidewalk ends near the road sign. Photograph taken looking southwest. 3/21/2023.
