Todd Prager & Associates
LLC

Tree Plan for SW Ibach Street Subdivision

Date: August 22, 2025

Site Address: 10150 SW Ibach Street
Tualatin, OR 97062

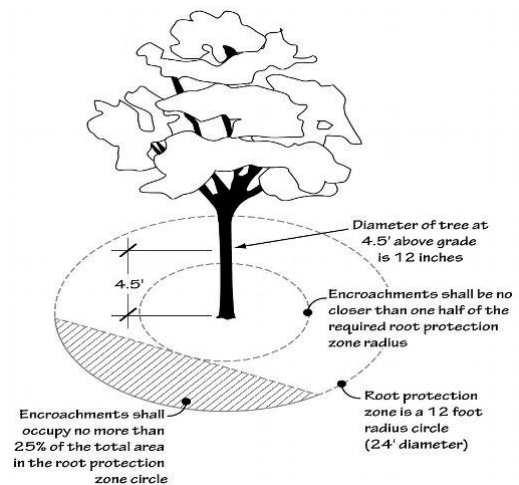
A typical minimum root protection zone allows encroachments no closer than a radius from a tree of 0.5 feet per inch of DSH if no more than 25 percent of the root protection zone area (estimated at one foot radius per inch of DSH) is impacted. Figure 1 illustrates this concept. This

Figure 1 Typical minimum protection zone.

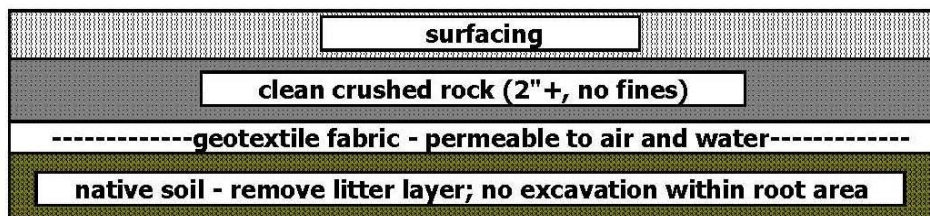
Figure 2 Sample profile for area within fenced tree protection zone. Depth of rock is dependent on grading.

- ***Modify the sidewalk and/or paving profile.*** A 6-foot-wide sidewalk is proposed 11.5 feet west of tree 10102. If the sidewalk could be curb tight for approximately 52-feet, that would reduce the level of encroachment on the west side of the tree. If a curb tight sidewalk is not an option, then a modified paving profile is recommended (Figure 2).

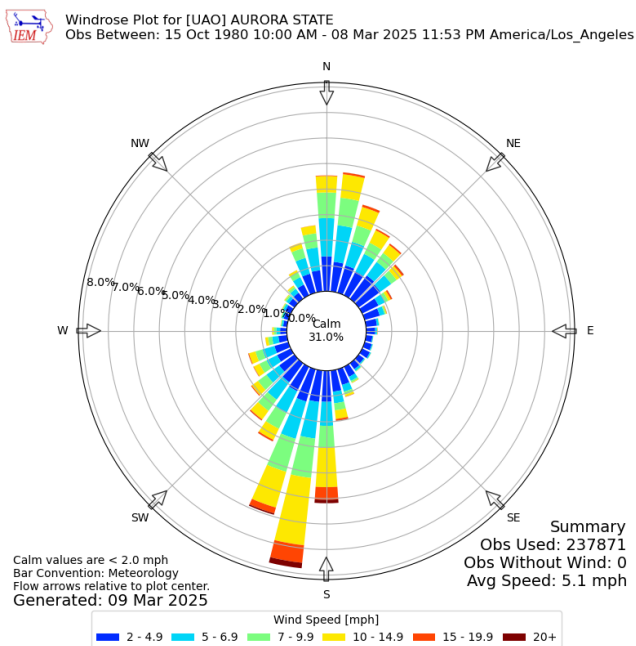
Furthermore, the removal of three large-diameter trees north of tree 10102 (trees 10104, 10105, and 10107) will significantly change wind exposure for tree 10102. Specifically, tree 10102 will be more exposed to wind forces on the north side. Upon review of wind data from the Aurora State Airport (approximately 9 miles south of the site, Figure 3) and Portland Hillsboro Airport (approximately 20 miles northwest of the site, Figure 4),¹ the tree will experience sustained winds and wind gusts from the north, though winds from the south are also common.

Figure 3 Windrose plot from Aurora State Airport, approximately 9 miles south of the site.

Therefore, if tree 10102 is to be retained, it should be assessed for risk following tree removal, routinely during construction, and periodically post-construction.

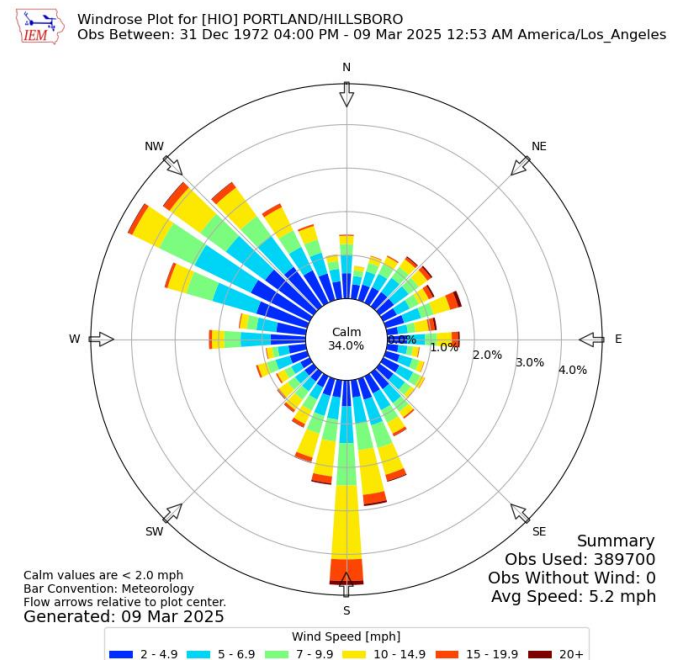
Figure 4 Windrose plot from Portland-Hillsboro Airport, approximately 20 miles northwest of the site.

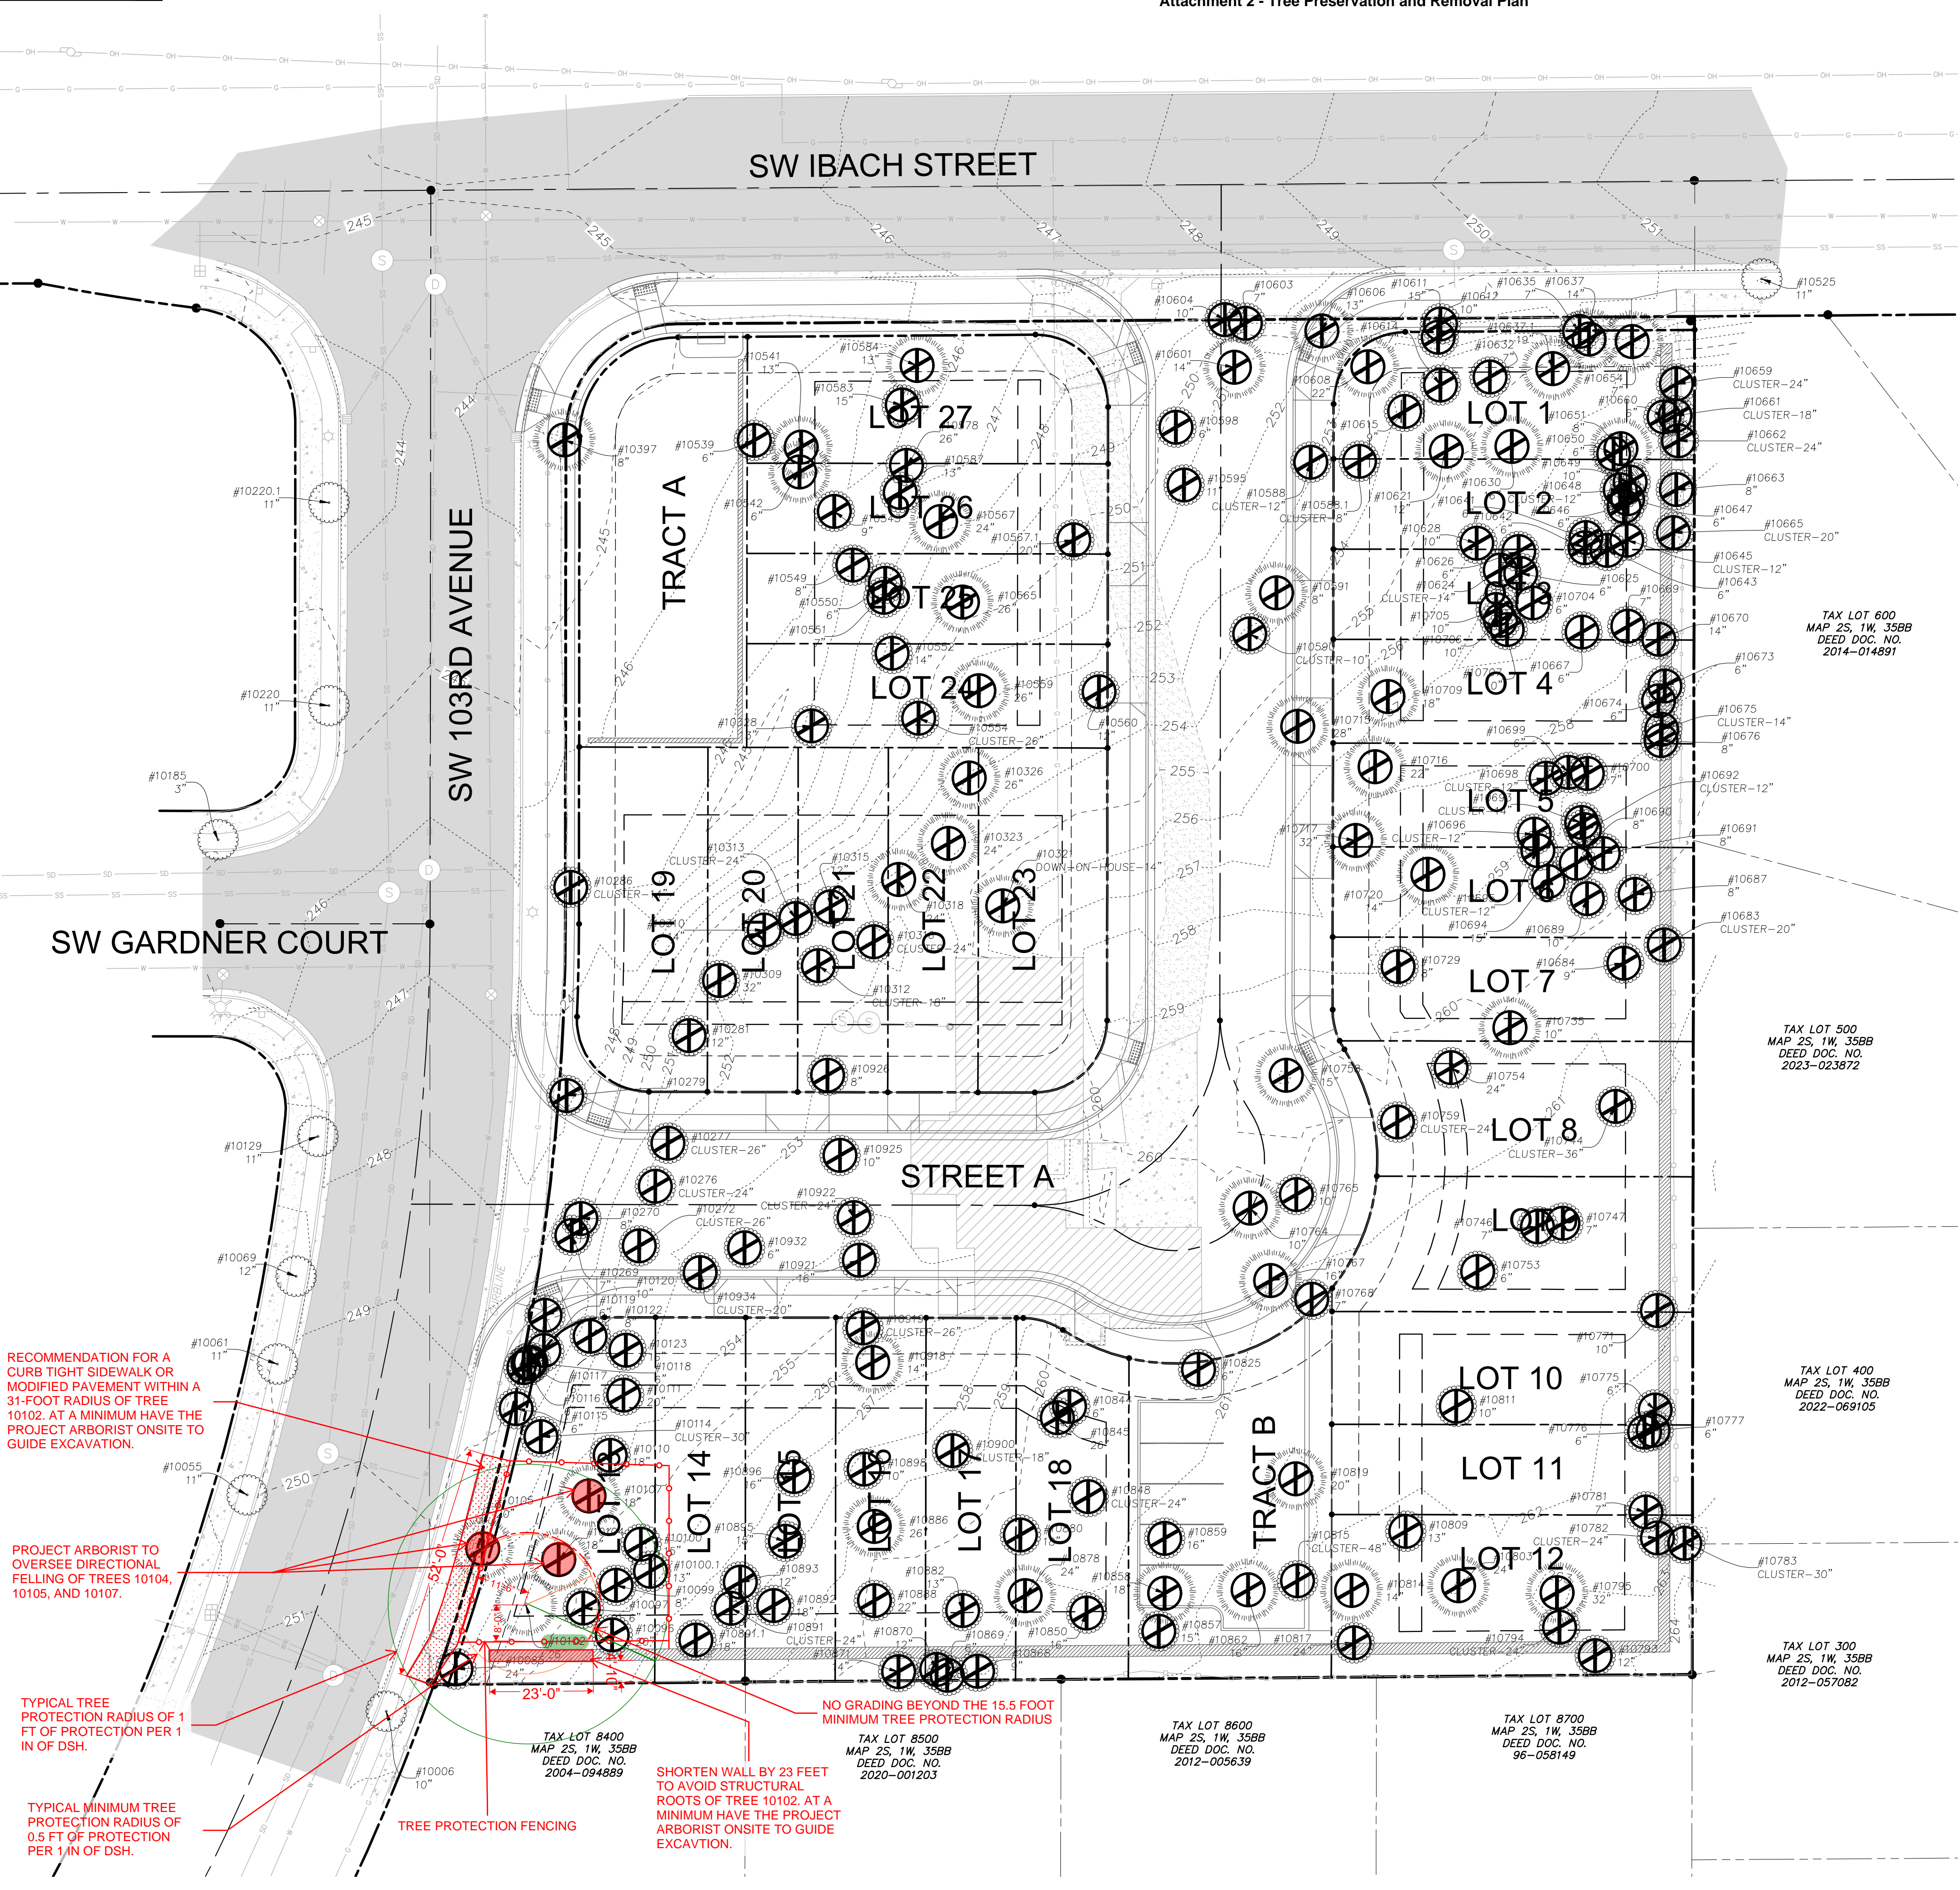
TREE REMOVAL AND PRESERVATION PLAN
SW IBACH ST
SUBDIVISION
DEZ DEVELOPMENT LLC
TUALATIN, OR

NO GRADING BEYOND THE 15.5 FOOT MINIMUM TREE PROTECTION RADIUS

RECOMMENDATION FOR A CURB TIGHT SIDEWALK OR MODIFIED PAVEMENT WITHIN A 31-FOOT RADIUS OF TREE 10102. AT A MINIMUM HAVE THE PROJECT ARBORIST ONSITE TO GUIDE EXCAVATION.

PROJECT ARBORIST TO OVERSEE DIRECTIONAL FELLING OF TREES 10104, 10105, AND 10107.

SHORTEN WALL BY 23 FEET TO AVOID STRUCTURAL ROOTS OF TREE 10102. AT A MINIMUM HAVE THE PROJECT ARBORIST ONSITE TO GUIDE EXCAVATION.
