Appendix E: Capital Project Modeling Results

Appendix F: Stream Assessment TM (TM4)

Stream Channel Condition Survey

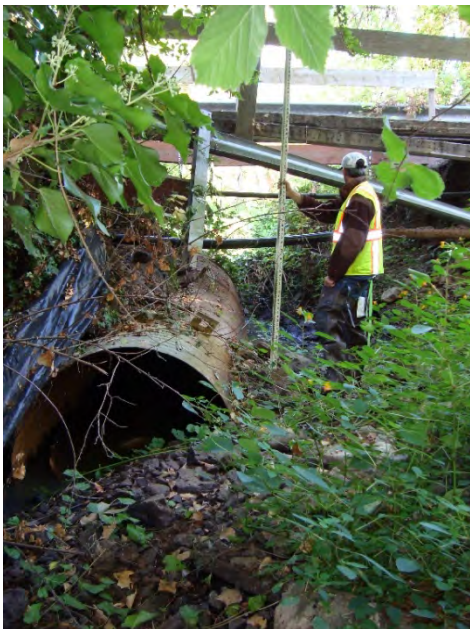
Approximately 200 feet downstream, another private structure is located on the top of the bank on the outside bend of a meander. This structure may have similar risks due to proximity to the edge of the bank. Both of these structures are east of SW Martinazzi Ave and north of SW Boones Ferry Road.

Photo 8. Culvert placed in debris from washed out bridge to convey Hedges Creek.

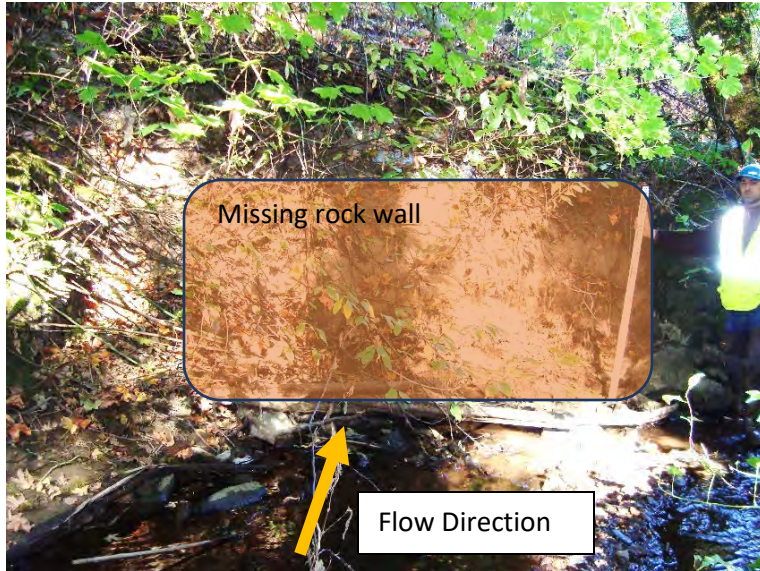
Hedges Reach #3A has a meandering characteristic and a relatively low gradient. Channel substrate consists of loose silt, hard silt, and an outcrop of bedrock present for about 100 feet of stream channel starting approximately 500 feet upstream of 105th Avenue. A rock wall protecting the bank (and presumably road embankment) 175 feet upstream and on the east side of 105th Avenue/Blake Street has been compromised, as it has been eroded by the stream (Photo 11). At this location, Hedges Creek makes a 90-degree turn, which is a point of maximum velocity and energy on the outside bend. It is recommended to reinforce/ rebuild the rock wall to ensure the road embankment is not compromised and/or reorient the culvert under 105th Avenue/ Blake Street to minimize flow velocity directed at the road embankment and wall. It is assumed that design and construction would be conducted in conjunction with the scheduled road widening project for 105th Avenue.

Photo 11. Hedges Creek Reach #3A, showing rock wall location and missing rocks.

The rock wall protecting the road embankment on 105th Avenue/Blake Street from Hedges Creek in Reach #3A was observed to be failing. Rocks have fallen into the stream, and only a few pieces of the wall remain in place. It is understood that the City plans to widen SW 105th Avenue, which will require a detailed evaluation and updated design of the road embankment and culvert crossings in relationship to the stream channel. A potential design option is to reorient the culvert in conjunction with the roadway widening project to mimic the direction of the natural stream channel and minimize flow velocity directed at the road embankment. Alternatively, reinforcement/ replacement of the existing rock wall would be needed.

It is recommended that locations of active channel erosion, in the vicinity of the rock wall and the sanitary sewer pipe, in this reach be monitored by the City to ensure that site conditions do not deteriorate. Additionally, the side channel entering Hedges Creek in Reach #3A has experienced erosion due to the flashiness of stormwater runoff from upstream. Flow control and onsite retention standards and policies are recommended for the City's consideration in Hedges Reach #3A, in the vicinity of the area west of Ibach Park, to mitigate for areas of active erosion and preserve the integrity of small streams such as this side channel.

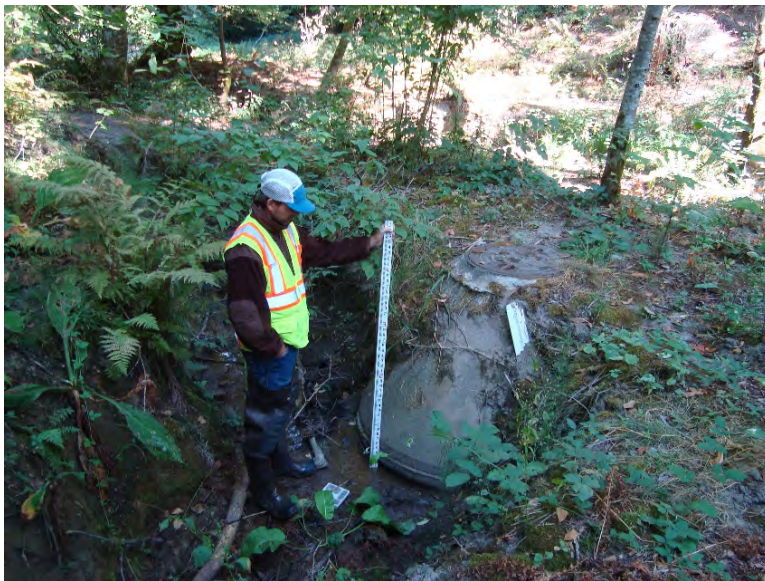
Another issue observed in Reach #3A is channel incision in a side channel entering the main channel from the south, approximately 700 feet upstream of SW 105th Avenue. The neighborhood west of Ibach Park contributes drainage to this side channel and it appears that this channel receives a large volume of water from the upstream catchment. The extreme erosion in this side channel has exposed a sanitary sewer manhole (Photo 12). This exposure, over time, may compromise the structural integrity of the manhole.

Photo 12. Side channel incision and erosion around sanitary sewer manhole.

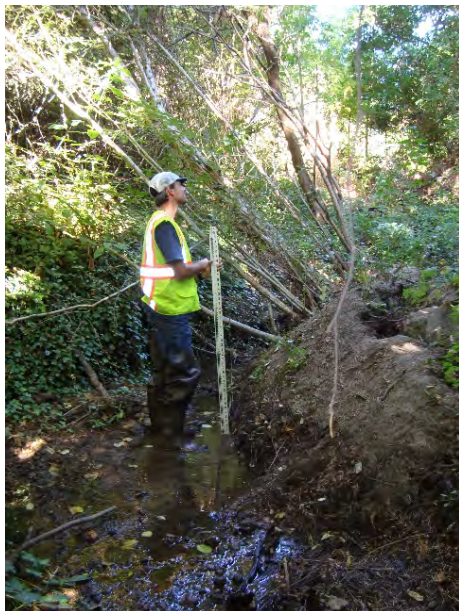
Hedges Reach #3B has a much steeper gradient than Reach #3A and the channel is incised with the width to depth ratio decreasing upstream along the reach. The channel is not stable in this reach. Adjacent slopes have failed on both banks (Photo 14) and the culvert under SW Alsea Ct. is perched resulting from erosion and downcutting at the base (Photo 15).

Photo 14. Left bank slump upstream of confluence.

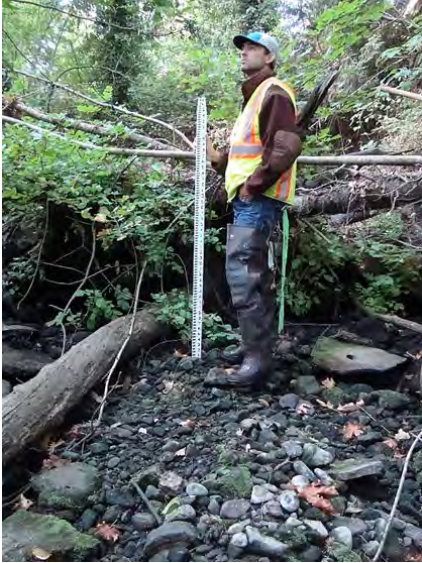
Channel-spanning debris jam in Hedges Creek Reach #1 approx. 300' upstream of Tualatin River (photo location shown below with camera icon)

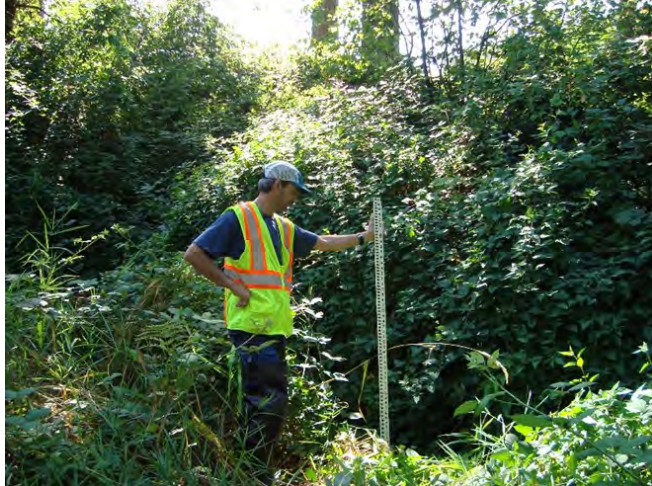
Typical photo of Hedges Creek Reach #2. Stream channel is overgrown with invasive vegetation. Channel is to the right and 4' below Ryan (standing on the bank). Photo location shown below with camera icon.

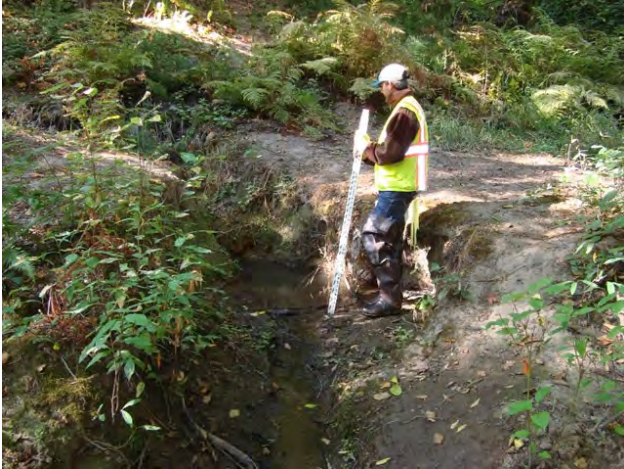
Incised side channel of Hedges Creek. Photo location shown below with camera icon.
