MEMORANDUM

FROM: Todd Prager, RCA #597, ISA Board Certified Master Arborist

RE: Tree Removal and Protection Plan for Tualatin Apartment Project

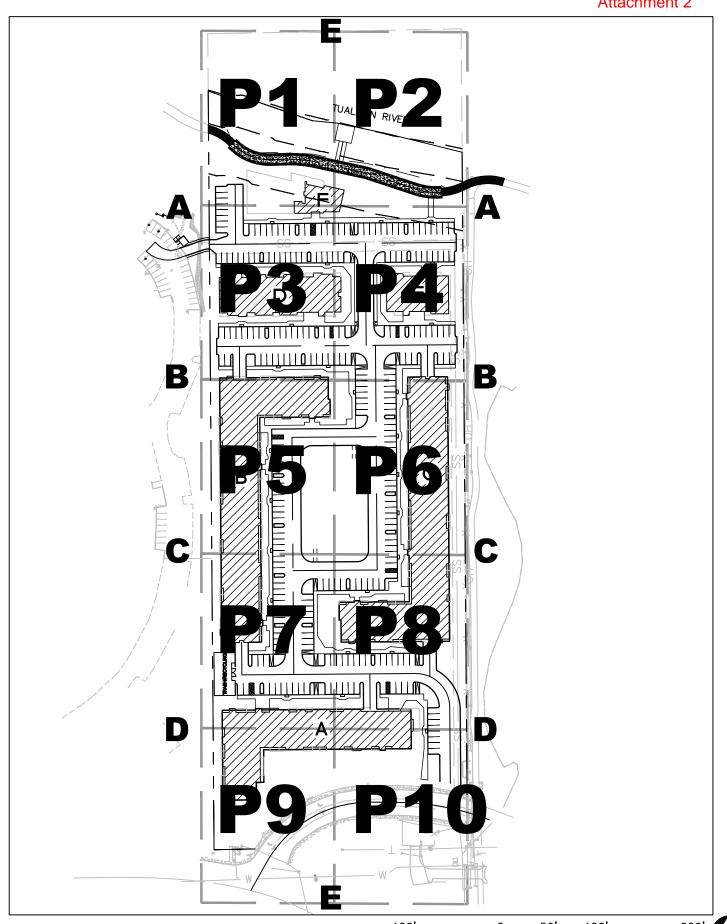
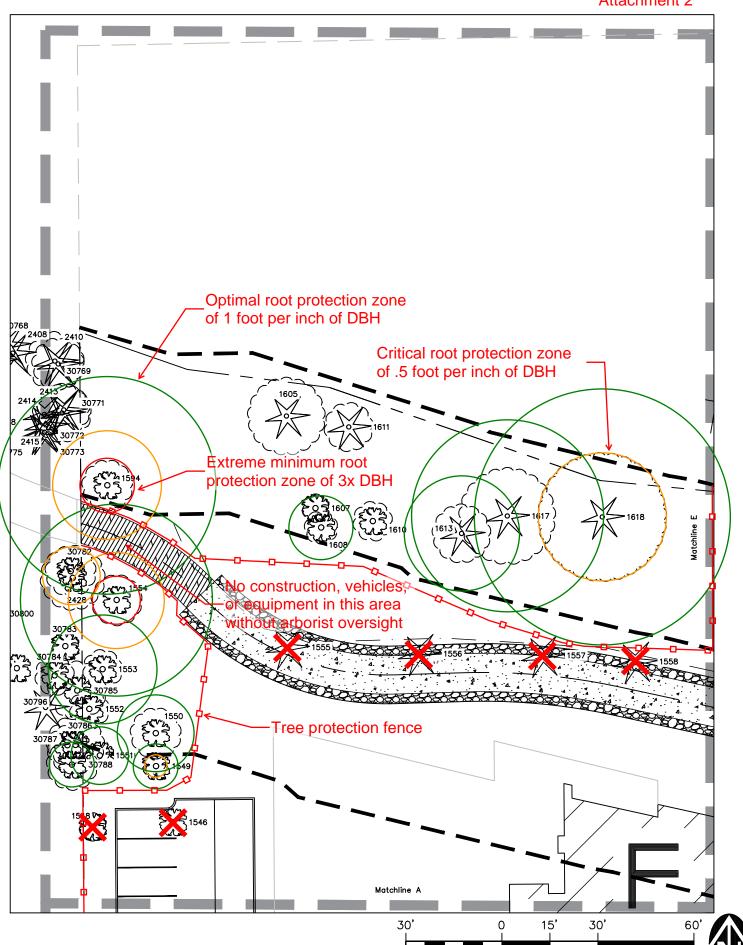
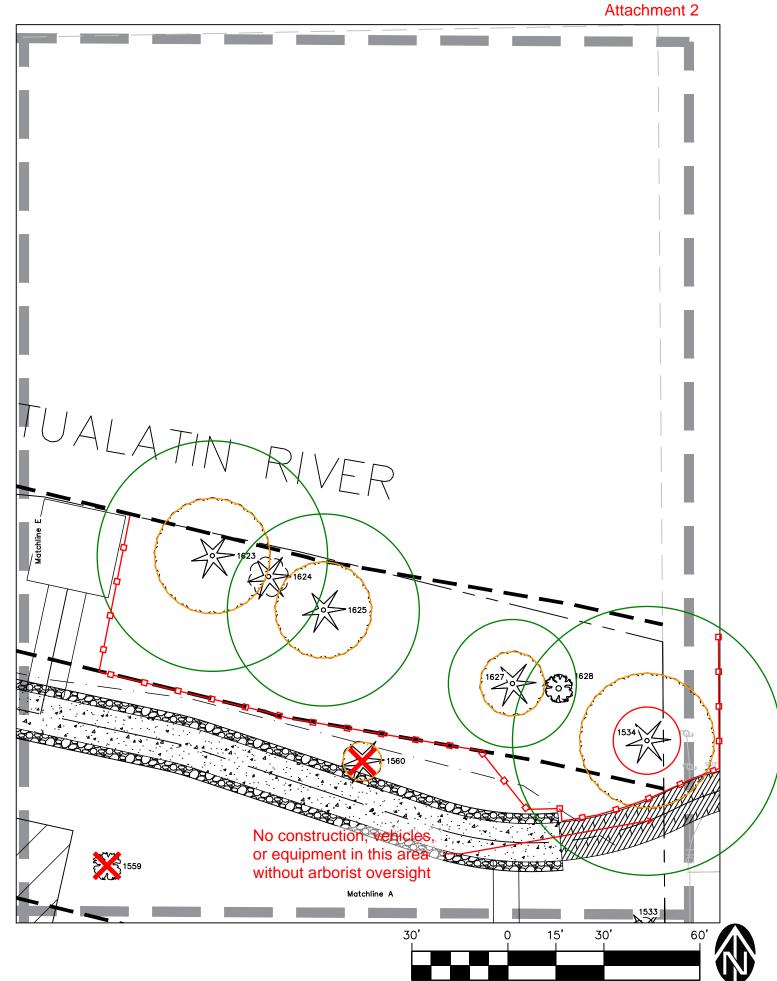
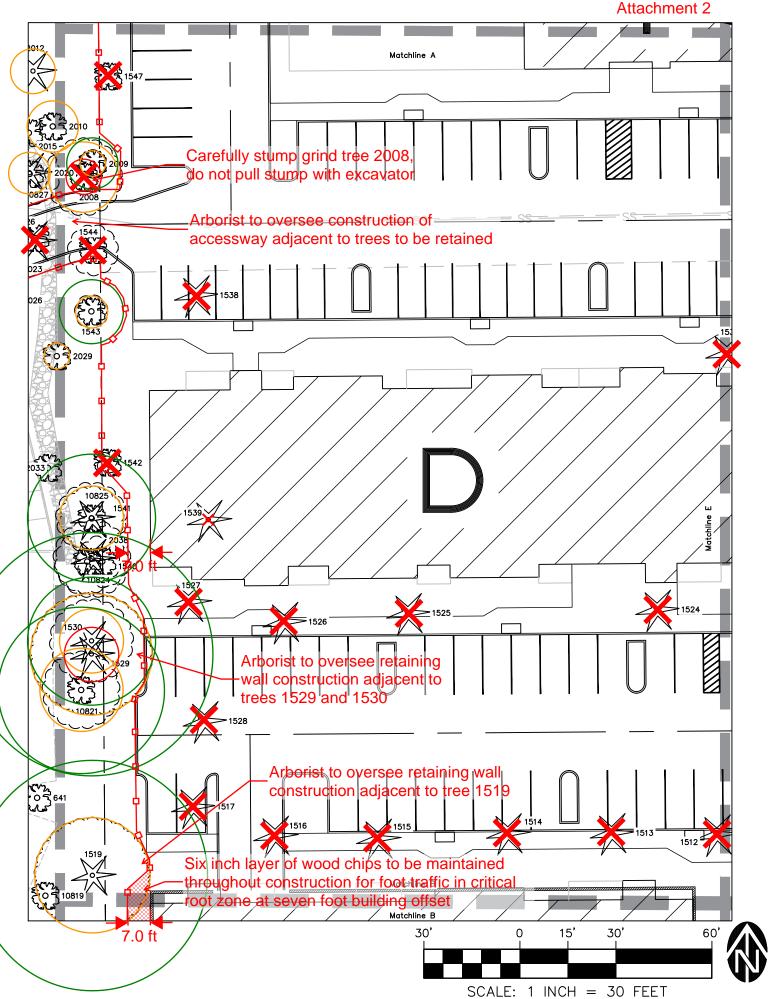
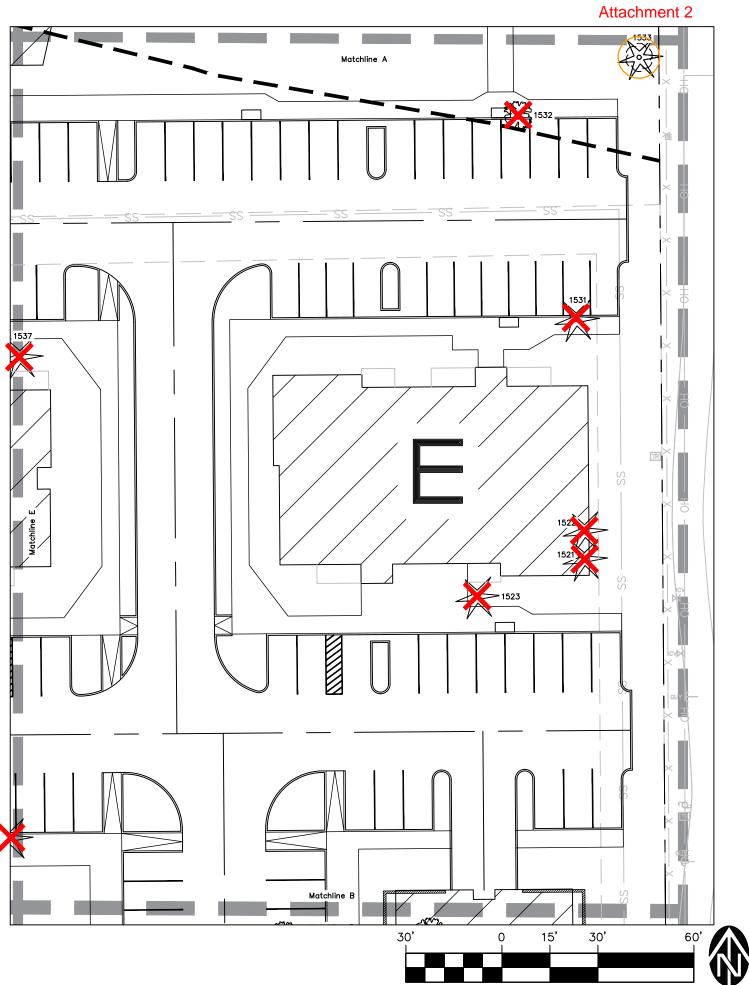
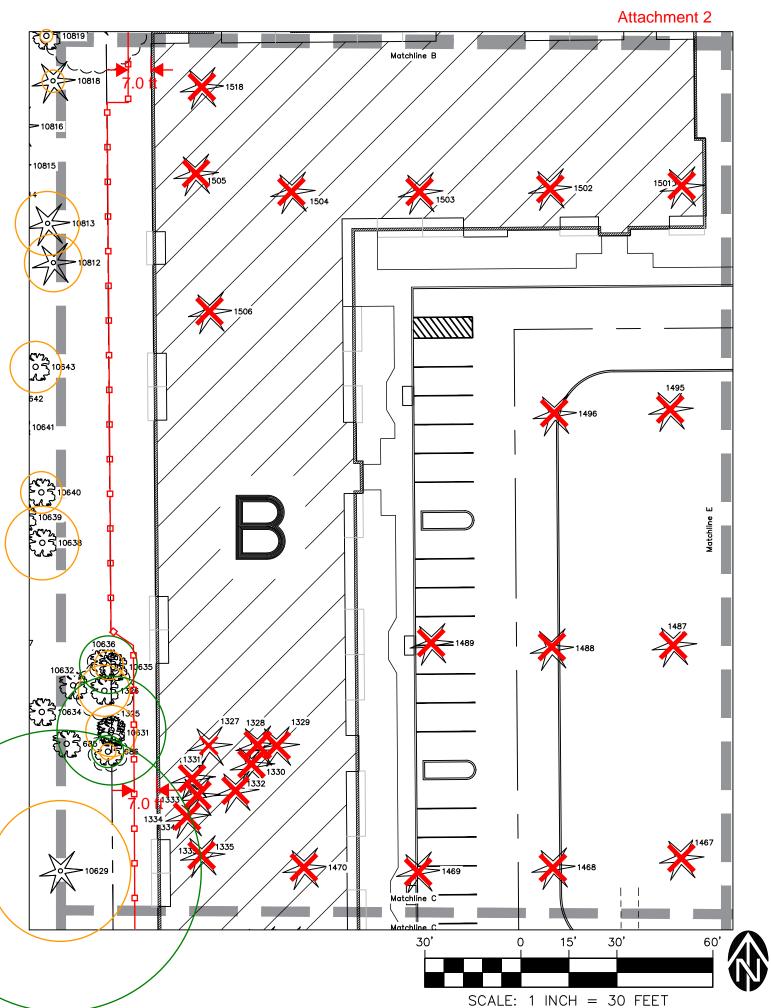
Exhibit L
Attachment 2

Attachment 2 along with the preliminary grading plan in Attachment 3 illustrate the proposed construction and grading impacts in relation to the existing trees. Based on the construction and grading impacts, 135 trees over 8-inch DBH are proposed for removal because they are within the construction and grading footprint. Therefore, the removal of these 135 trees meets the tree removal criteria in section 34.230.1(c) of the Tualatin Code because their removal is required "to construct proposed improvements".

- *Tree Protection Fencing*: Erect six foot metal tree protection fencing in the locations shown in Attachment 2 to protect the trees from construction.

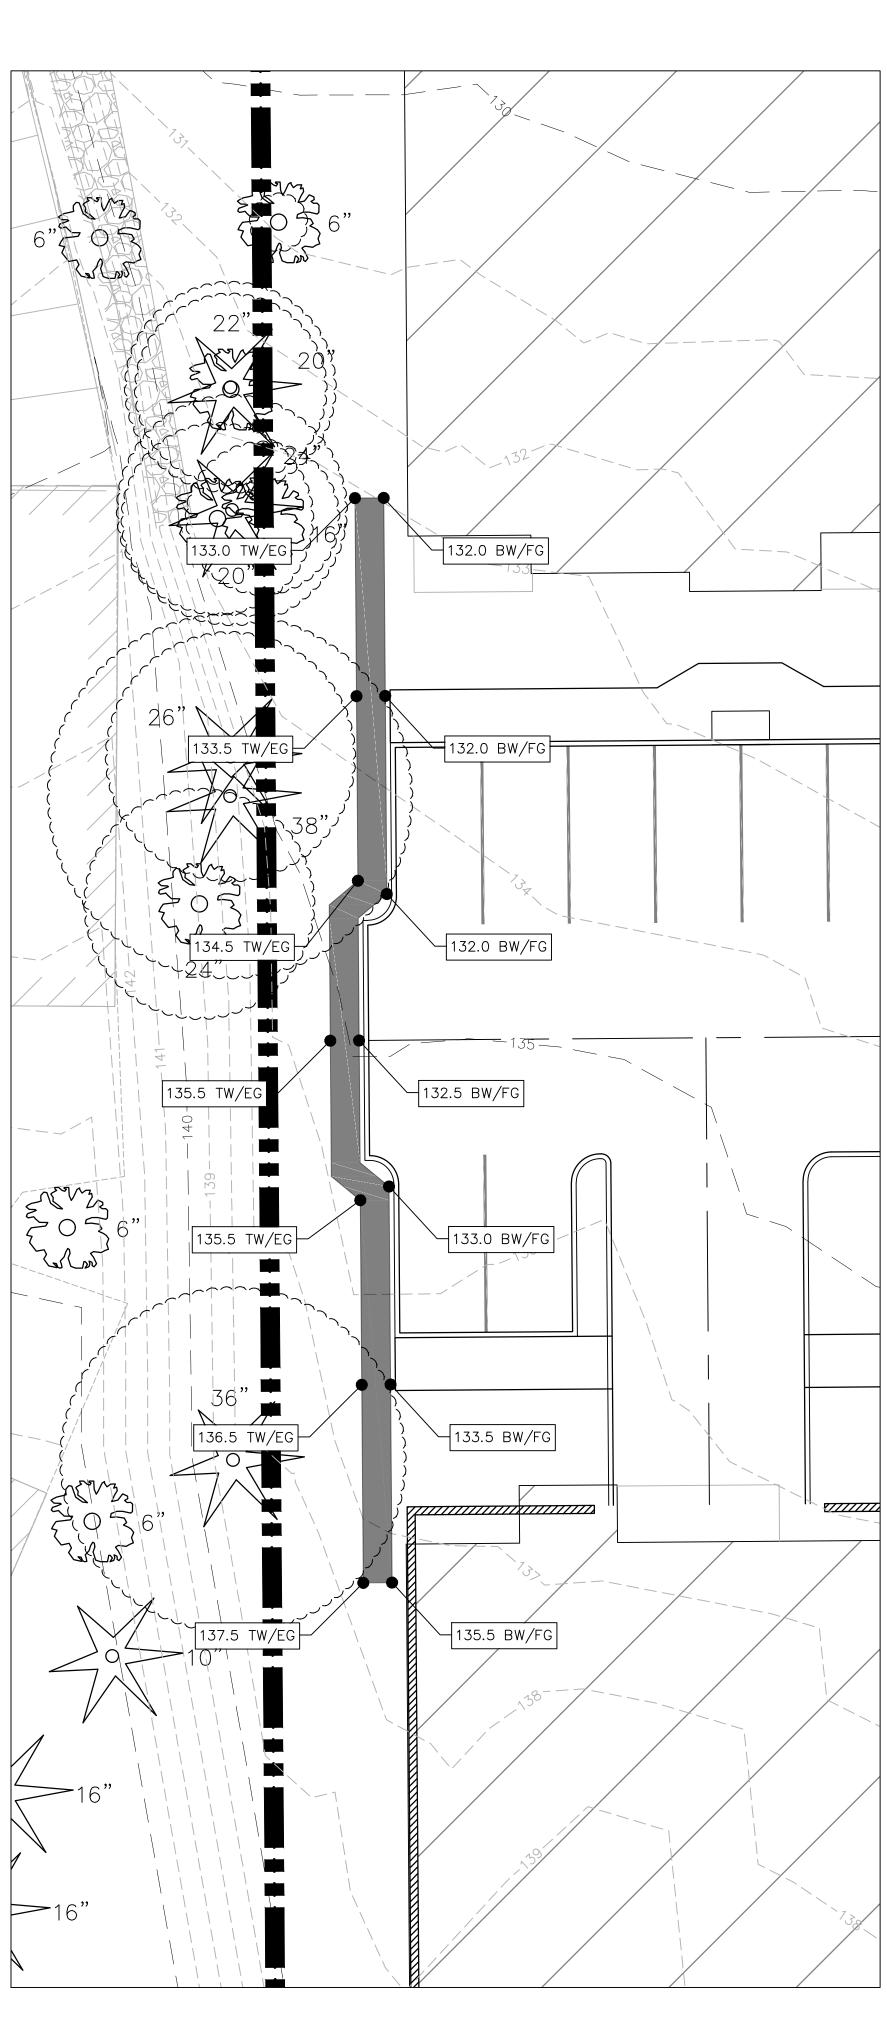
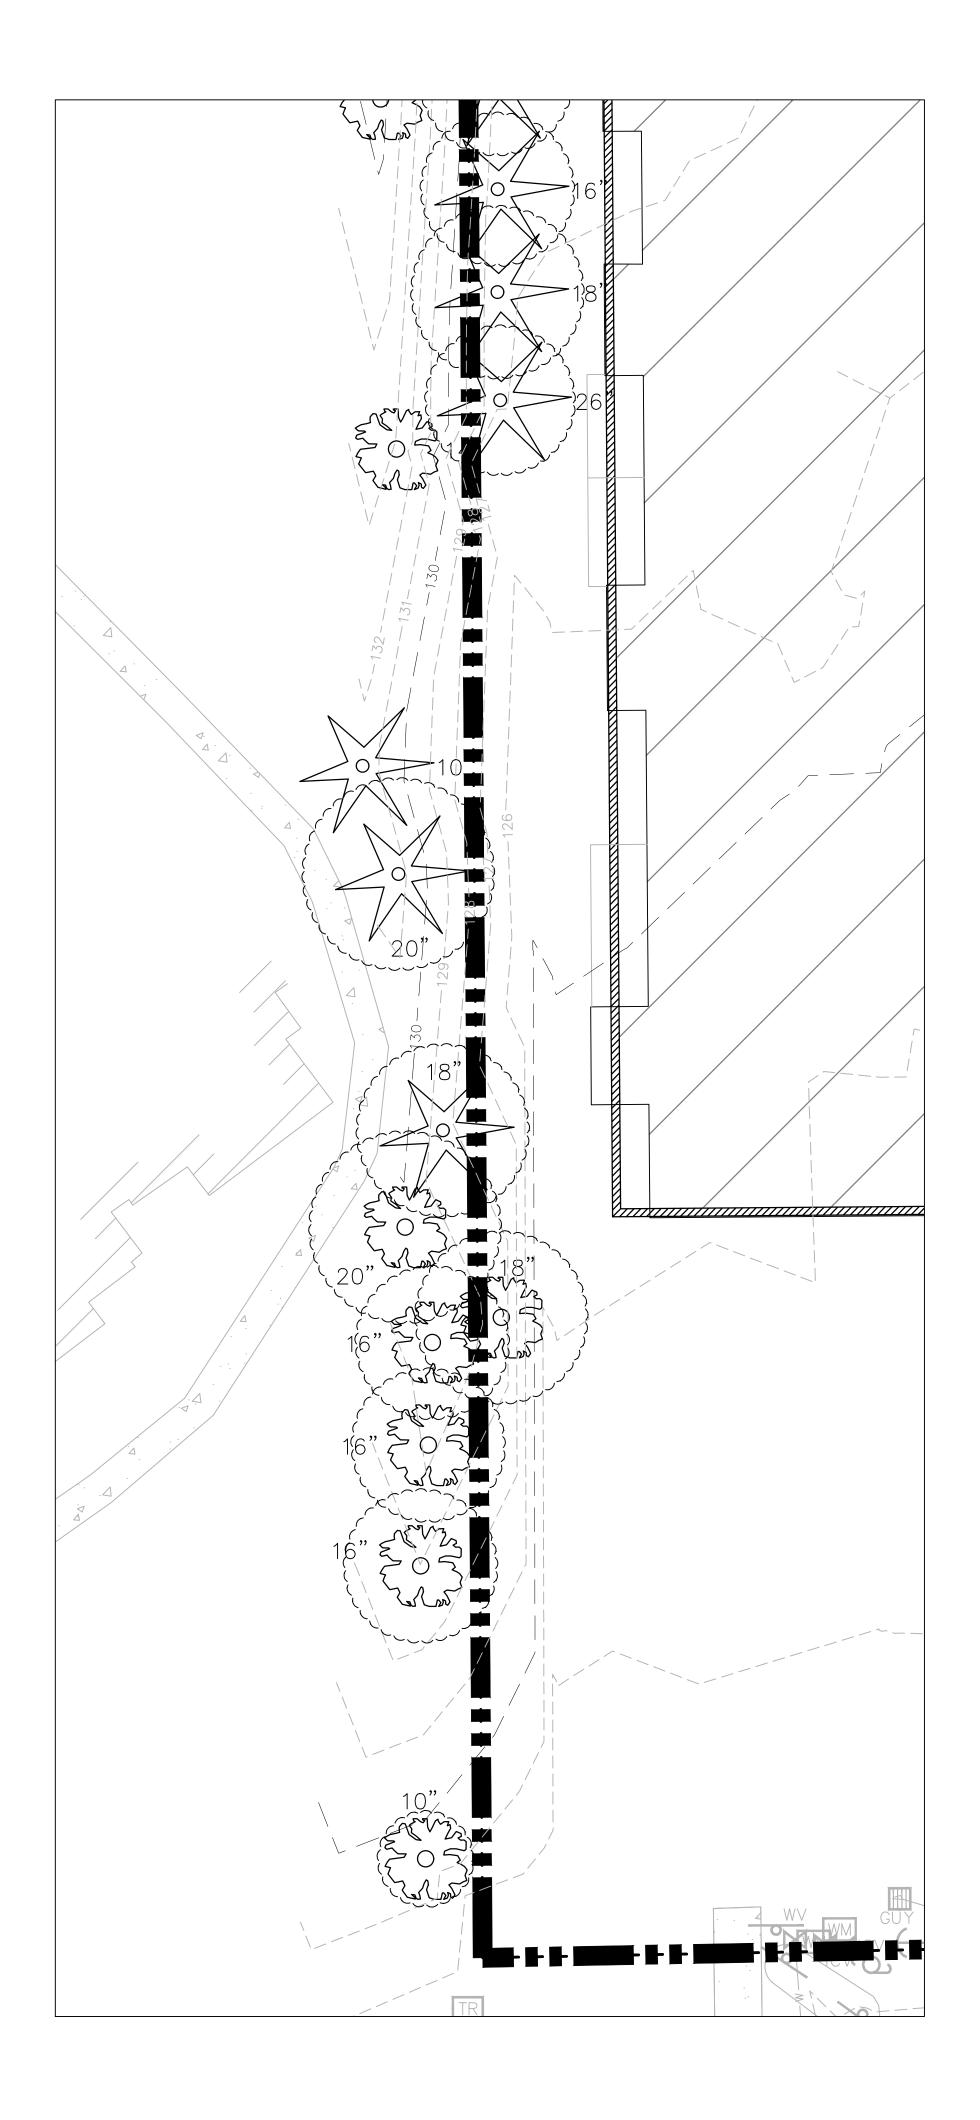
- Retaining Wall Construction Along West Property Line: A retaining wall is proposed to be constructed near the west property line to minimize grading impacts to the neighboring trees in that location. Attachment 5 includes a preliminary plan for the retaining wall to protect the neighboring trees. The retaining wall within the critical root zones of trees 1519, 1529, and 1530 shall be constructed under arborist supervision to ensure that impacts are minimized or the final wall location is adjusted as needed to protect the trees. It should be noted that fill was previously placed on the west sides of trees 1519, 1529, and 1530 which likely impacted that portion of their root systems. However, since it appears that the fill was placed over 20 years ago, new roots have likely grown and become adapted to the new growing

- environment. Therefore, the proposed retaining wall impacts on the east side of the trees' root systems are not anticipated to severely impact the trees' health or structural stability.
