# TERAGAN & ASSOCIATES, INC. ARBORICULTURAL CONSULTANTS

## MEMORANDUM

**RE:** Tree Removal and Protection Plan for Tualatin Apartment Project

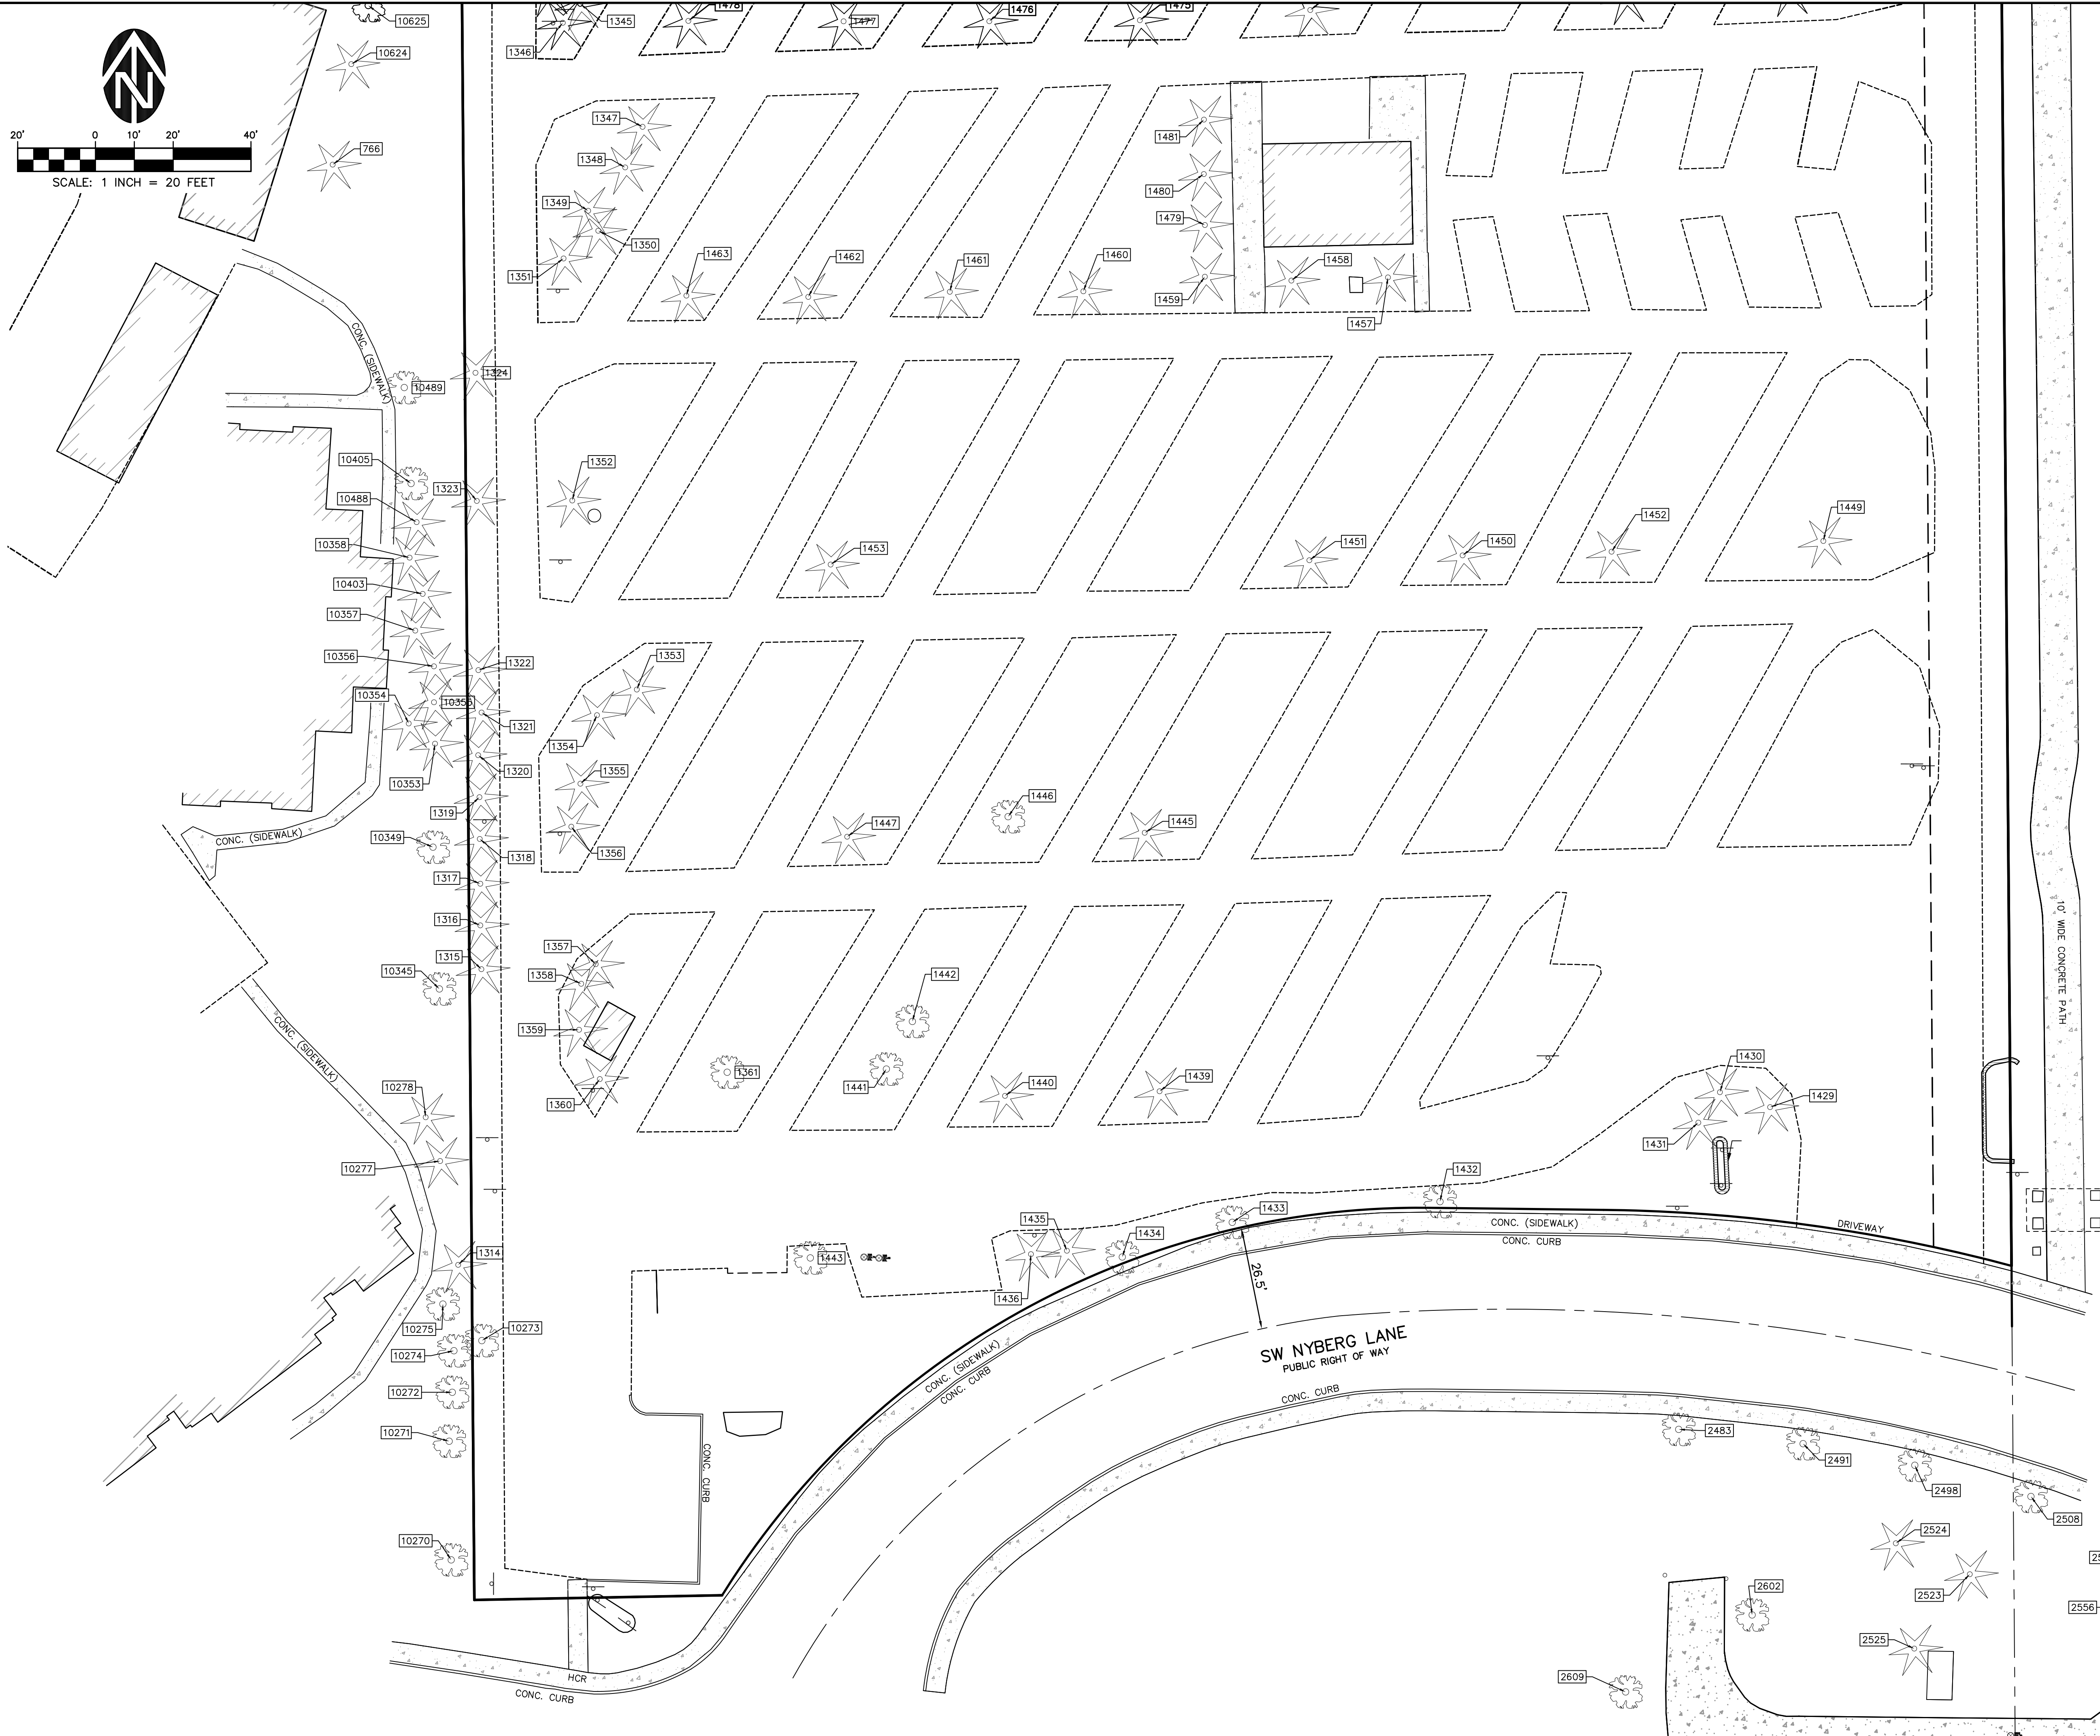
# Attachment 1

Tandem Property Management is proposing to construct the Tualatin Apartment Project at 6645 SW Nyberg Lane in Tualatin. The existing conditions survey with existing tree locations is provided in Attachment 1. The proposed site plan with the trees to be retained and removed is provided in Attachment 2. A preliminary copy of the grading plan is provided in Attachment 3.

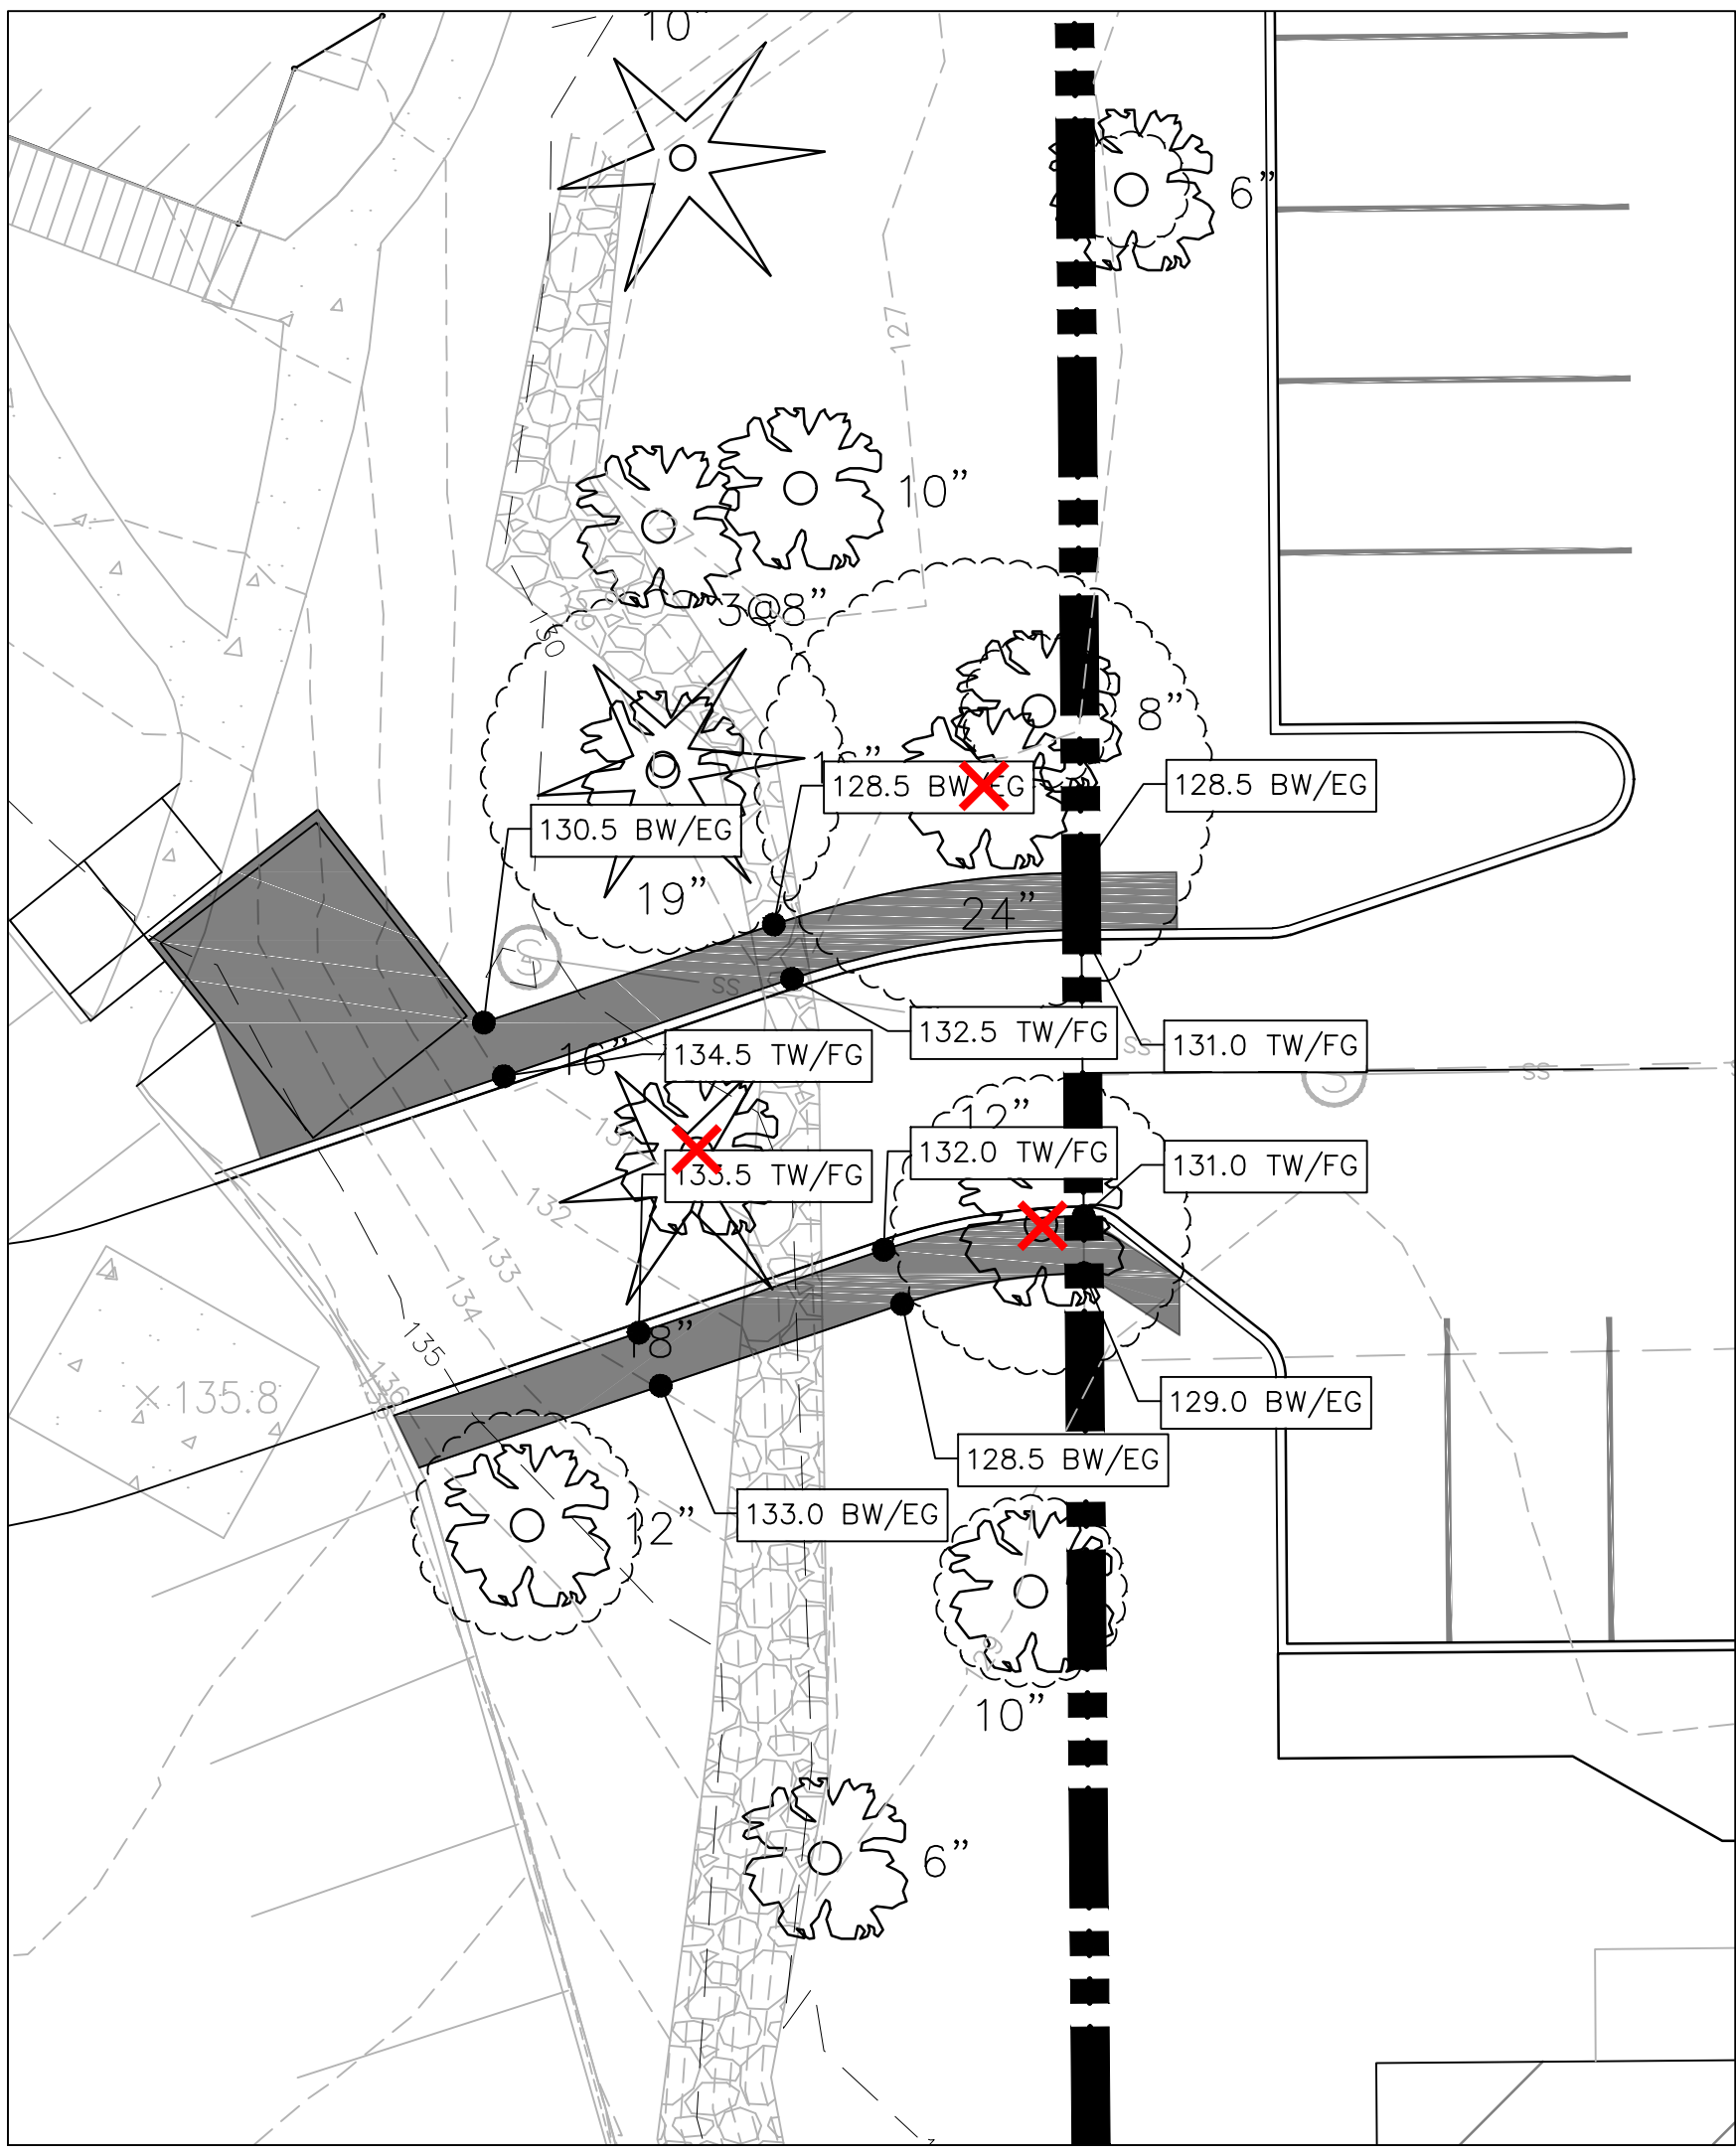
- *Retaining Wall Construction Along West Property Line*: A retaining wall is proposed to be constructed near the west property line to minimize grading impacts to the neighboring trees in that location. Attachment 5 includes a preliminary plan for the retaining wall to protect the neighboring trees. The retaining wall within the critical root zones of trees 1519, 1529, and 1530 shall be constructed under arborist supervision to ensure that impacts are minimized or the final wall location is adjusted as needed to protect the trees. It should be noted that fill was previously placed on the west sides of trees 1519, 1529, and 1530 which likely impacted that portion of their root systems. However, since it appears that the fill was placed over 20 years ago, new roots have likely grown and become adapted to the new growing

environment. Therefore, the proposed retaining wall impacts on the east side of the trees' root systems are not anticipated to severely impact the trees' health or structural stability.
