RE: Tree inventory and removal plan for Lu Pacific Development.

Lu Pacific Development ATTN: Teresa Long Proposed building construction at: 10005 SW Herman Rd Tualatin, OR 97062

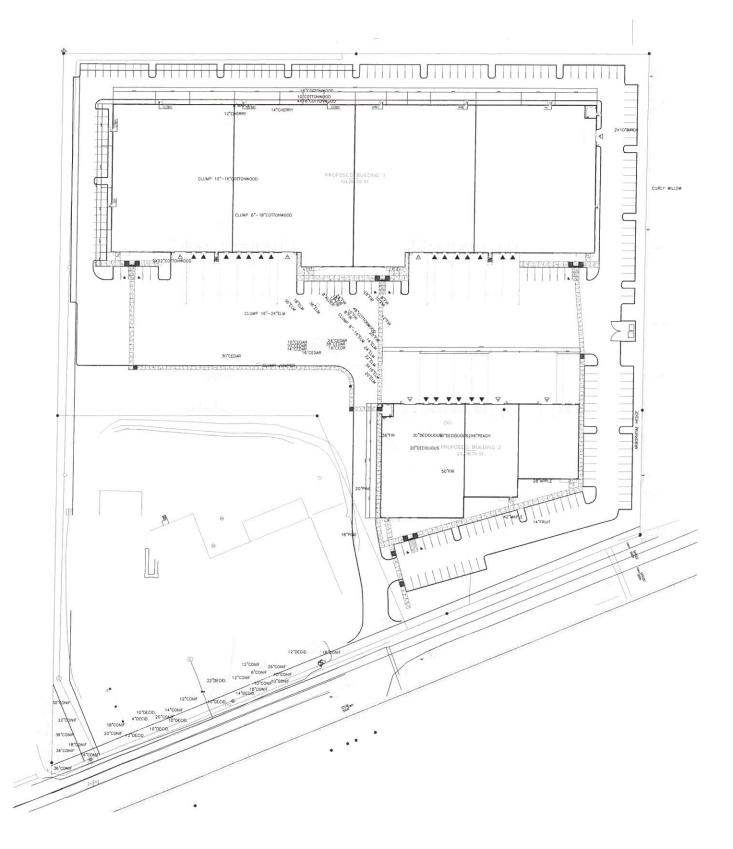
Attachment 1: Site Plan with Tree removal and Protection

After careful examination of the proposed construction, all trees will have to be removed. All the trees on this site are in development areas per the proposed plan.

48 trees are recommended for removal for the proposed construction of the two buildings by Lu Pacific Development. The trees that are not directly impacted by this plan are number 7 and number 8. The Pines are in poor condition however and do not have a long life expectancy due to the Blue stain fungi caused by the Pine Borer Beetle. The recommendation for all trees is removal.
