MEMORANDUM

DATE: September 9, 2021
TO: Erin Holsonback, Otten + Associates Landscape Architects, Inc
FROM: Terrence P. Flanagan, ISA Board Certified Master Arborist, PN-0120BMTL
RE: Manhasset Tree Plan

APPENDIX 4 - TREE INVENTORY

TREE PLAN

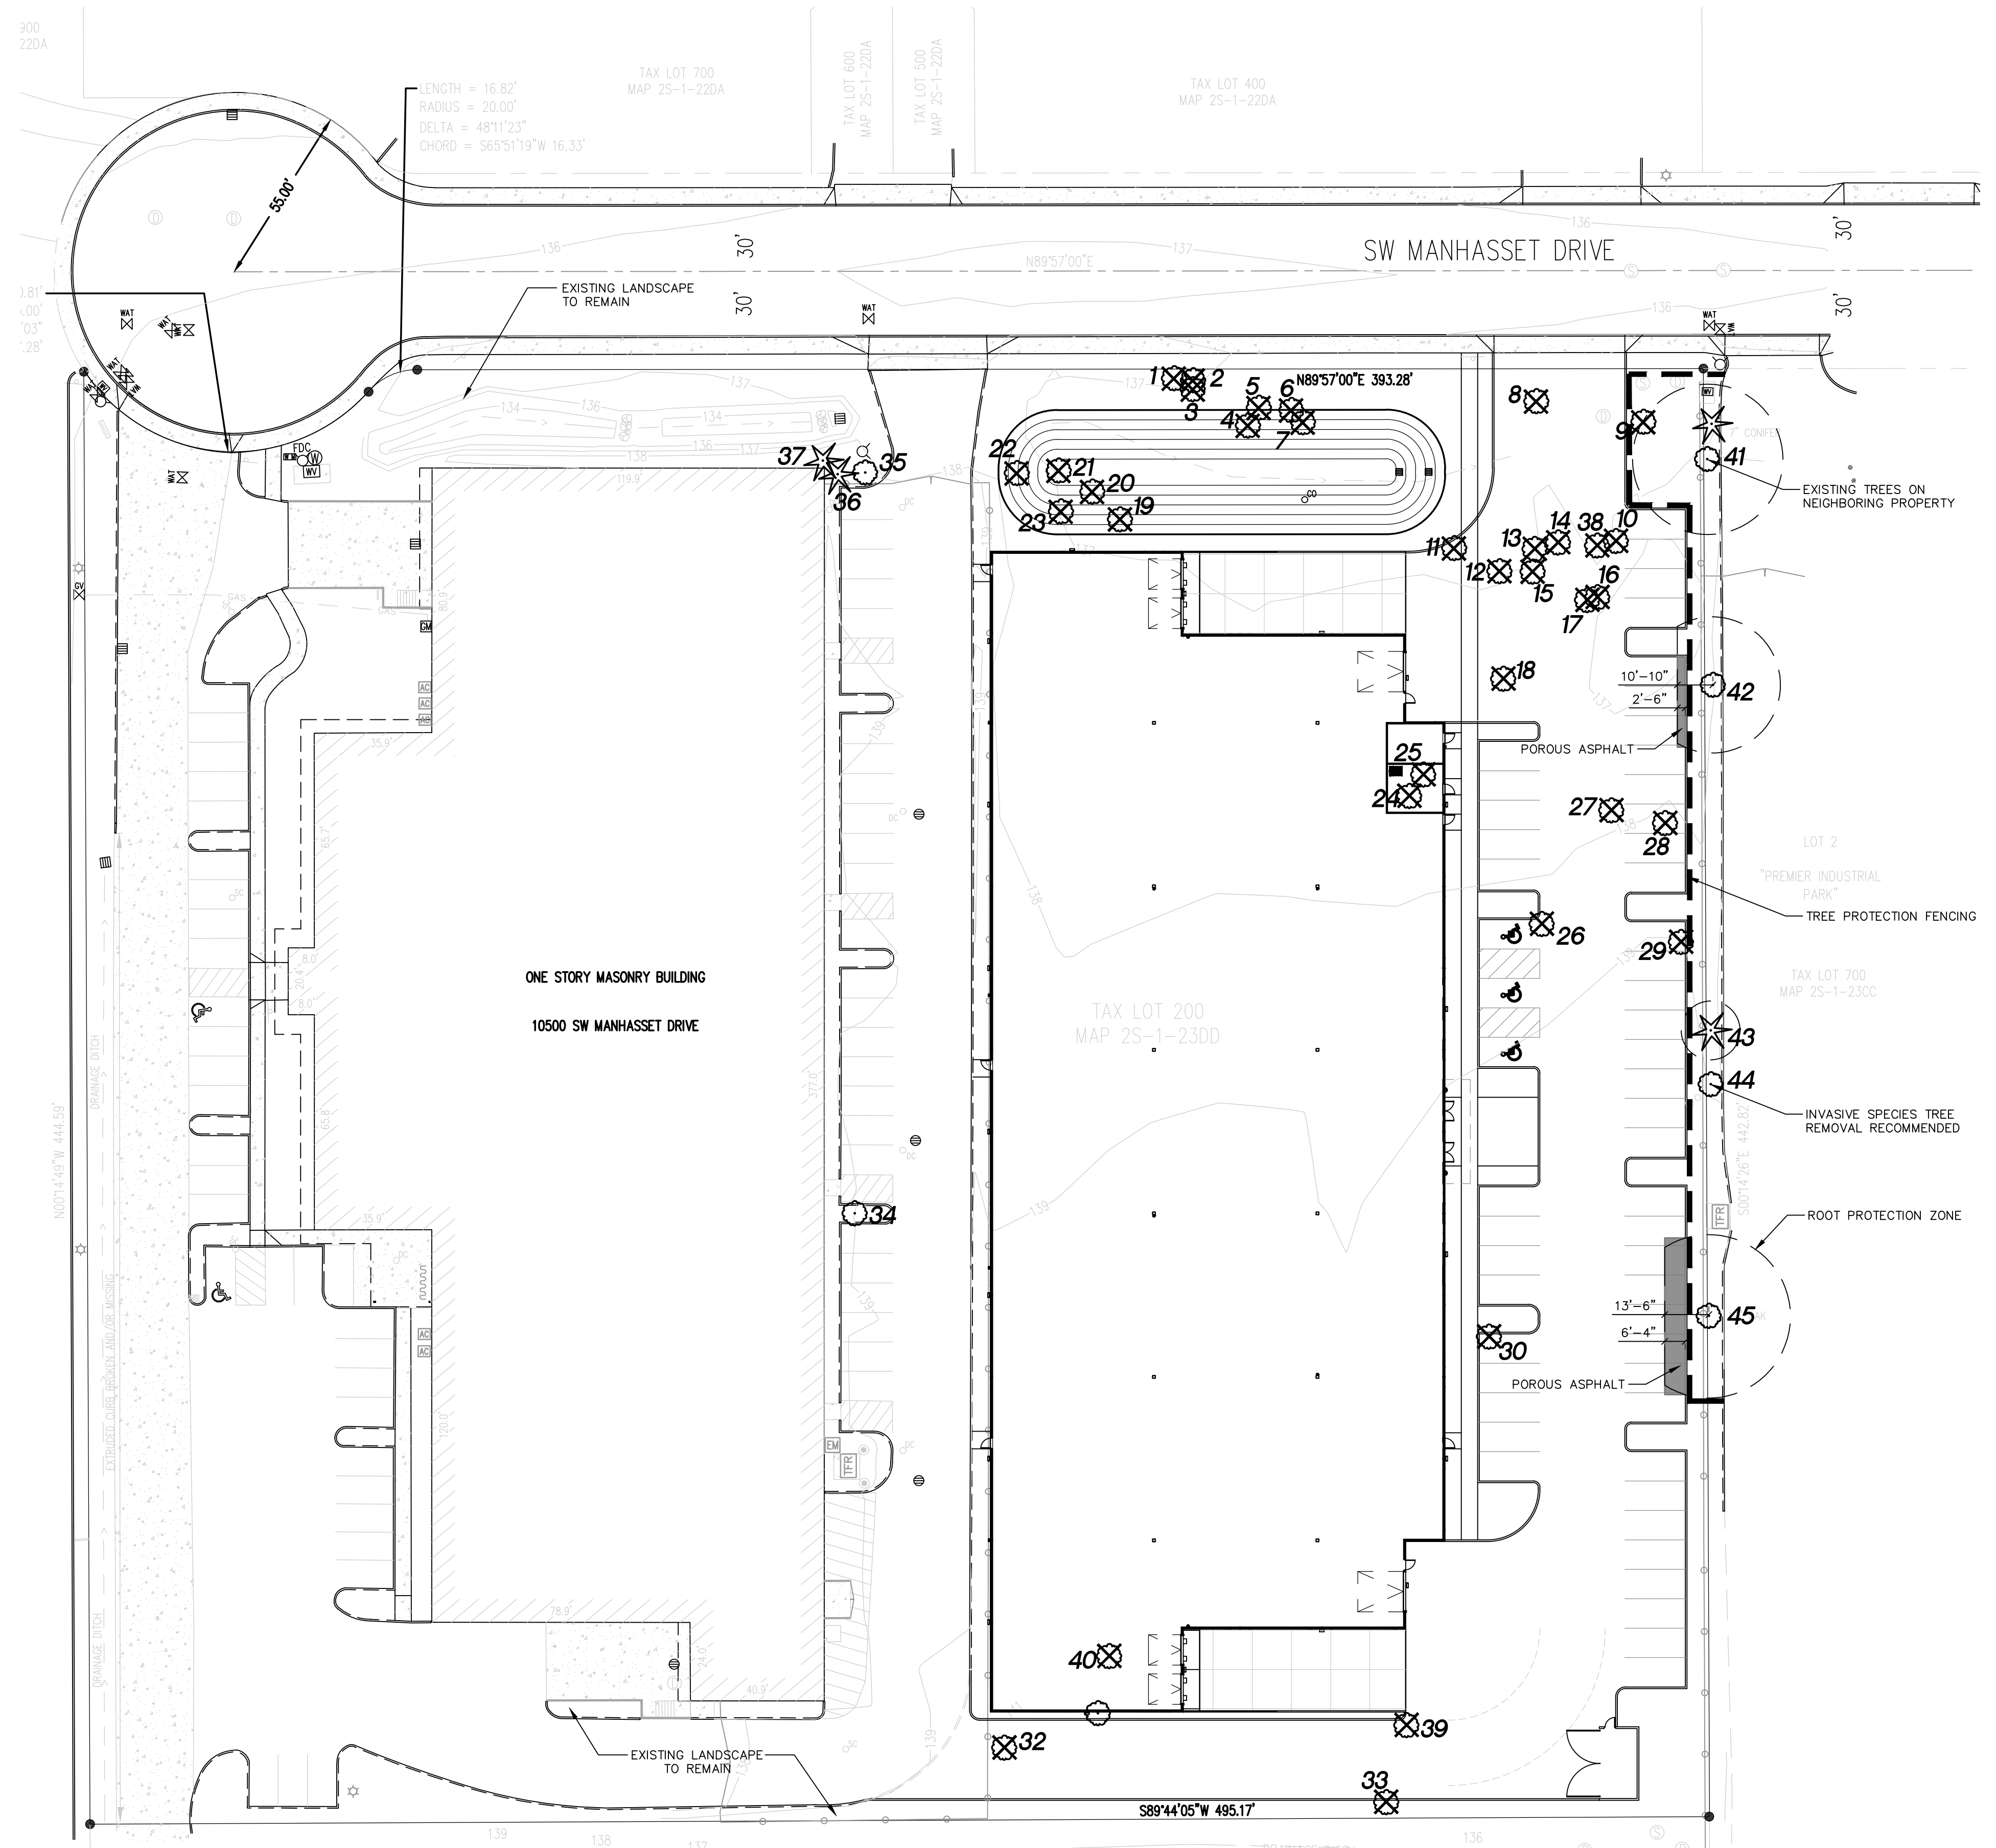
TREE PLAN

Erin Holsonback provided the site plan with trees marked for removal and the location of tree protection fencing as well as areas of pervious paving. All of the trees marked with X will have to be removed to accommodate the construction of the new building and paved areas.

The eastern neighbor's Oregon white oaks (*Quercus garryana*) will be protected during construction from long term impacts by the erection of the tree protection fence whose location is shown on the site plan. In addition, oak number 42 and 45 will have areas of pervious pavement placed just east of the of the trees with no curbs to prevent the need to cut roots and allow moisture to reach the roots of the oaks in the areas of the protected tree rooting protection zone. On the site plan, those areas are shown as greyed out and should be treated as extensions of the tree protection areas. No cut or fill beyond four inches shall be allowed within the tree protection areas or areas that are to have pervious pavement nor shall the area have the soil compacted. If a curb of some type is desired, an asphalt curb or concrete parking stop could be placed on top of the pervious pavement. Either pervious asphalt or concrete can be used with the idea that the base would be no deeper than four inches thick placed on top of the existing soil with the duff layer removed. No soil cut shall be allowed. As the pervious payment is only to be placed at the end of the parking stall, it shouldn't have to support too much weight as only the vehicle's front or rear end will have to be supported.

On the site plan, the area of protected tree rooting protection is shown as extending onto the neighboring property. It should be understood that there should be no need to extend any tree protection fencing onto the neighboring property and only in the areas where the fence is shown on the plan.

All of the trees marked with X on the site plan need to be removed to accommodate the construction of the new building.

The location of the tree protection fencing should adequately provide protection to the trees long term as long as the areas where pervious pavement is to be placed has no excavation or fill greater than four inches.
