Exhibit A5: Arborist Report

Tree Plan for SW Ibach Street Subdivision

Date: August 22, 2025

Site Address: 10150 SW Ibach Street
Tualatin, OR 97062

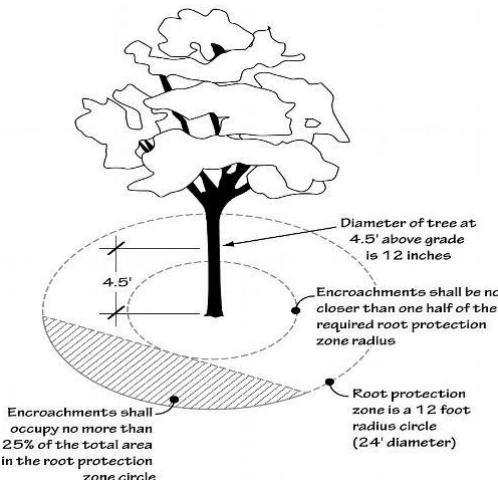
A typical minimum root protection zone allows encroachments no closer than a radius from a tree of 0.5 feet per inch of DSH if no more than 25 percent of the root protection zone area (estimated at one foot radius per inch of DSH) is impacted. Figure 1 illustrates this concept. This

Figure 1 Typical minimum protection zone.

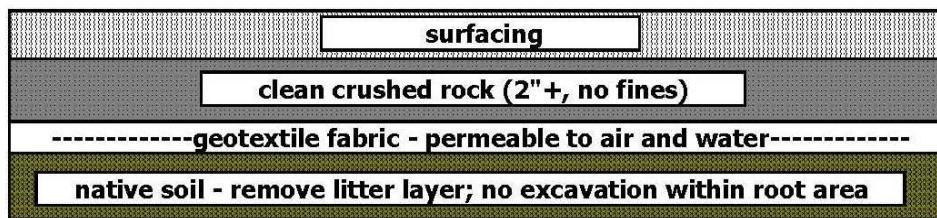
Figure 2 Sample profile for area within fenced tree protection zone. Depth of rock is dependent on grading.

- *Modify the sidewalk and/or paving profile.* A 6-foot-wide sidewalk is proposed 11.5 feet west of tree 10102. If the sidewalk could be curb tight for approximately 52-feet, that would reduce the level of encroachment on the west side of the tree. If a curb tight sidewalk is not an option, then a modified paving profile is recommended (Figure 2).

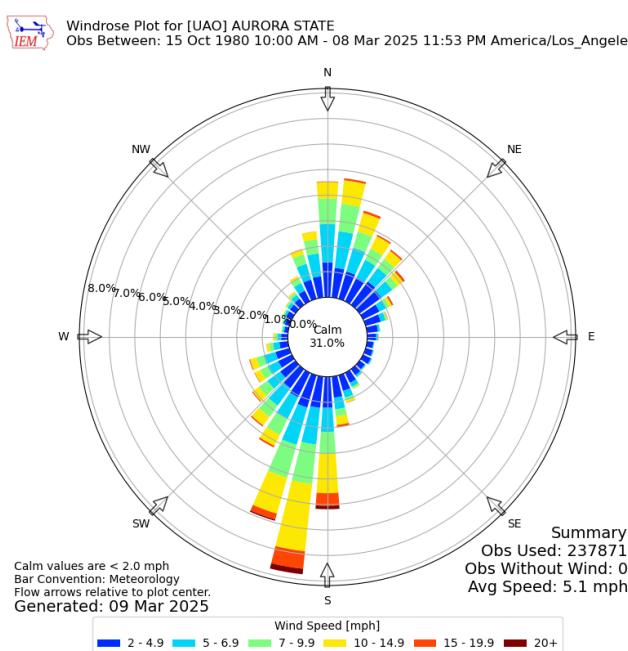
Furthermore, the removal of three large-diameter trees north of tree 10102 (trees 10104, 10105, and 10107) will significantly change wind exposure for tree 10102. Specifically, tree 10102 will be more exposed to wind forces on the north side. Upon review of wind data from the Aurora State Airport (approximately 9 miles south of the site, Figure 3) and Portland Hillsboro Airport (approximately 20 miles northwest of the site, Figure 4),¹ the tree will experience sustained winds and wind gusts from the north, though winds from the south are also common.

Figure 3 Windrose plot from Aurora State Airport, approximately 9 miles south of the site.

Therefore, if tree 10102 is to be retained, it should be assessed for risk following tree removal, routinely during construction, and periodically post-construction.

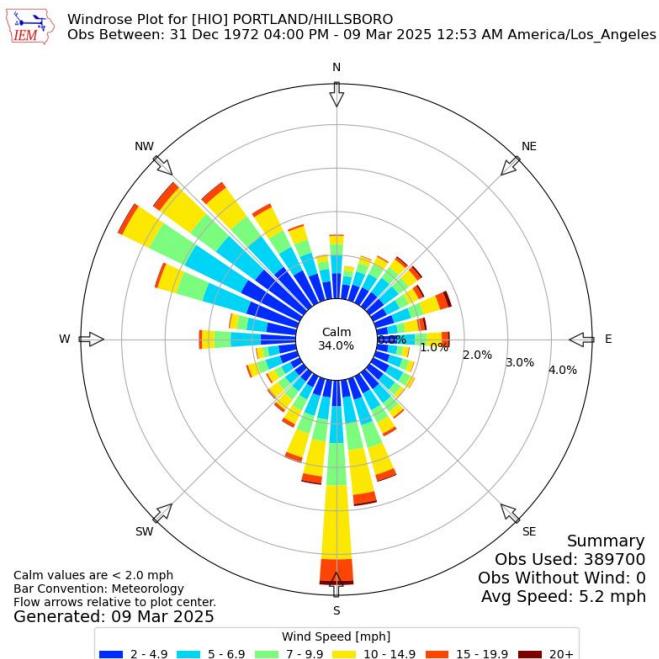
Figure 4 Windrose plot from Portland-Hillsboro Airport, approximately 20 miles northwest of the site.
