TUALATIN CITY COUNCIL

Monday, June 22, 2015

The City Facilities Study project was identified during previous discussions regarding the conditions of existing city facilities, desires for additional city programs, and concerns regarding space needs for city programs and staff.

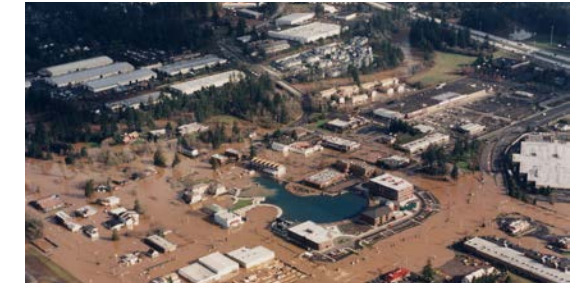
The Tualatin River reaches flood stage at 118 feet – during the 1996 floods it reached 125 feet. Flooding is based on a number of factors: rainfall, river-flow and tidal-surge data, topography, flood-control measures, and changes in natural environment due to building and development.

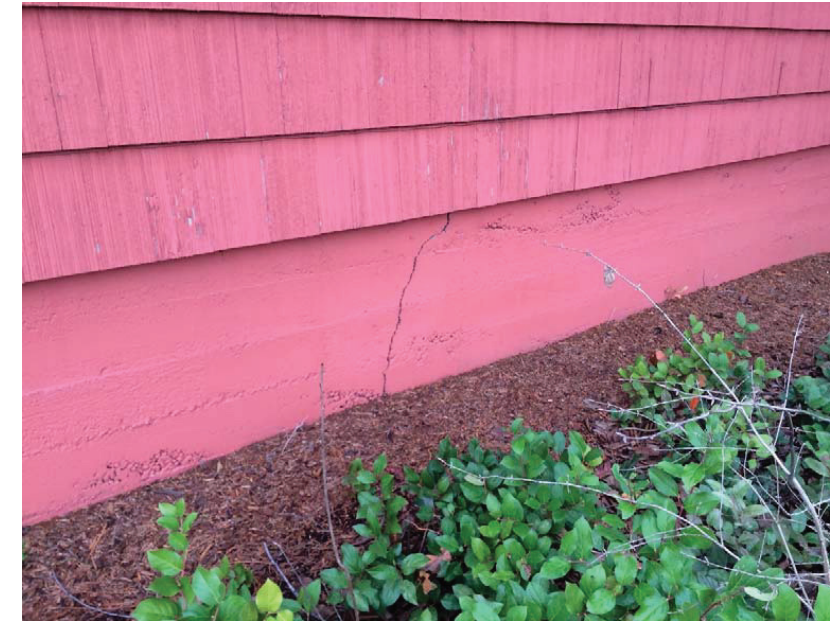
Figure A10.1 Minor cracking observed at basement walls (this location at south side)

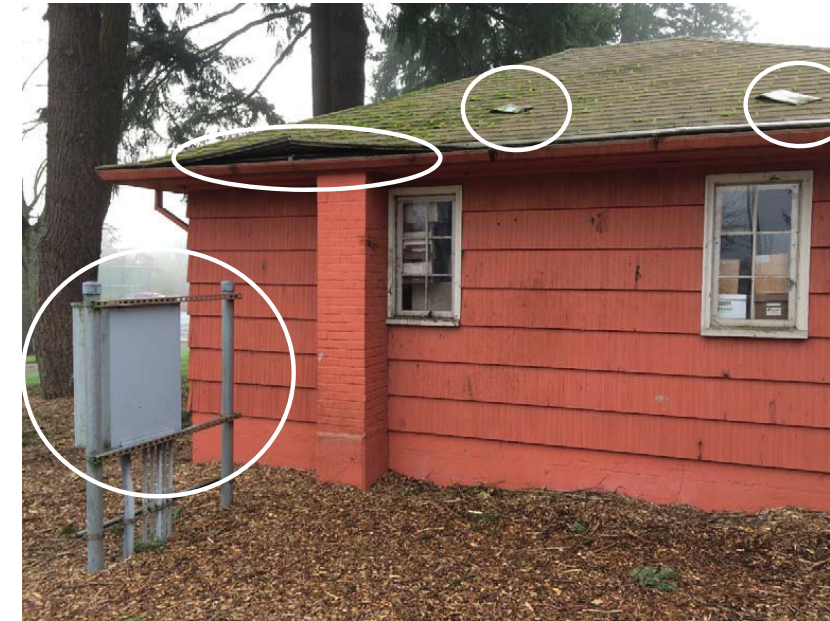
Figure B30.2 Damage at eave edge of Garage roof; Staff indicated that following the inspection, the observed damage at the Garage roof had been repaired; roof access may be possible by adjacent electrical equipment; abandoned skateboard decks on Garage roof

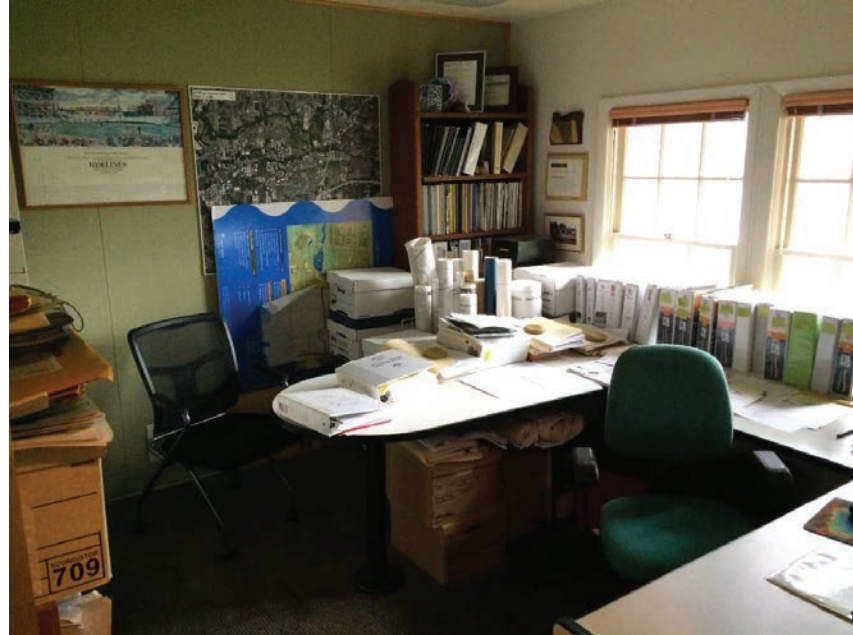
Figure B10.5A Office functions impose loads differently than residential use

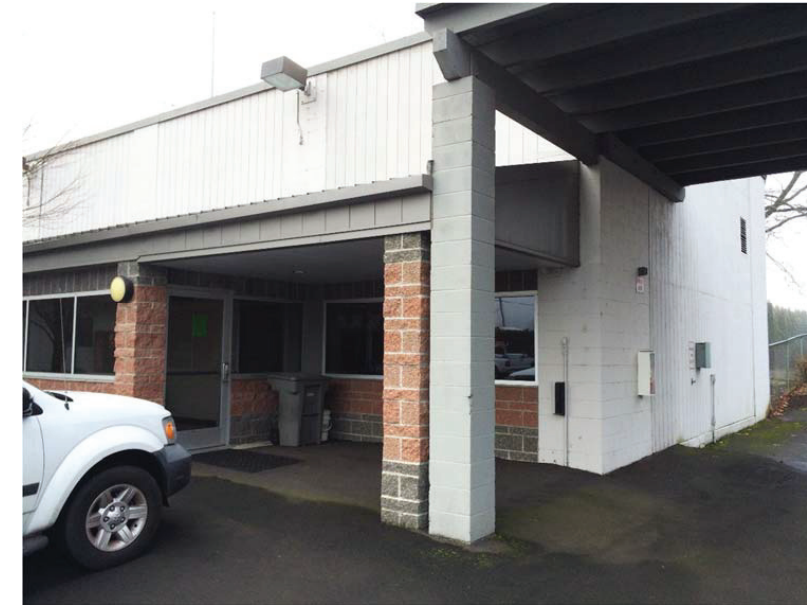
Figure B30.1A CMU corners and between former maintenance bays; T1-11 exterior plywood infill at front of building; split-faced CMU and aluminum storefront windows added for lobby

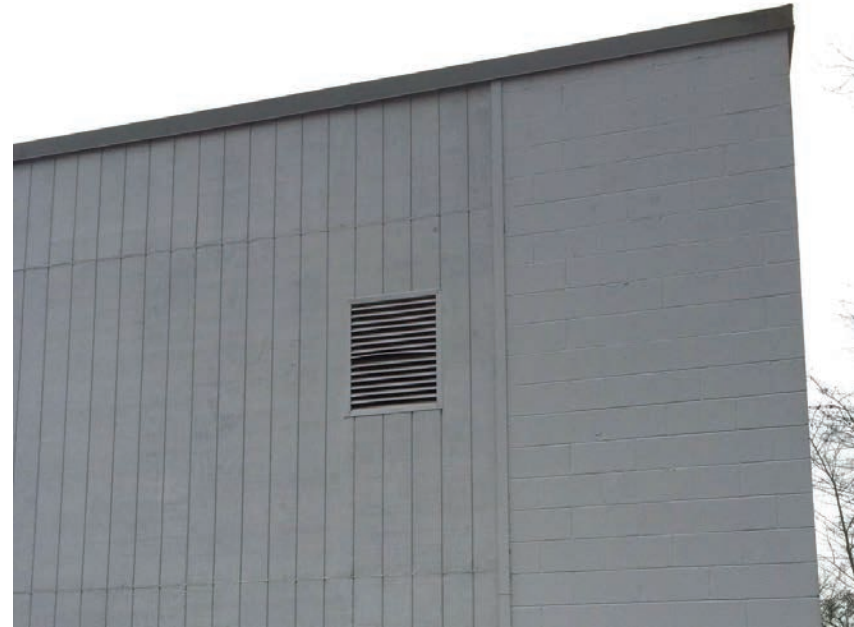
Figure B30.1C Louver at north is disused, staff noted that capped at interior

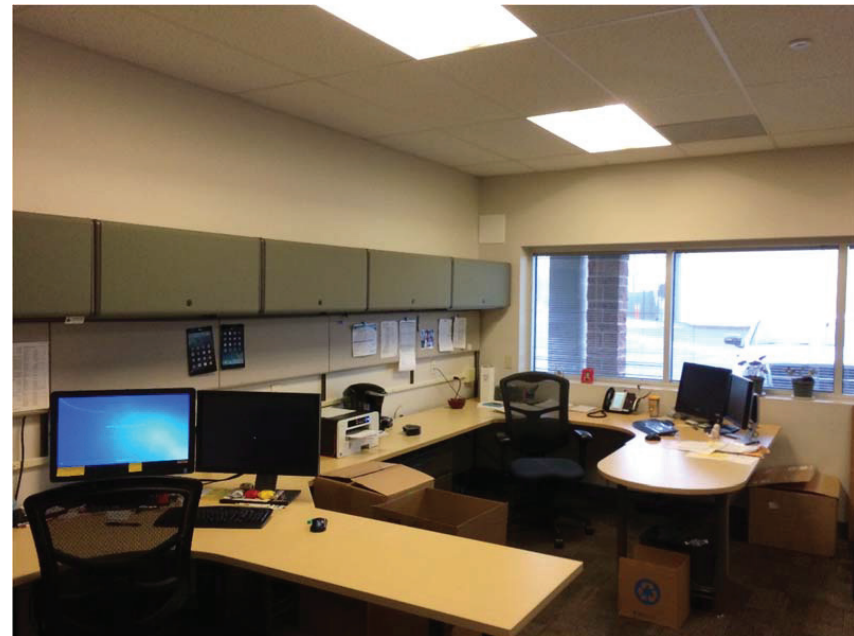
Figure C30.1 Interior finishes at IT space

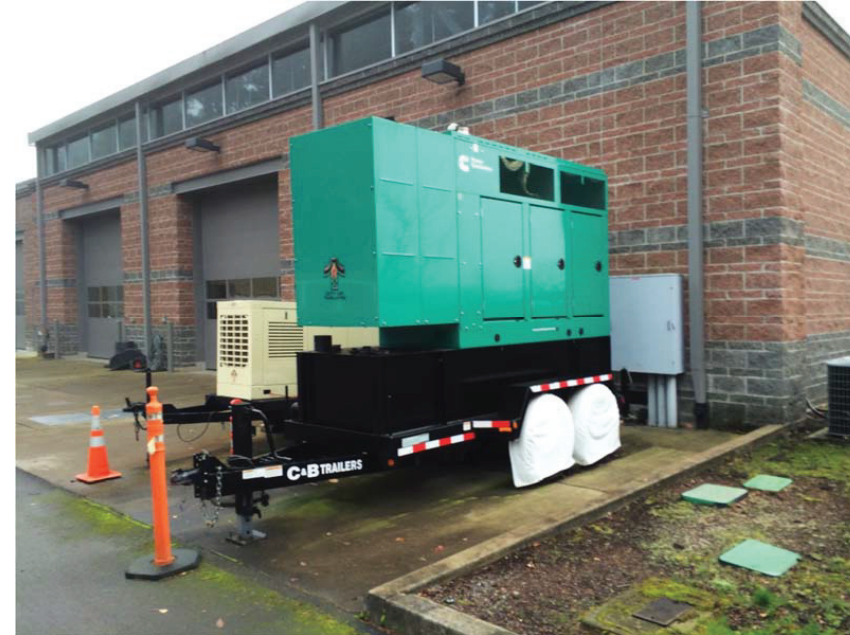
Figure D50.21 Trailer-mounted engine-generator set with base tank

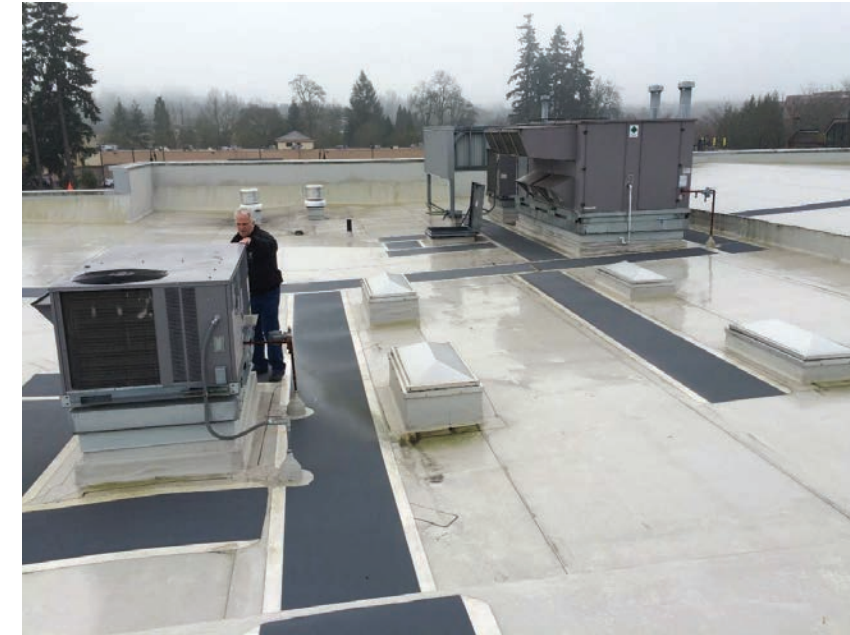
Figure B30.1 Rooftop conditions observed

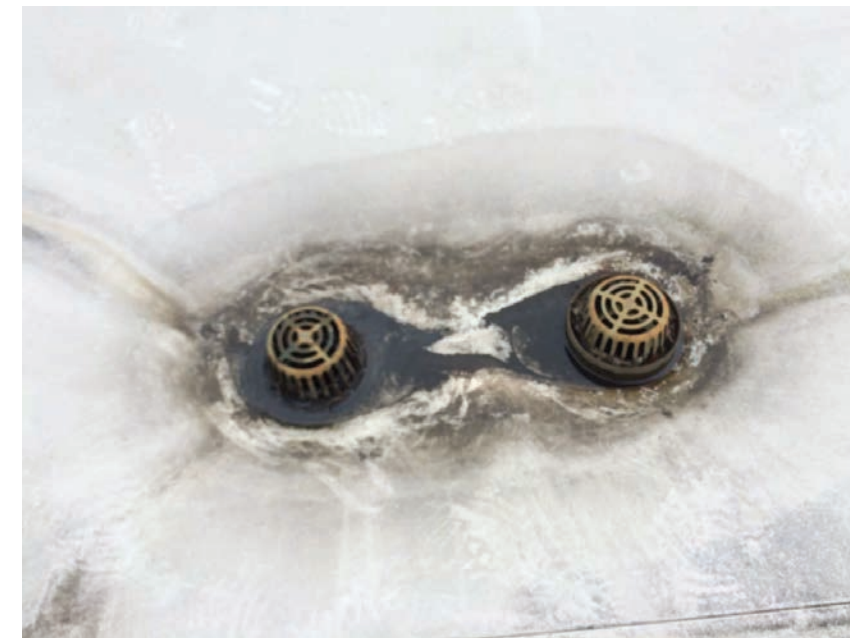
Figure B30.2 Typical roof drain and overflow drain conditions

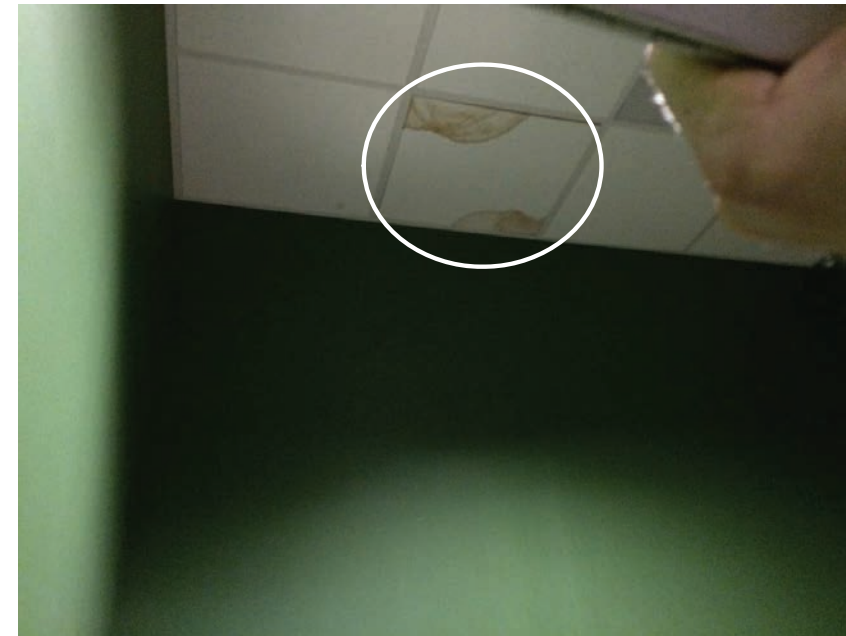
Figure C30.2 Evidence of leak visible in acoustic ceiling tile in Library

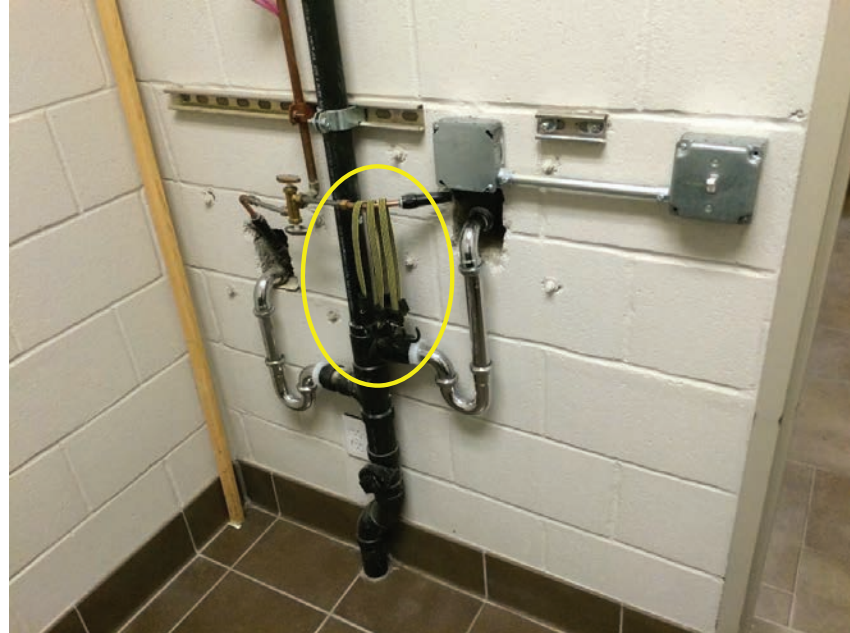
Figure D20.1/8 Copper water supply and PVC sanitary lines; note straps hung from plumbing

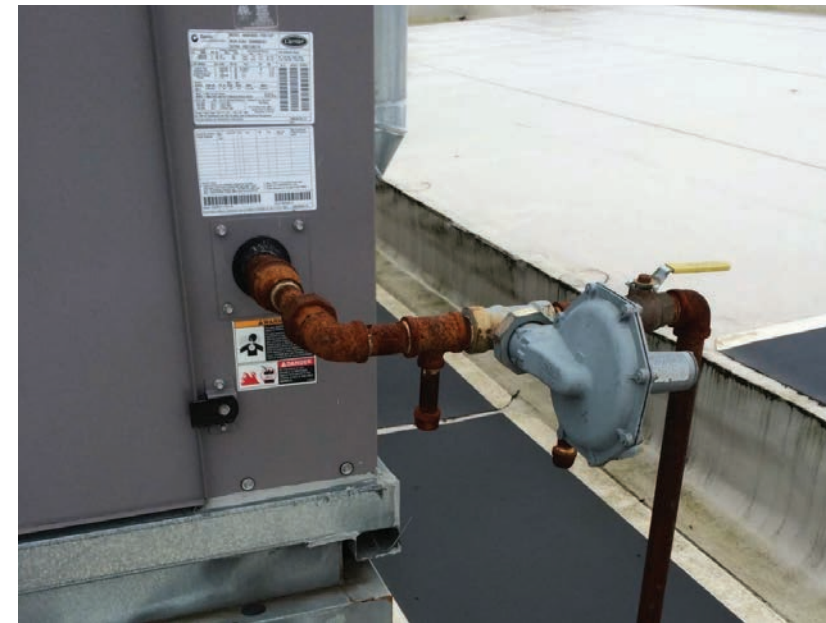
Figure D30.4A Rooftop mechanical units are gas-fired; typical gas line is unpainted pipe, corroded

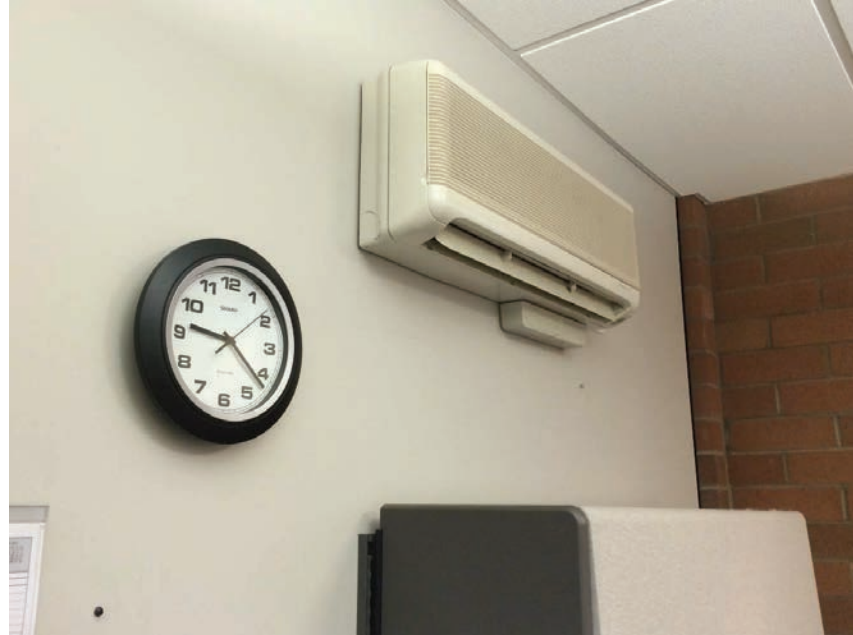
Figure D30.4B Remote split systems provided at south-facing offices in original portion of building

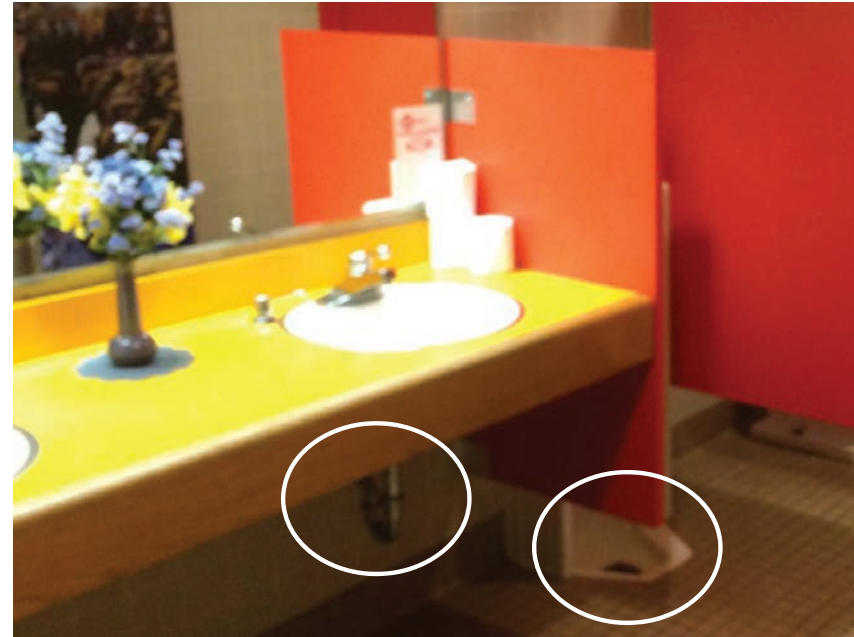
Figure C10.4 Sink and urinal are not accessible (Men's Room observed)

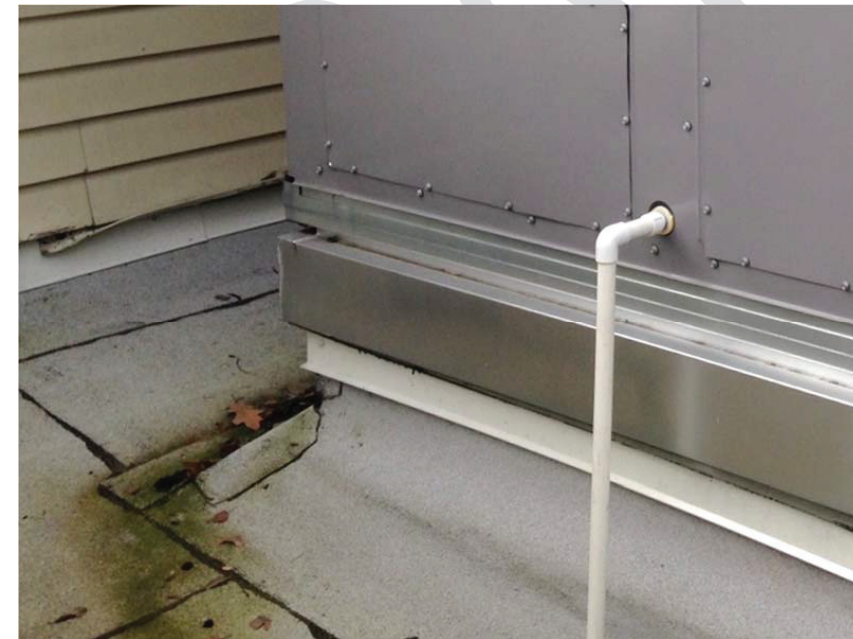
Figure B30.1 Staff photo of roof condition above Activity Room space

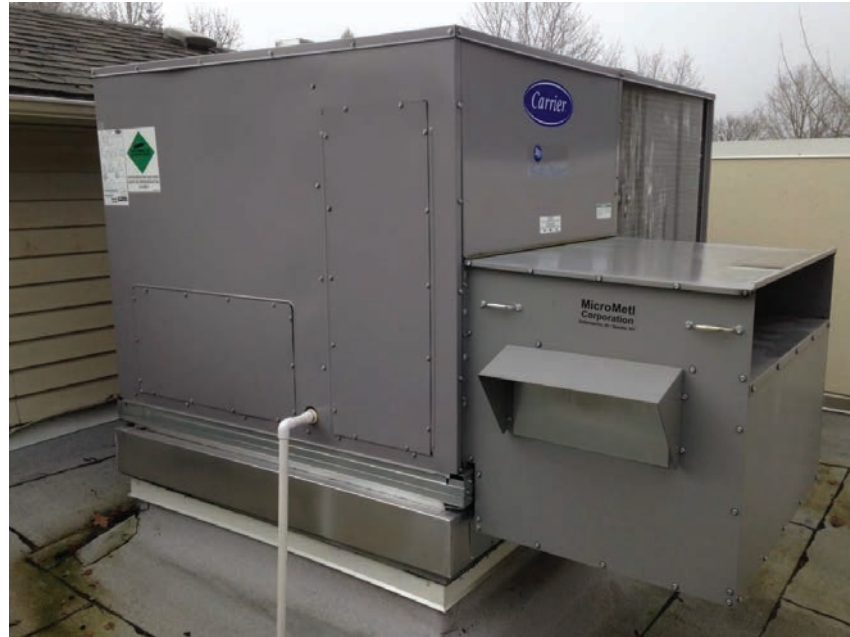
Figure D30.6 Staff photo of air handler configuration and access above Activity Room space

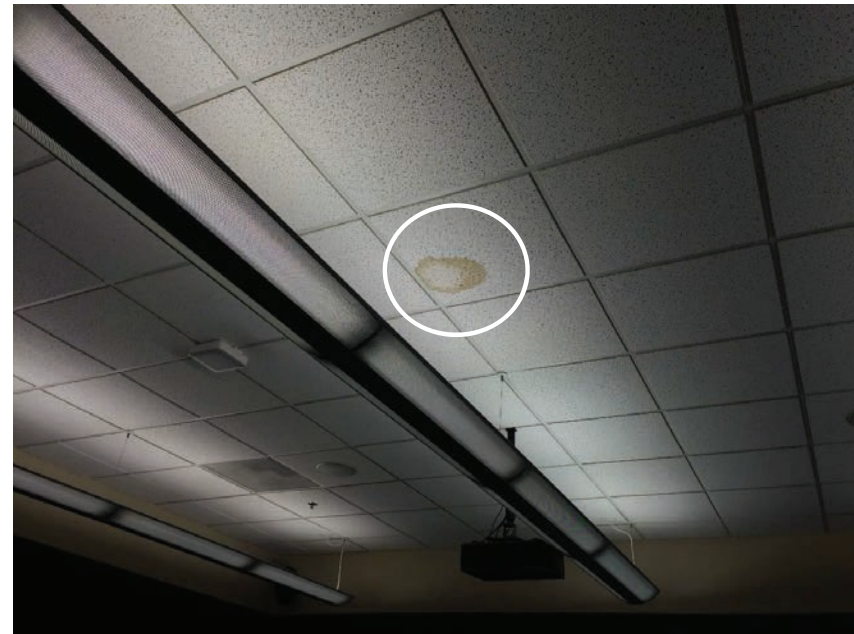
Figure C30.2 Evidence of past leak visible in acoustic ceiling tile; Staff noted that leak was repaired

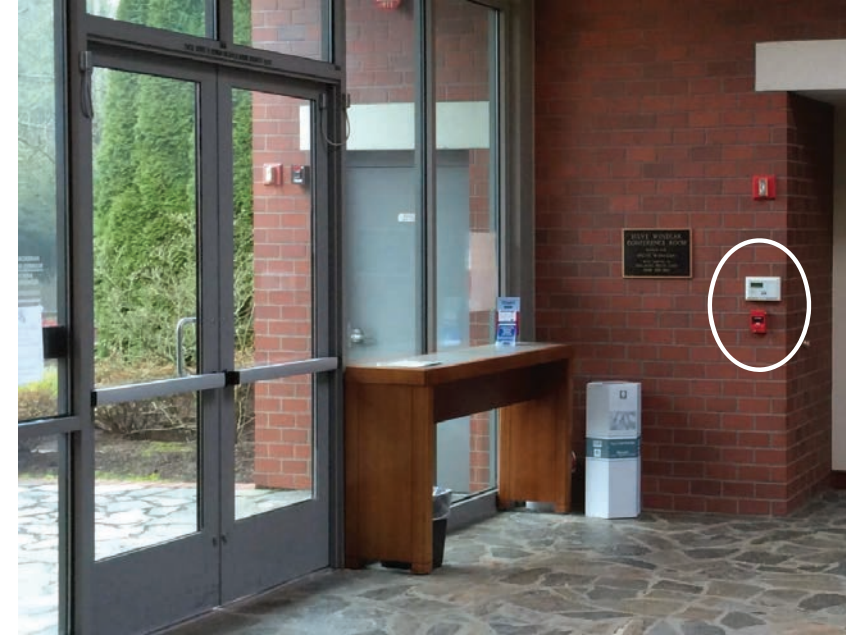
Figure D40.12 Fire alarm pull station and system panel adjacent to entry door

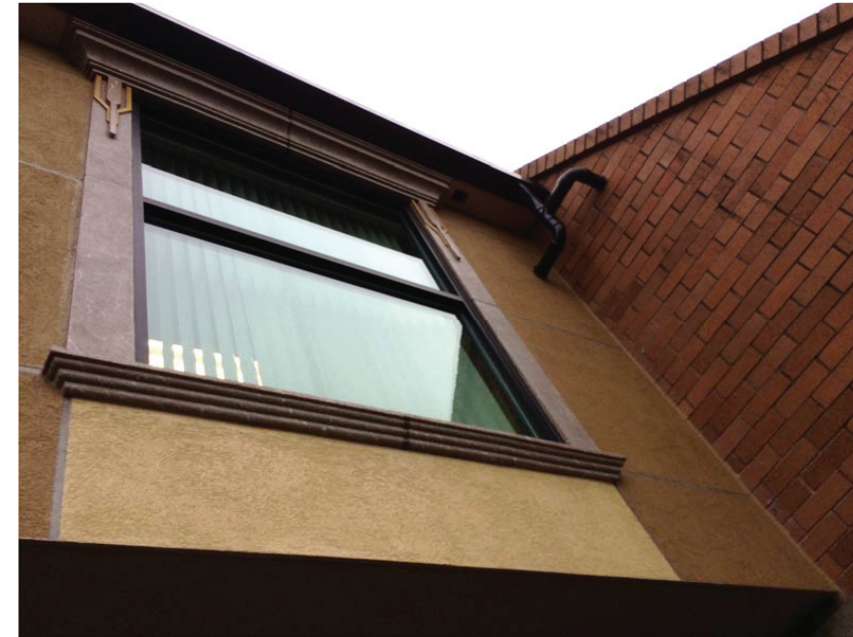
Figure B30.1 Metal roof edge, flashings and gutters appear to be in good condition
