HAZELBROOK ESTATES

PRELIMINARY SUBDIVISION APPLICATION

HAZELBROOK ESTATES
SUBDIVISION
TUALATIN
OREGON
TAX MAP 2S 1W 15DA

COVER SHEET WITH
VICINITY AND SITE MAPS

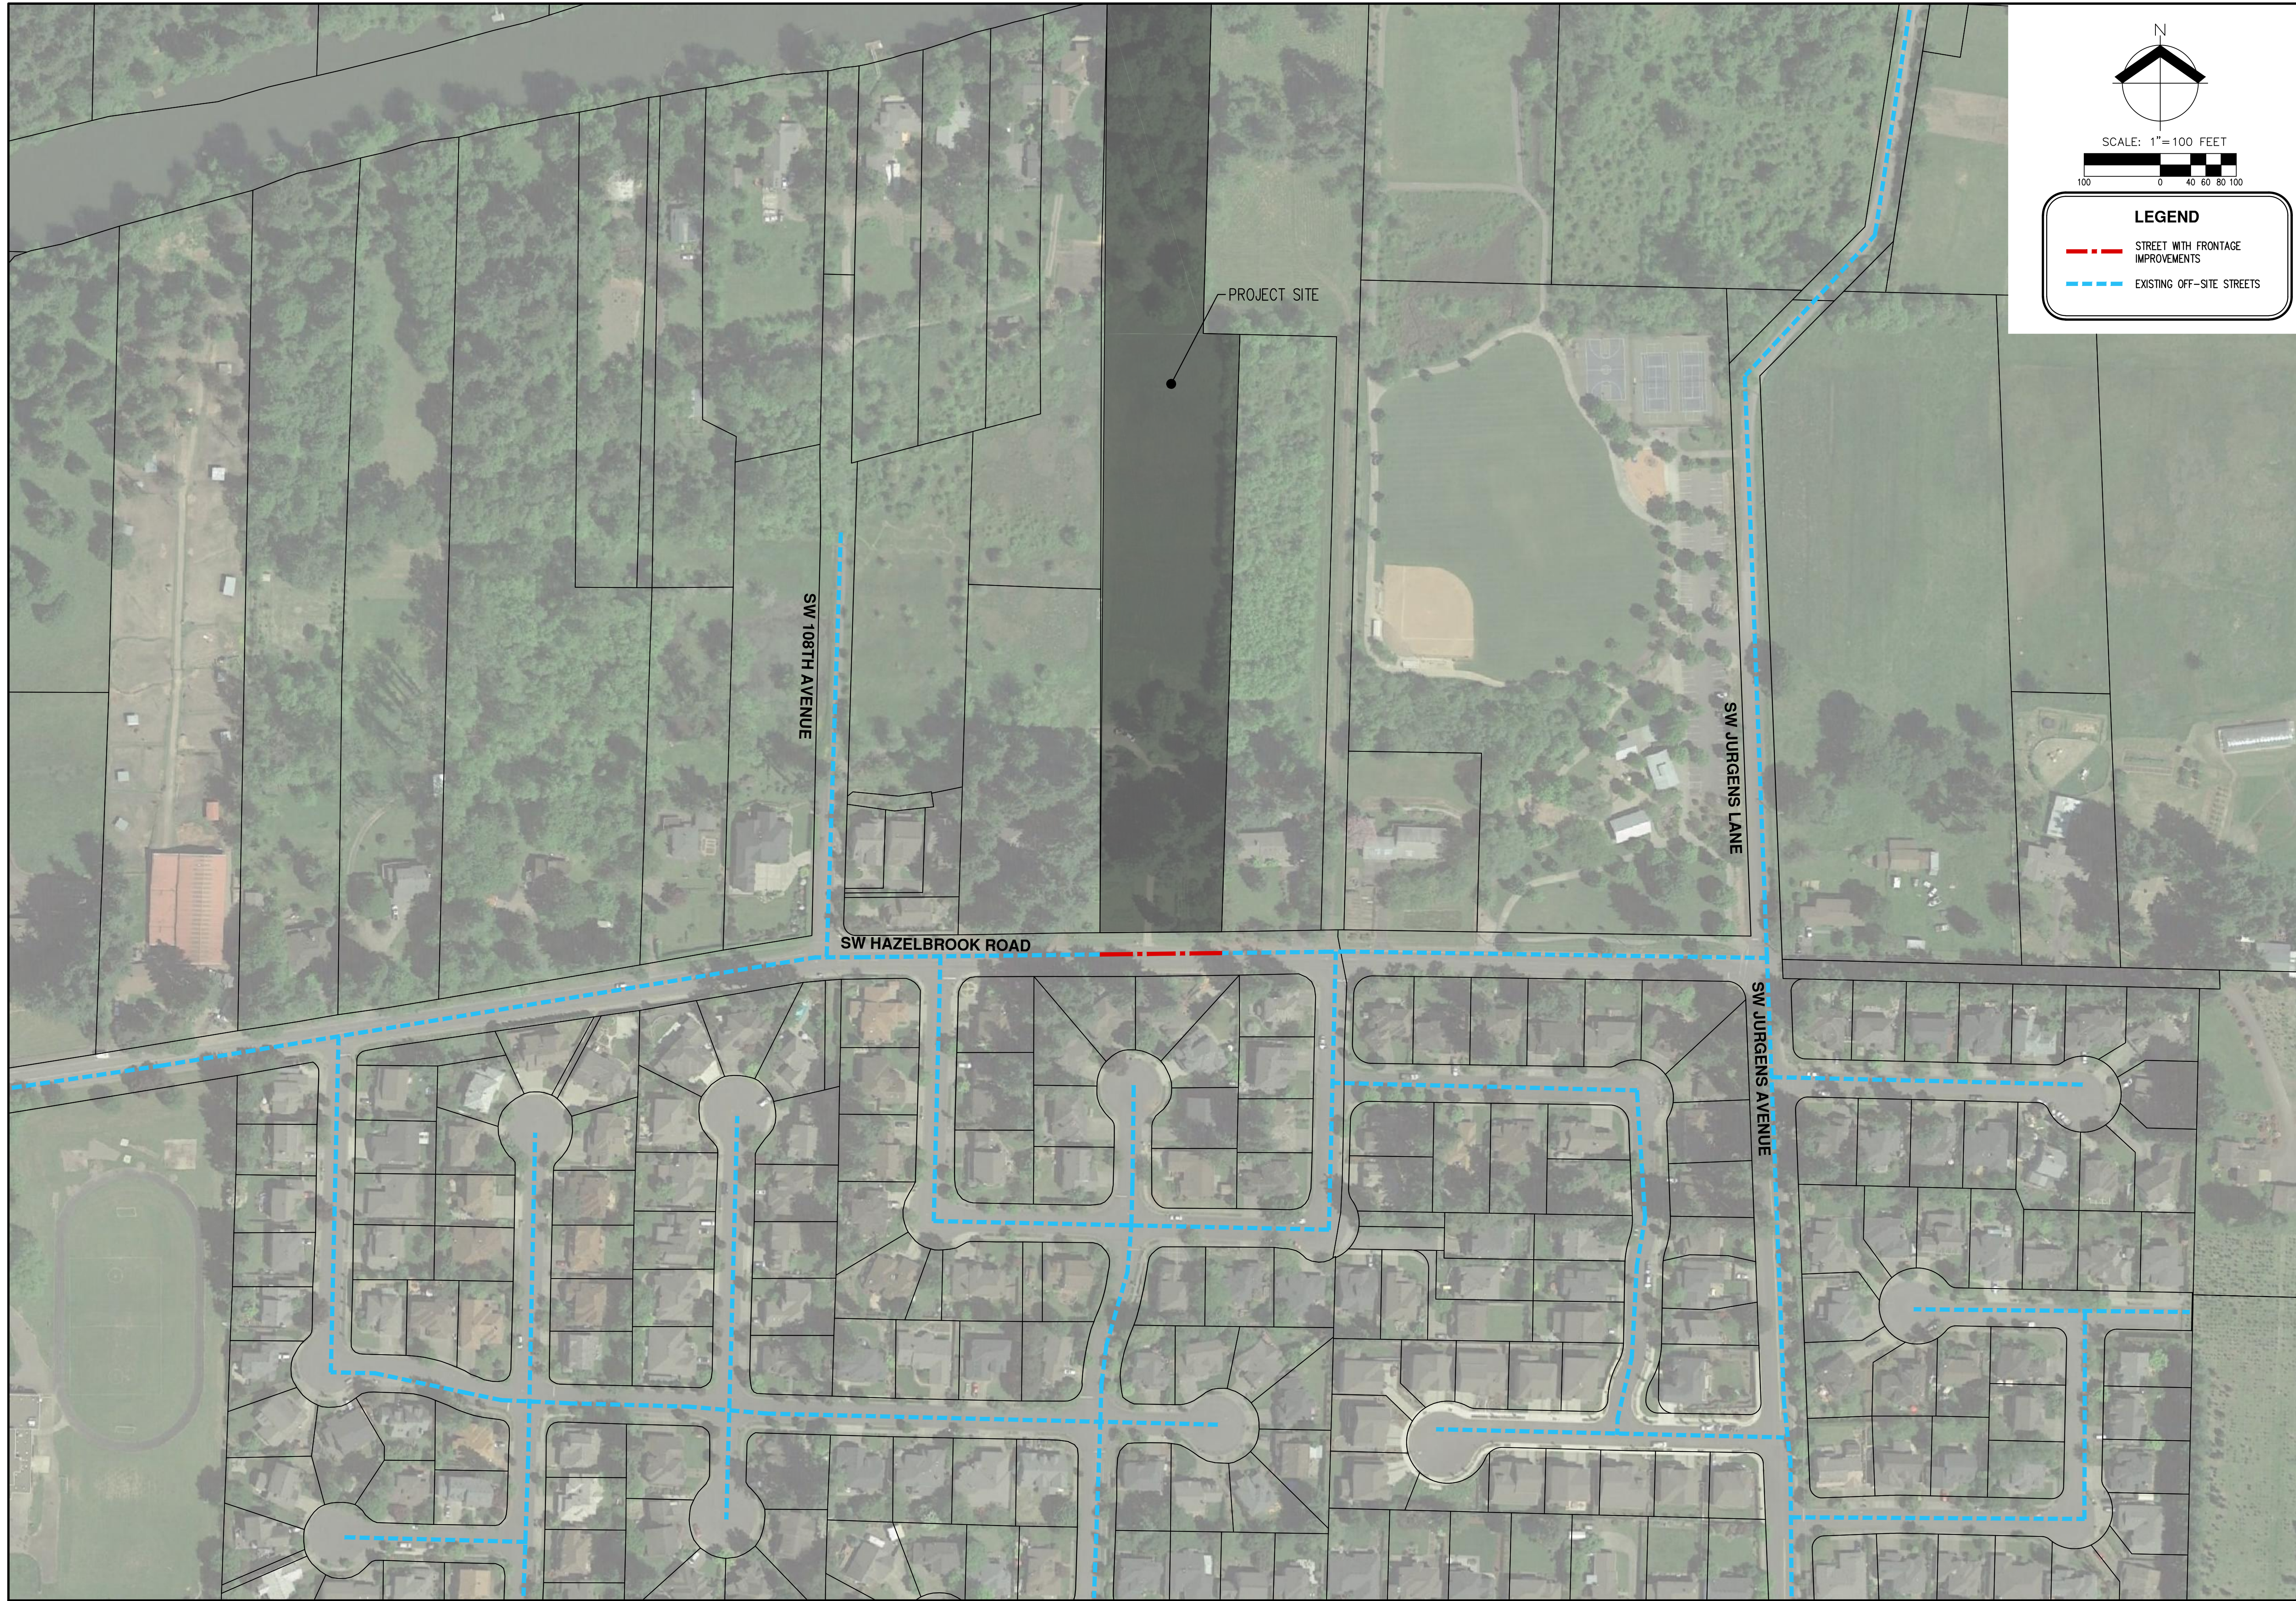
**PRELIMINARY
 NEIGHBORHOOD
 CIRCULATION PLAN**

- - - - - STREET WITH FRONTAGE IMPROVEMENTS

- - - - - EXISTING OFF-SITE STREETS
