Prepared for City of Tualatin Oregon

Stormwater Master Plan

April 2019 | DRAFT-FINAL

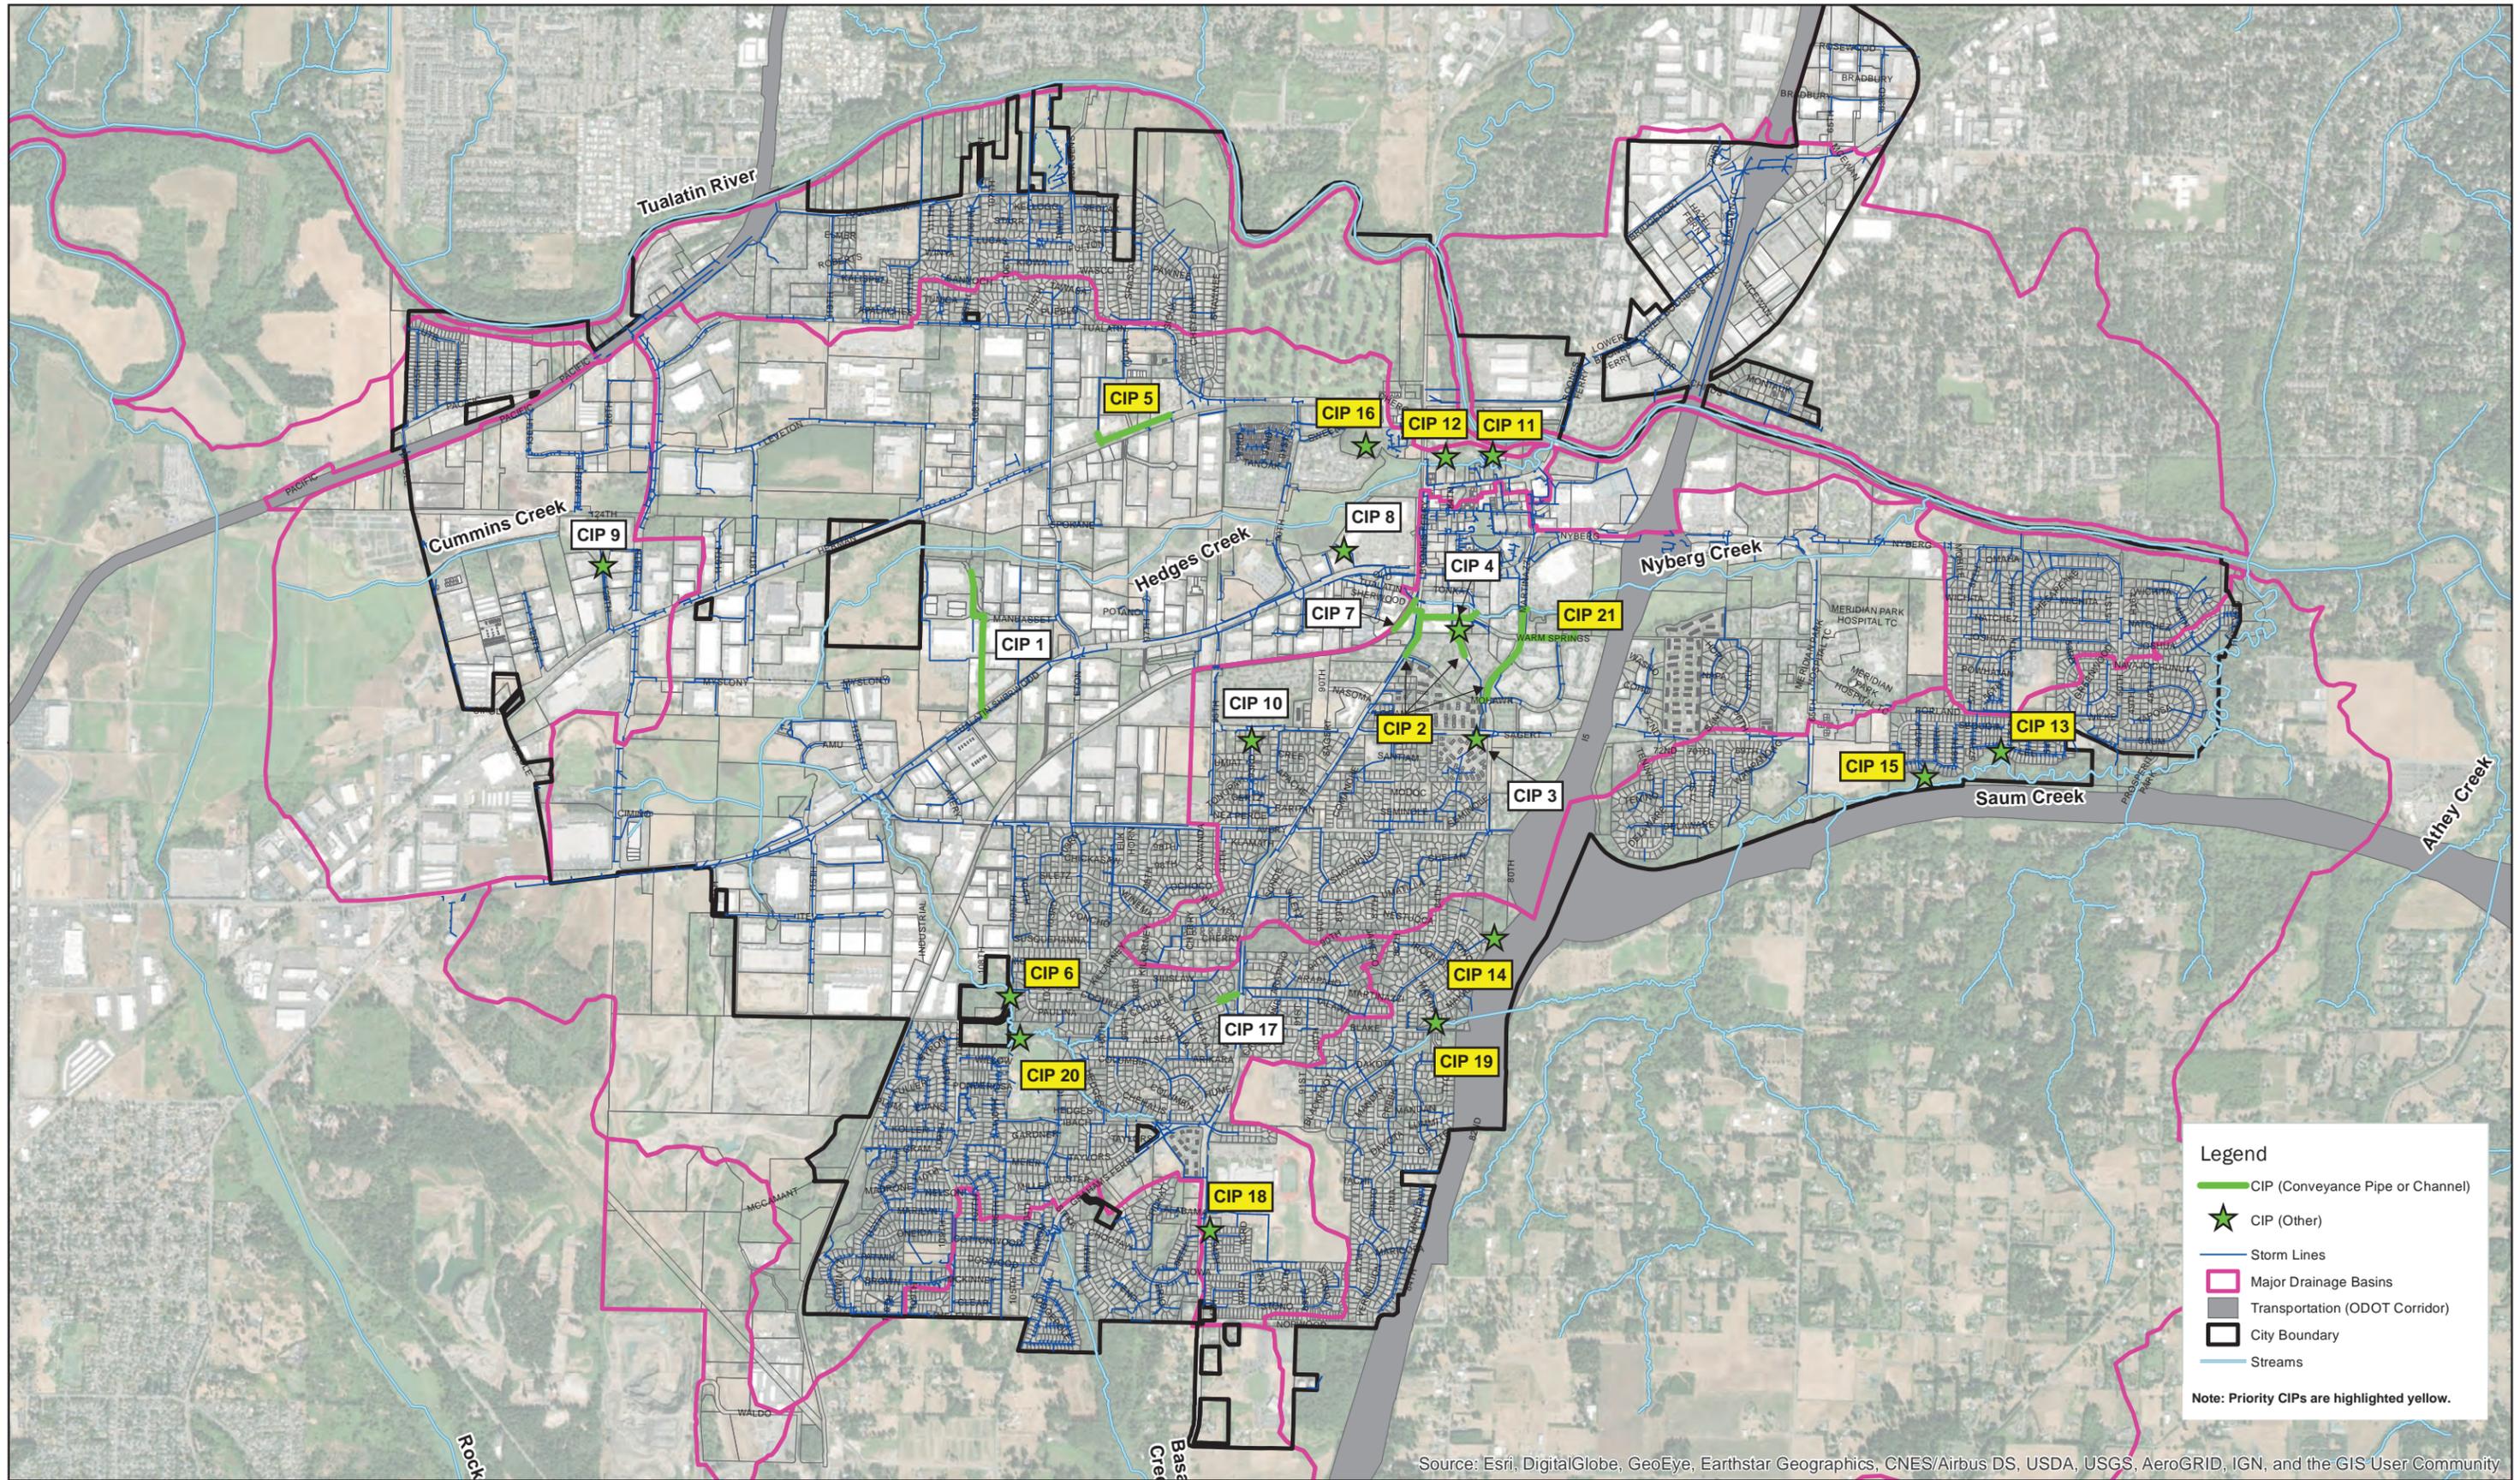
Figure ES-1 shows the location of the proposed CIPs, with priority projects identified. Detailed fact sheets for each CIP can be found in Appendix A.

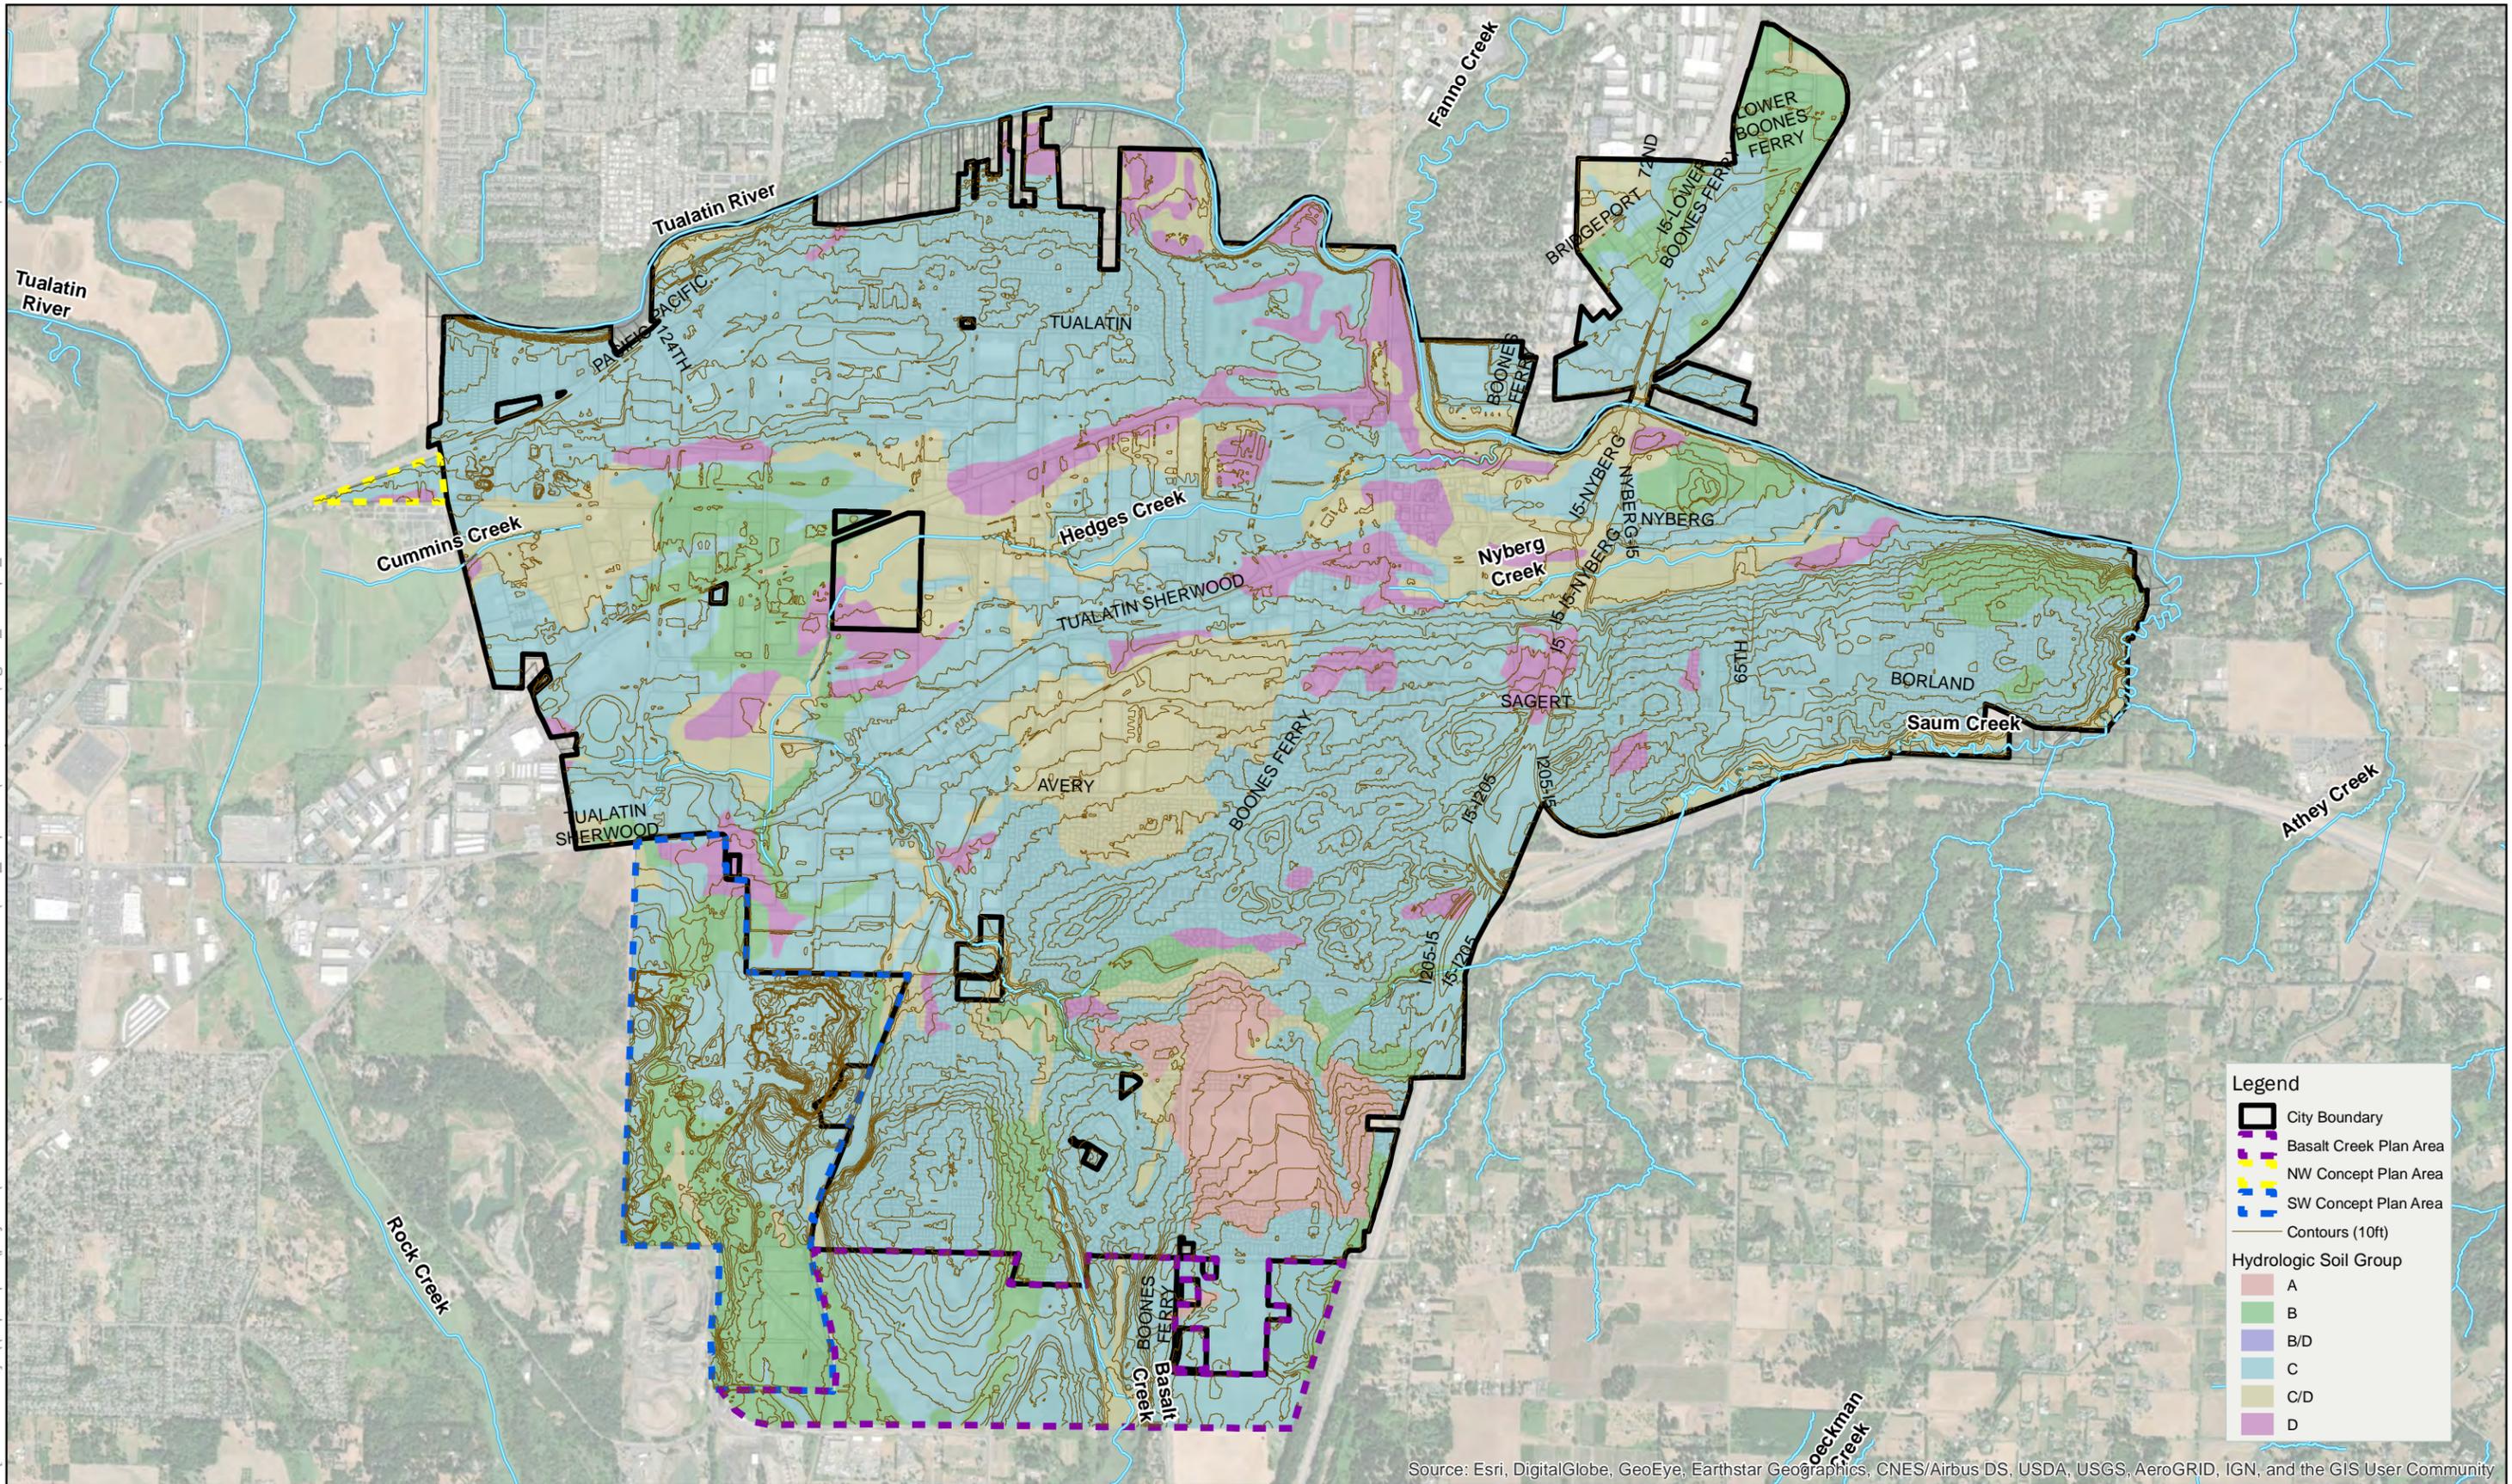
Figure 2-3
Topography and Soils

The National Resources Conservation Service (NRCS) Soil Survey online tool was used to gather soils information for Tualatin. Soils are an important watershed characteristic for evaluating potential runoff rates and volumes. Soils are generalized into four categories or hydrologic soil groups (HSG), which approximate soil runoff potential. These groups are A, B, C, and D, where A soils are characterized by high rates of infiltration and low runoff potential and D soils are characterized by low rates of infiltration and high potential for runoff. HSG conditions are reflected on Figure 2-3.

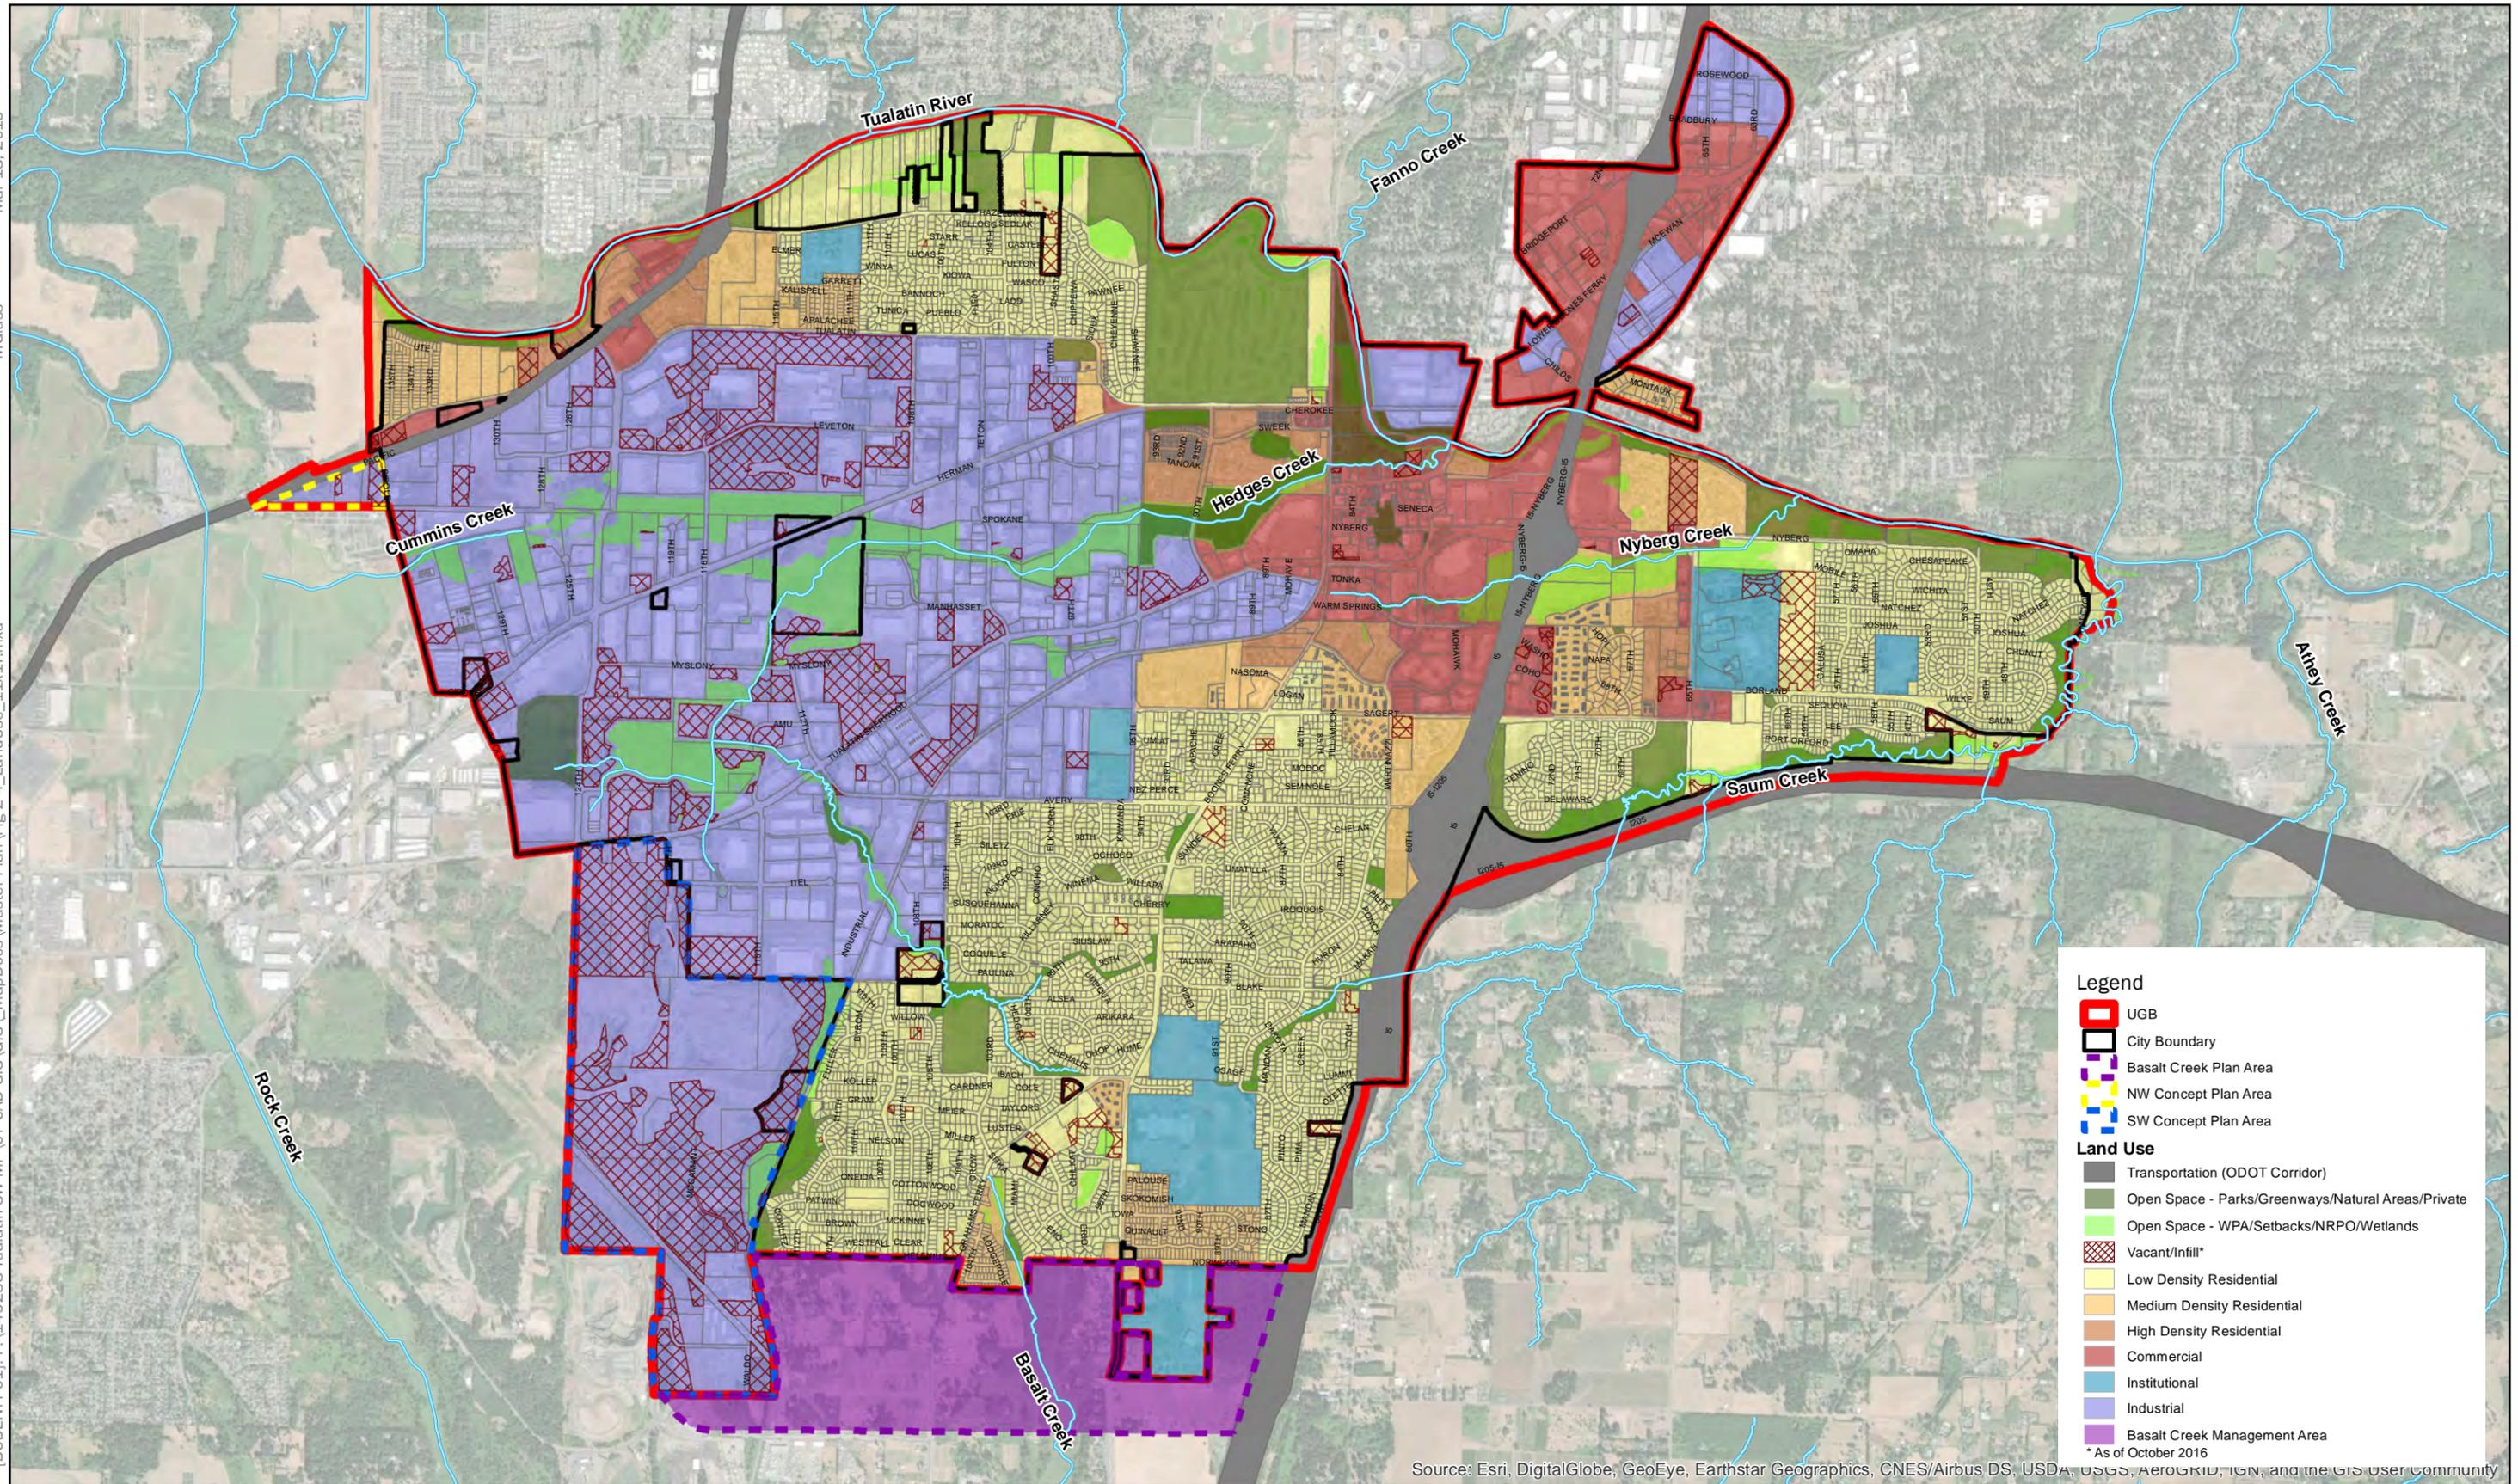
Figure 2-4
Land Use

Land use coverage was developed in GIS as part of this SMP to evaluate stormwater drainage conditions in the city. Land use coverage was based on City-provided GIS coverage of planning districts (zoning), open space areas, and developable lands. A detailed summary of the process to develop the City's land use coverage and associated impervious area estimates is provided in Technical Memorandum 1 (TM1), included in this SMP in Appendix B. Land use coverage is shown on Figure 2-4. Land use categories and impervious assumptions are reflected in Table 2-2.

Future growth for purposes of evaluating stormwater drainage infrastructure is based on projected development (i.e., vacant lands) (see Figure 2-4). Future industrial, primarily in the western half of the city, and commercial and multi-family residential development, is expected. Residential infill development is also anticipated. For the Basalt Creek planning area, future growth and development is expected but the timeframe is unknown. For purposes of this plan, future development conditions were not evaluated or assessed hydrologically for this area.

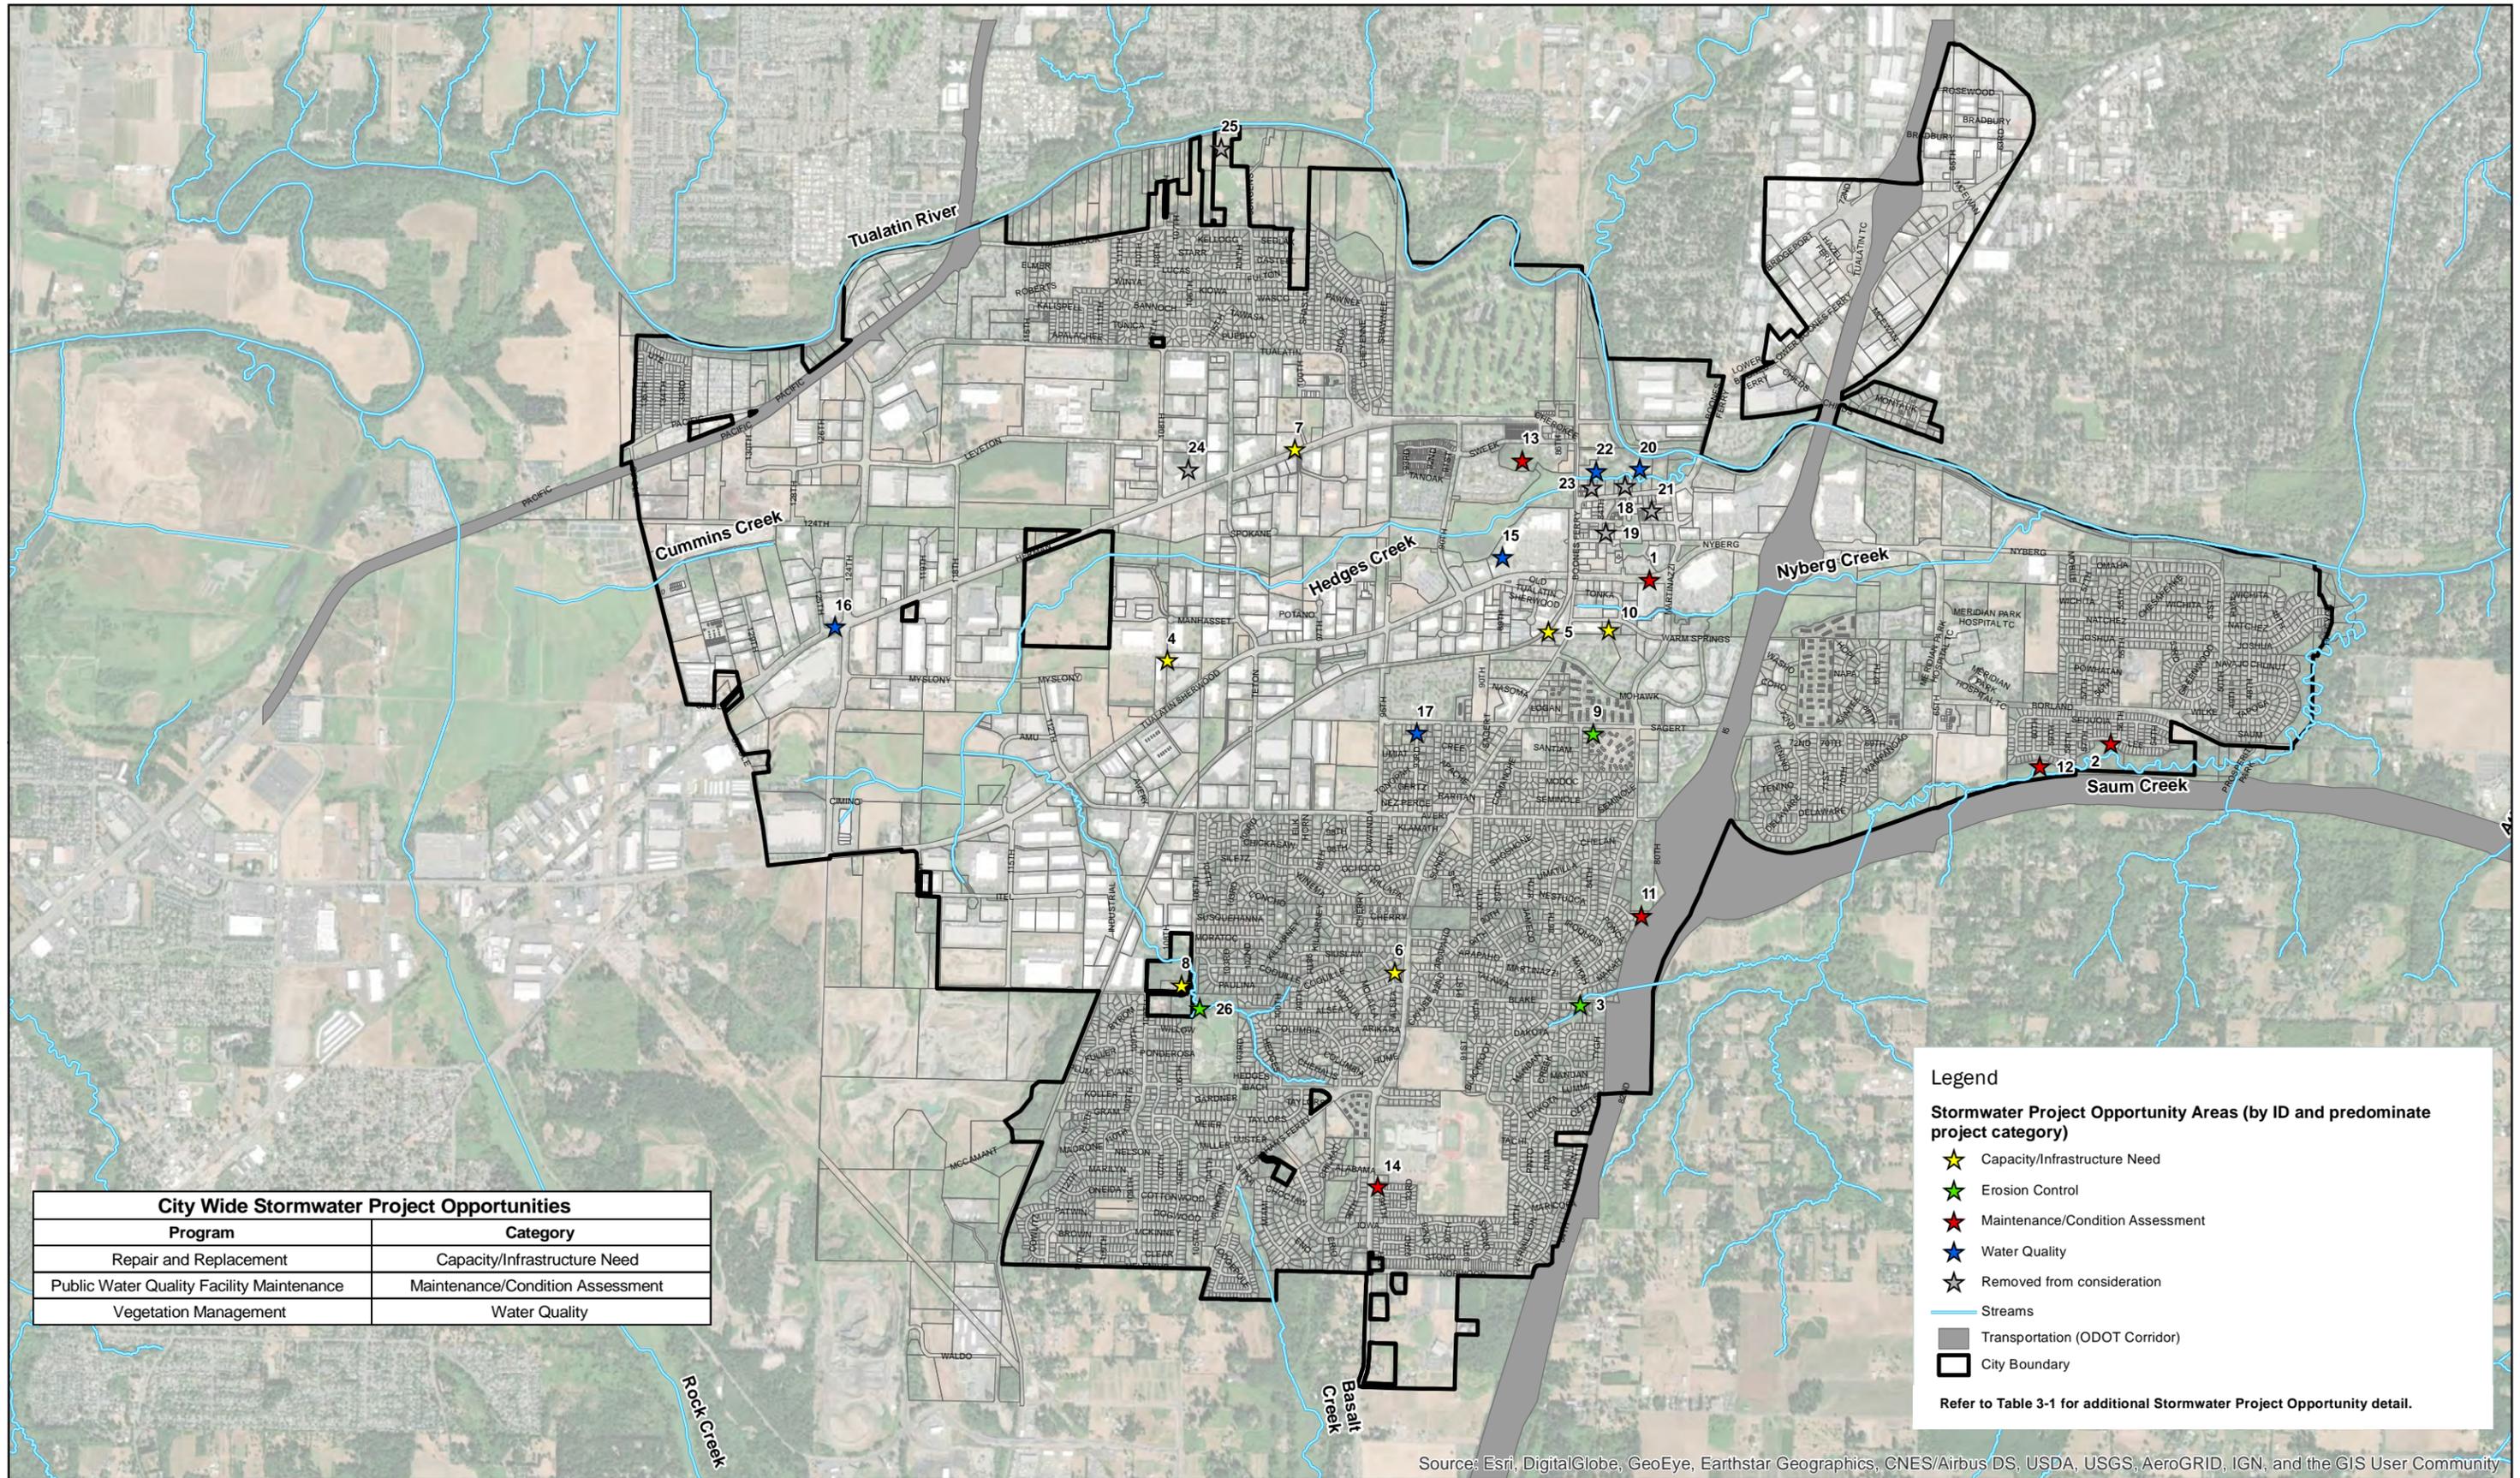
Table 3-1 documents the list of final Stormwater Project Opportunity Areas used to develop capital projects and programs for this SMP. Figure 3-1 identifies each Stormwater Project Opportunity Area by ID (a numeric identifier) and primary project category—capacity/infrastructure need, erosion control, maintenance/condition assessment, and water quality. Multiple project categories may be relevant to one project opportunity, but the predominant category was used for mapping.
