Appendix E: Capital Project Modeling Results

Appendix F: Stream Assessment TM (TM4)

Stream Channel Condition Survey

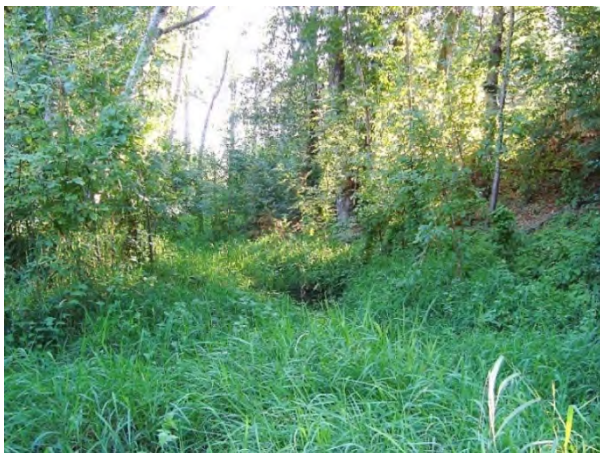
Photo 4. Saum Creek immediately upstream of SW Blake Street. Channel is obscured by reed canary grass. This area is very flat, and wet.

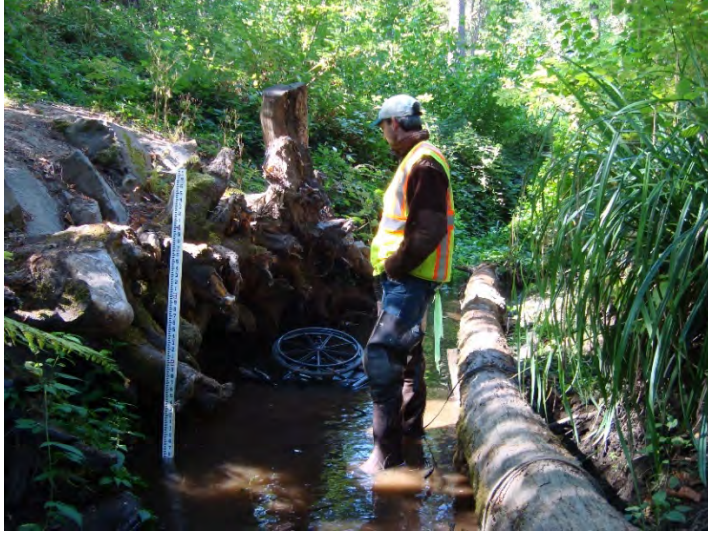
Evidence of a recent stream restoration project was observed upstream of Ibach Park (Photo 13), starting approximately 950 feet upstream of SW 105th Avenue. Large wood, bed protection matting and tiles, and root wads were placed and cabled at several different locations in the channel. It is unclear based on the locations of the restoration efforts what the goals might have been. Bank erosion and hillslope slumps were observed throughout the reach, however, property or infrastructure did not appear to be impacted or immediately threatened by the erosion. Invasive vegetation, including English ivy, and Himalayan blackberry were present throughout the reach as well.

Photo 13. Restoration area showing cabled logs and root wads. Approximately 950 feet upstream of SW 105th Avenue.

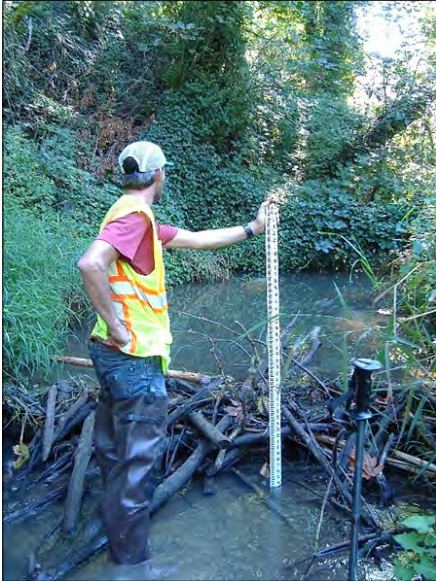
Beaver dam ~ 700 ft. downstream of Borland Rd (photo location shown below with camera icon)

Stream	Saum Creek
Reach	#1 (Tualatin River to SW Prosperity Park Rd)
General Characteristics	
Reach Length:	~6,775 ft.
Gradient:	~0.6%
Valley Width:	~100—200 ft
Planform:	Meandering
Average BFW:	~13' (range 12' to 15')
Average BFD:	~6' (range 4' to 7')
Substrate:	Predominantly silt, some small gravel
Vegetation:	Invasive vegetation (reed canary grass, blackberries, ivy), Douglas fir
Beaver Activity:	Yes. Four beaver dams observed.
Issues:	Minor erosion downstream of Borland Rd.

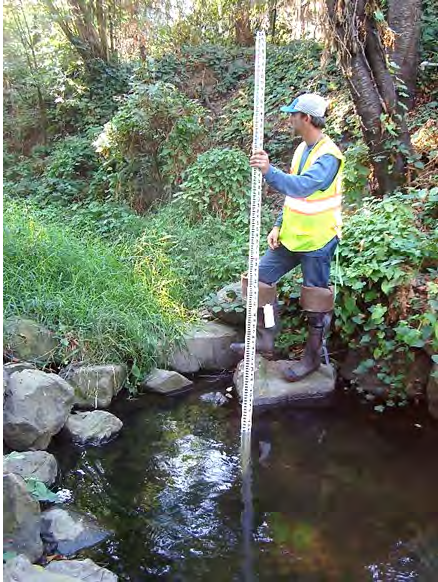
Rock check dam and pool in restored section upstream of Blake Street (photo location shown below with camera icon)

Stream	Saum Creek
Reach	#3 (Vicinity of Blake Street)
General Characteristics	
Reach Length:	~600 ft.
Gradient:	~1.1 % (ds of Blake), ~3% (us of Blake)
Valley Width:	~75' to 100' (confined)
Planform:	Straight
Average BFW:	~6'
Average BFD:	~2'
Substrate:	Fine sediment
Vegetation:	Conifer and deciduous trees (many down in channel), reed canary grass, ivy
Beaver Activity:	None observed.
Issues:	Unstable hillslope and perched culvert, invasive vegetation.

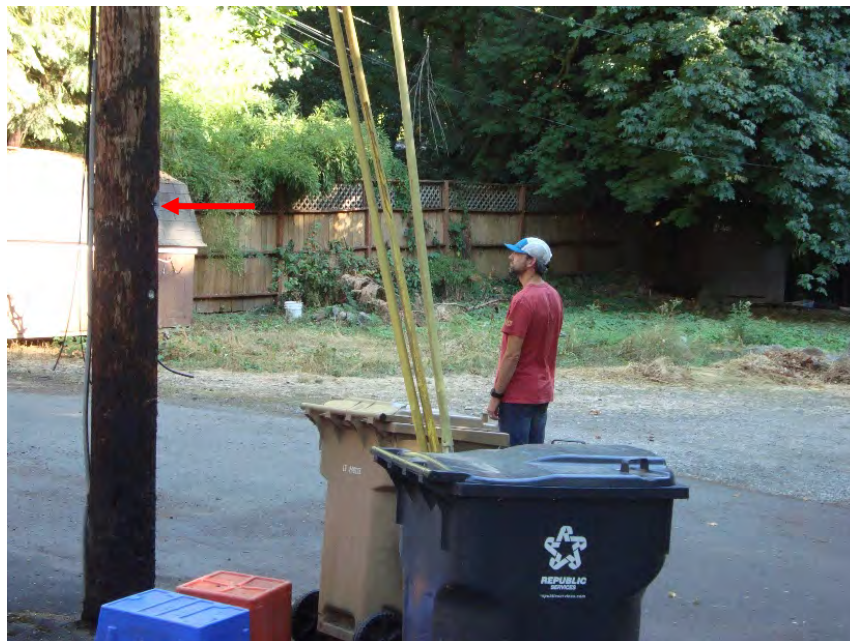
Site location: Near Tualatin
Photo number: Tual-2
Description: View of utility pole with flood marker (1996 flood). Red arrow shows marker location.

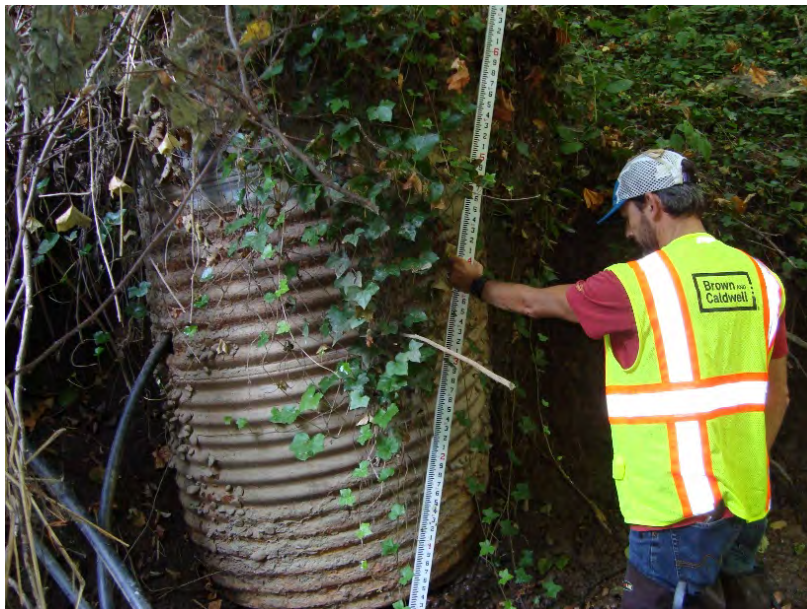
Site location: ~400' upstream from Tualatin River
Photo number: S1-4
Description: Corrugated steel pipe (former water intake?) on left bank

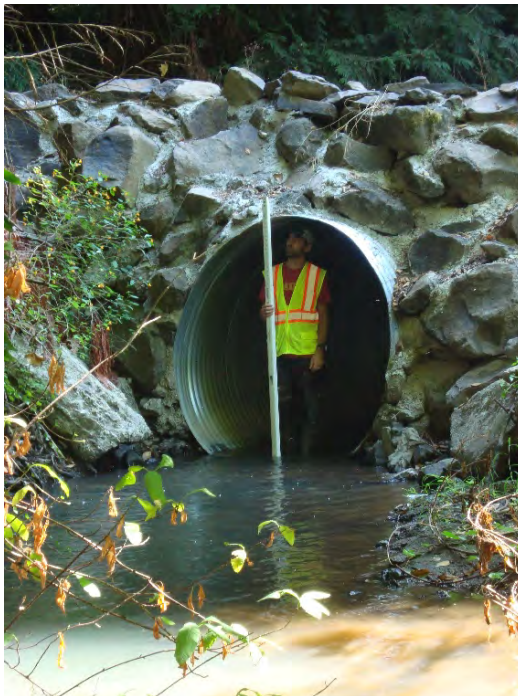
Photo number: S1-6

Description: Private driveway culvert crossing (6'), looking upstream

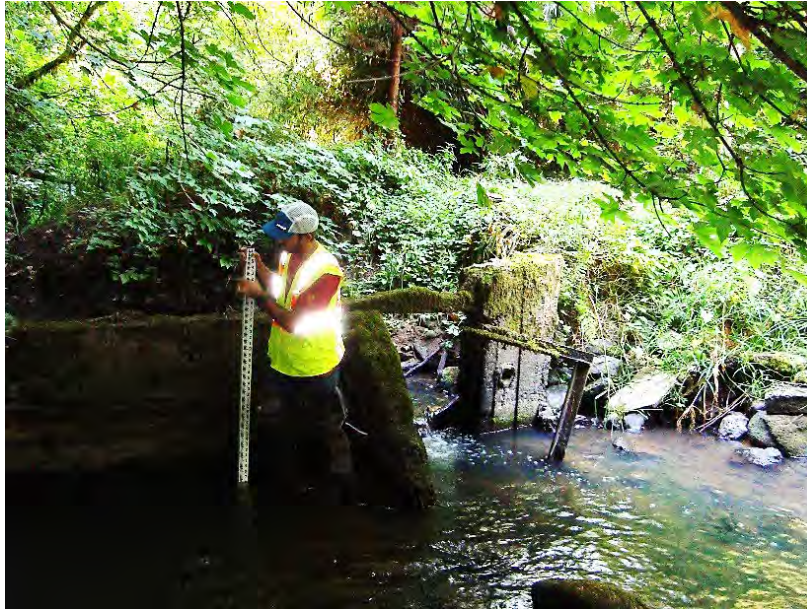
Photo number: S1-7

Description: Old 3' high concrete weir wall (2 ½' wide opening) with pool on downstream end. Weir is leaning downstream and sediment has deposited behind it on upstream side.

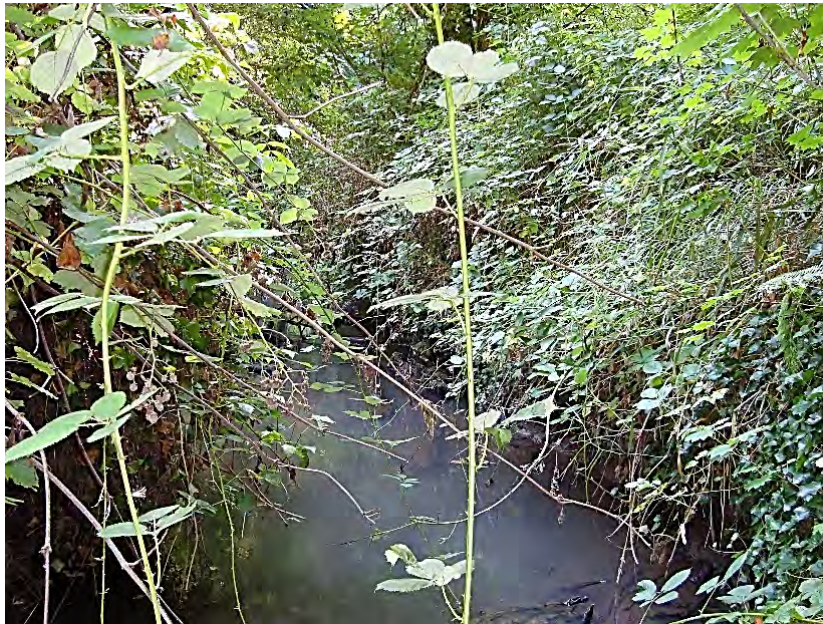
Photo number: S1-8

Description: Silty bottom, water depth 1 ½' - 2', bankfull width ~ 12', bankfull depth ~ 6'

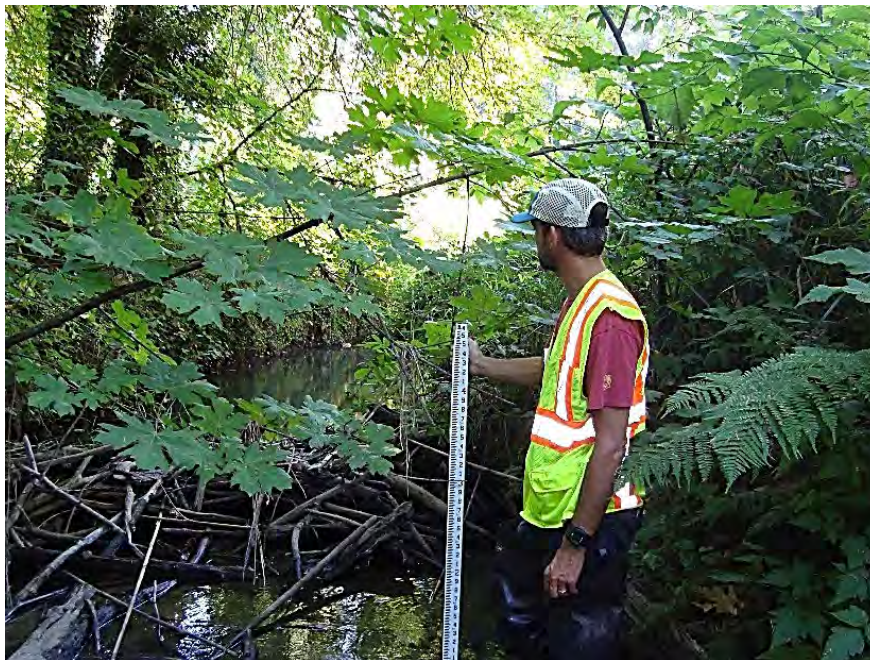
Site location: 850' upstream from SW Halcyon Rd.
Photo number: S1-14
Description: Looking upstream at beaver dam, debris on branches (high water mark near Ryan's right hand ~4.5 feet above channel bed)

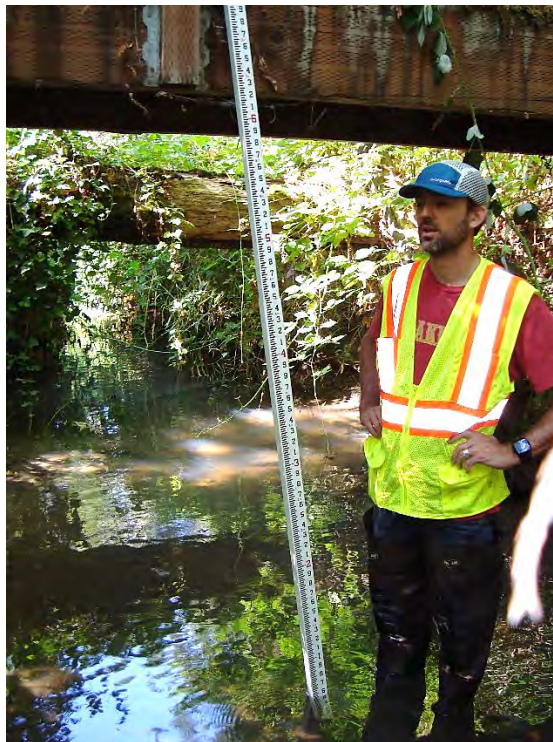
Site location: ~1,200' downstream from SW Borland Rd.
Photo number: S1-16
Description: Pedestrian bridge looking downstream, large tree down across channel in distance

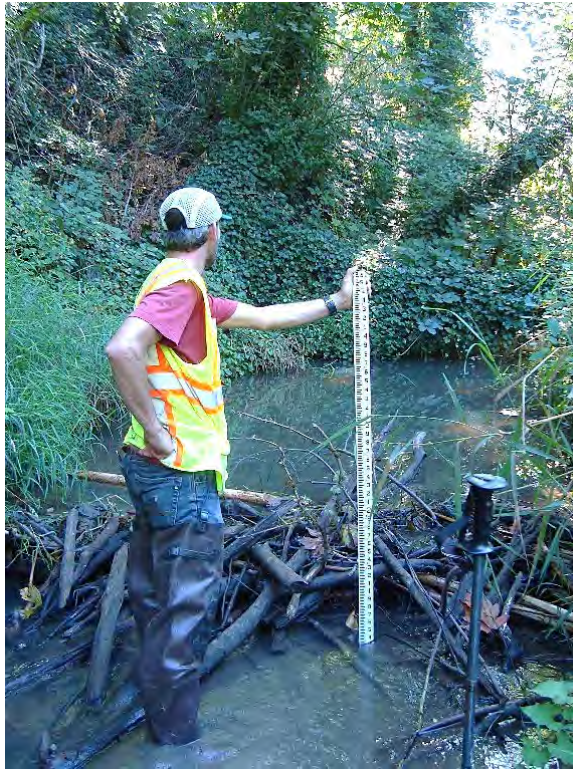
Site location: ~ 700' downstream of SW Borland Rd.
Photo number: S1-17
Description: Beaver dam, ivy-covered trees in distance, looking upstream

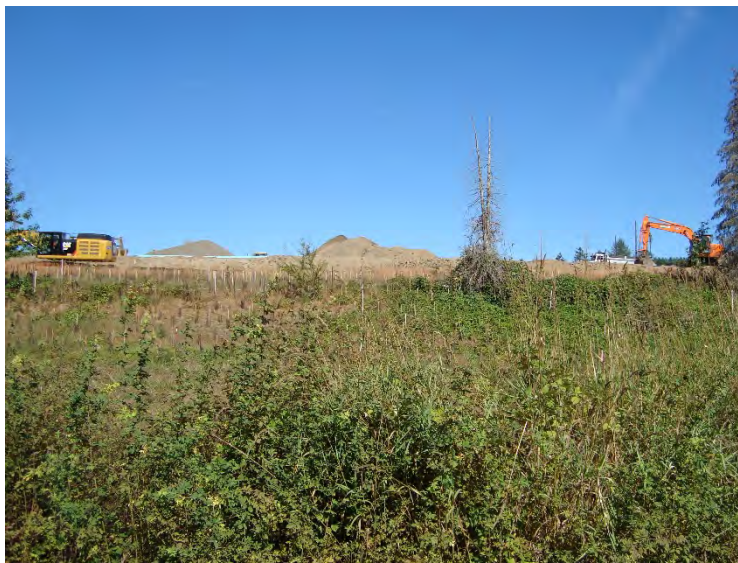
Site location: 1000' east of SW 65th Ave.
Photo number: S2-16
Description: Looking north at construction site across channel

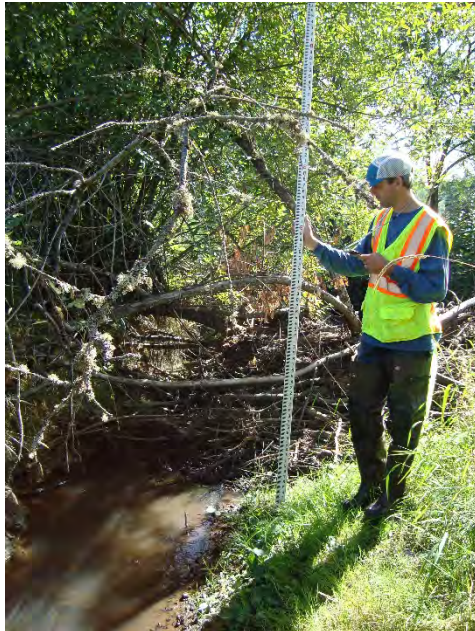
Site location: 100' east of SW 65th Ave.
Photo number: S2-18
Description: Debris jam looking downstream

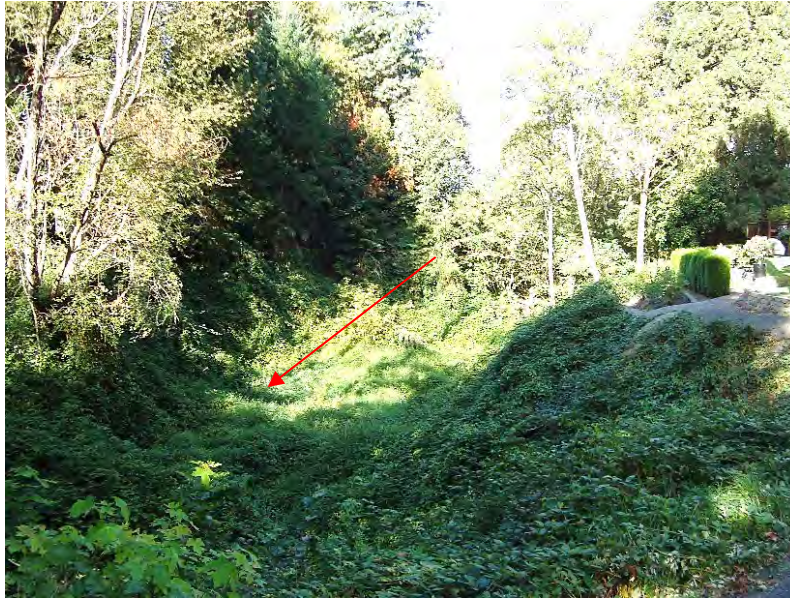
Site location: Downstream of SW Blake St.

Description: Looking down at valley bottom from above. Red arrow indicates location of channel.

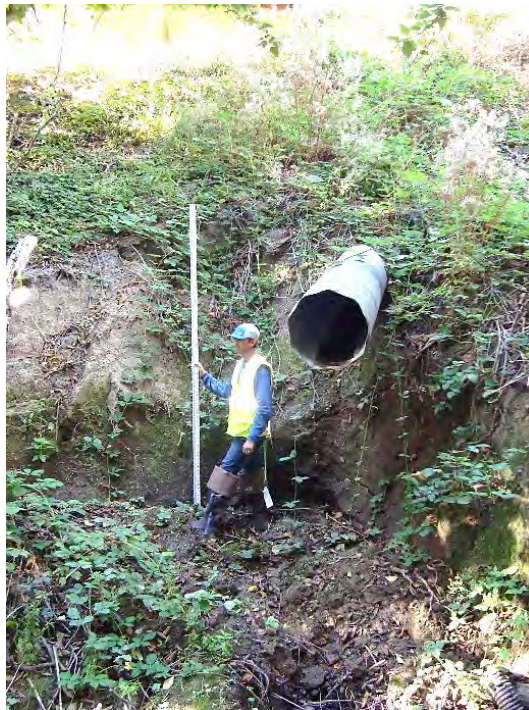
Site location: Downstream of SW Blake St.

Results of the stream assessment identified one location where a capital project may be developed to address City infrastructure potentially susceptible to failure. A perched stormwater pipe above the stream channel in Saum Creek Reach #3 was identified during the stream assessment. Stormwater discharge from this pipe will cause further erosion of the slope around it if left in its current position. A capital project is recommended to replace the pipe and repair the hillslope failure in the vicinity in conjunction with the pipe replacement. The new pipe should be placed on the hillside (i.e., thick-walled flexible pipe or similar) to the bottom of the slope, with energy dissipation provided. A geotechnical evaluation is recommended in order to determine the cause of the slope failure in the vicinity of the perched pipe, and provide input to the slope repair design.

Description: Hillslope failure and perched culvert

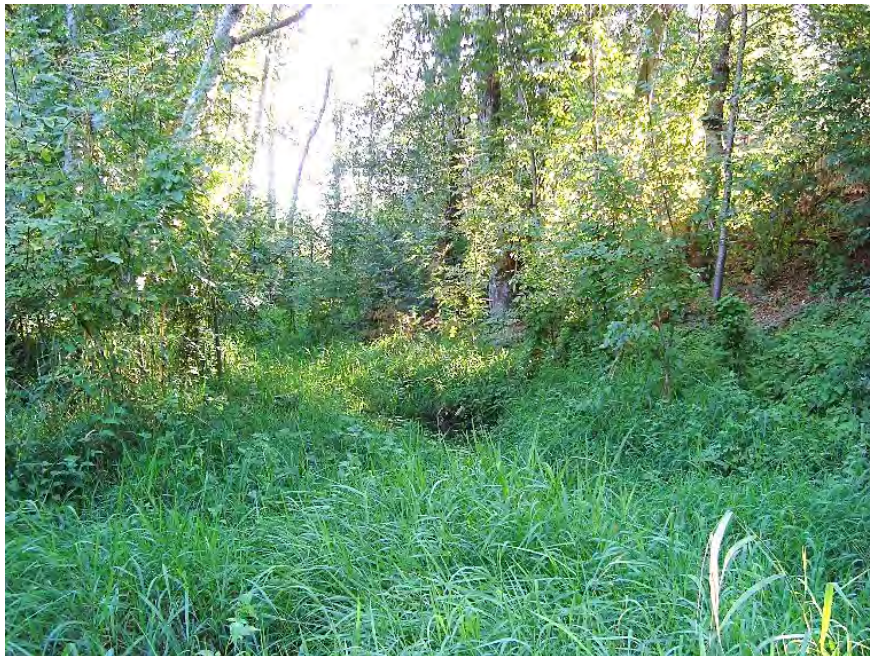
Site location: ~80' upstream of SW Blake St.
Photo number: S3-5
Description: Looking upstream, mucky conditions

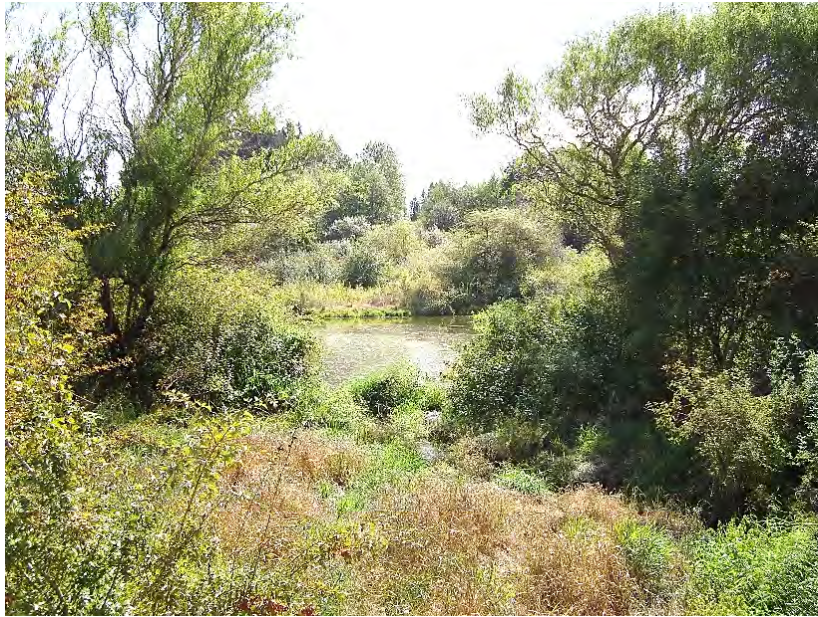
Site location: South side of SW Nyberg Lane
Photo number: N1-1
Description: Poned area adjacent to Nyberg Creek upstream of SW Nyberg Lane

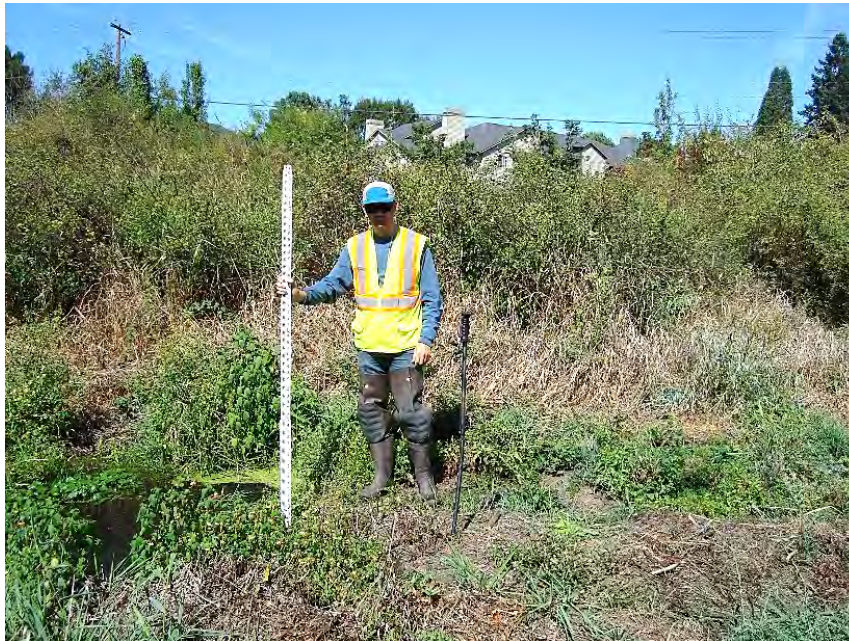
Site location: 200' upstream from SW Nyberg Lane
Photo number: N1-4
Description: Old roadbed. Stream is in 30" CMP culvert under road.

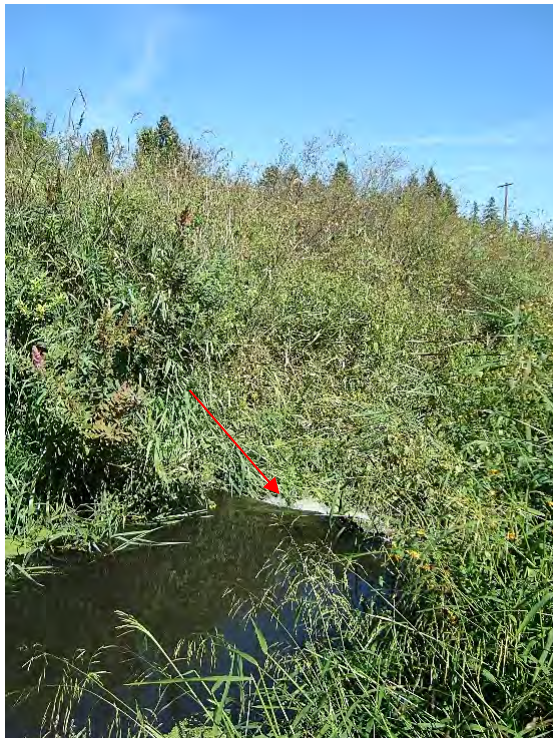
Site location: 400' upstream of SW Nyberg Lane
Photo number: N1-6
Description: Looking downstream at top of beaver dam. Red arrow points to top of dam. Drop is approximately 3 feet.

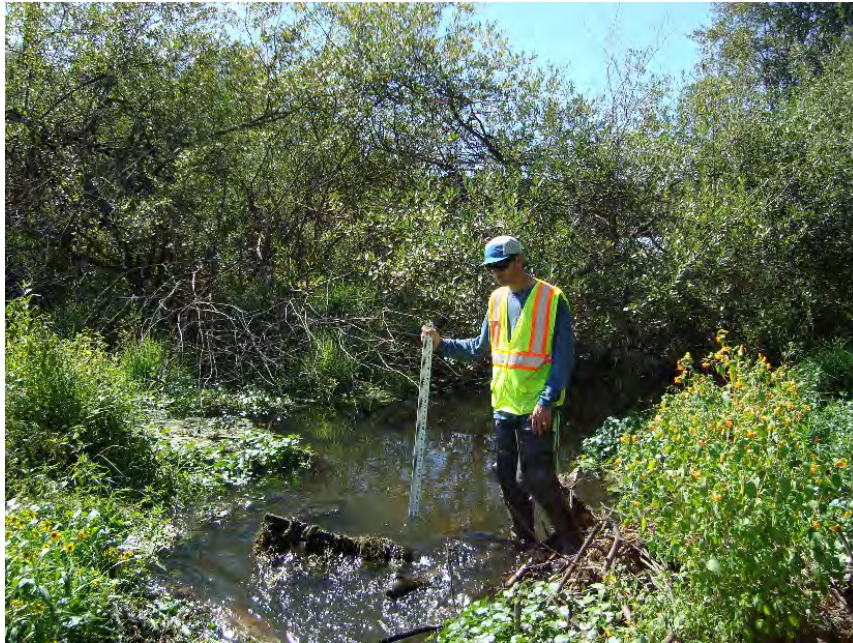
Site location: 100' downstream of SW 65th Ave.

Description: Upstream end of ponded area

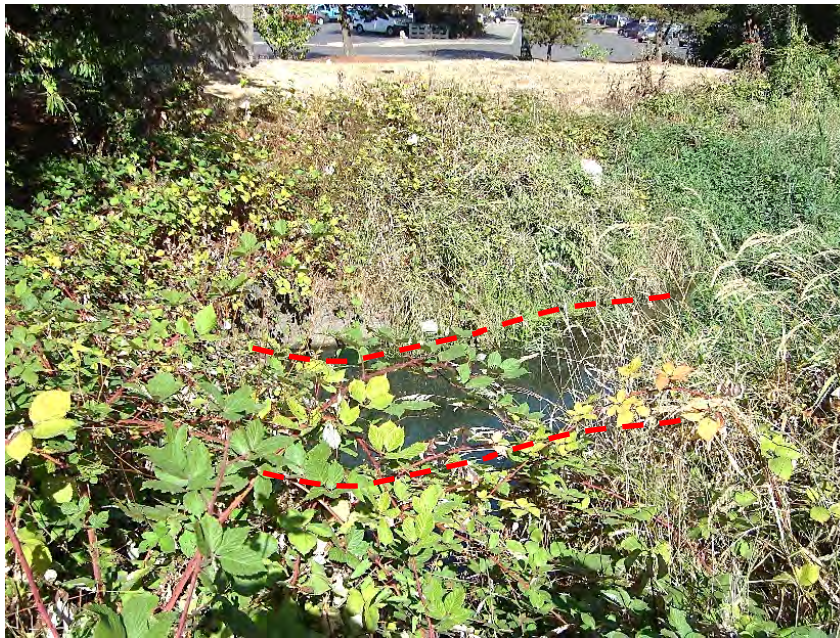
Site location: South of business park
Photo number: N2-4
Description: Constructed channel opening on north side of beaver dam (shown by red dashed lines)

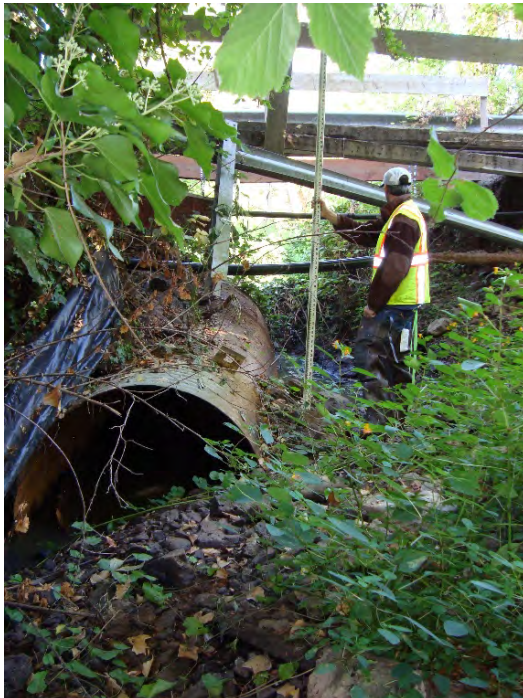
Photo number: H1-12

Description: Looking upstream at culvert under washed out bridge amongst debris that has not been removed

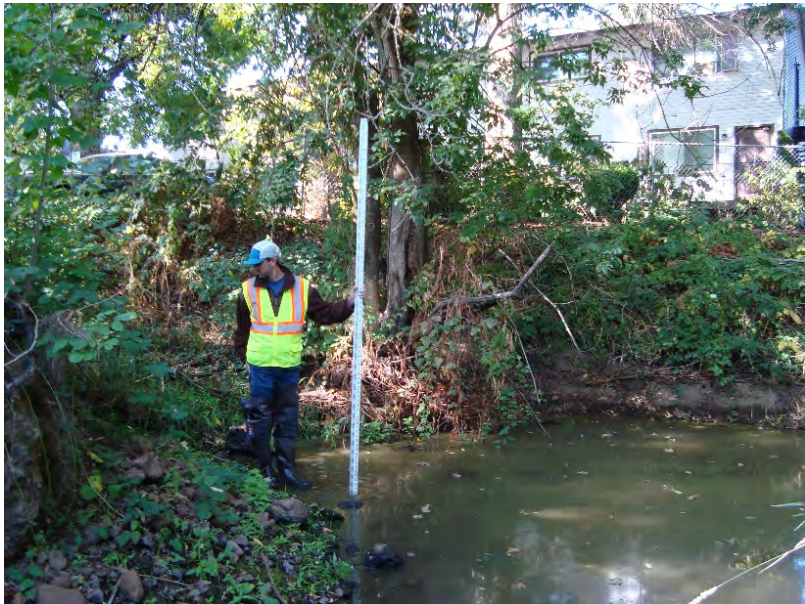
Photo number: H1-16

Description: Old culvert (where Ryan is standing), photo is looking upstream at outside bend where stream takes a sharp turn to the north

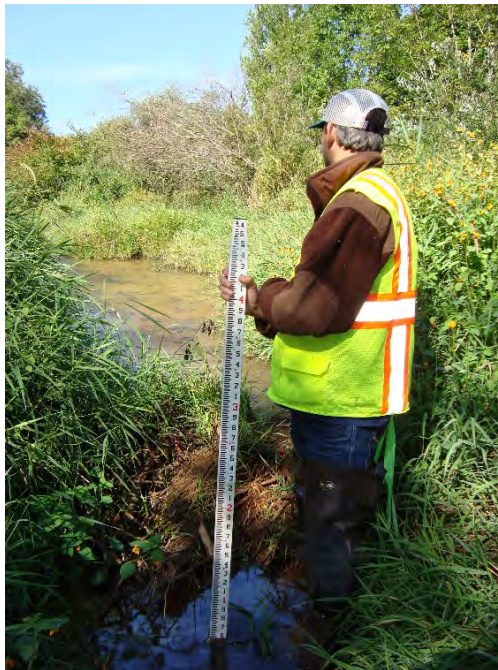
Site location: 1450' upstream of Tualatin River
Photo number: H1-20
Description: Beaver dam looking upstream, wider floodplain west of this location (open space).

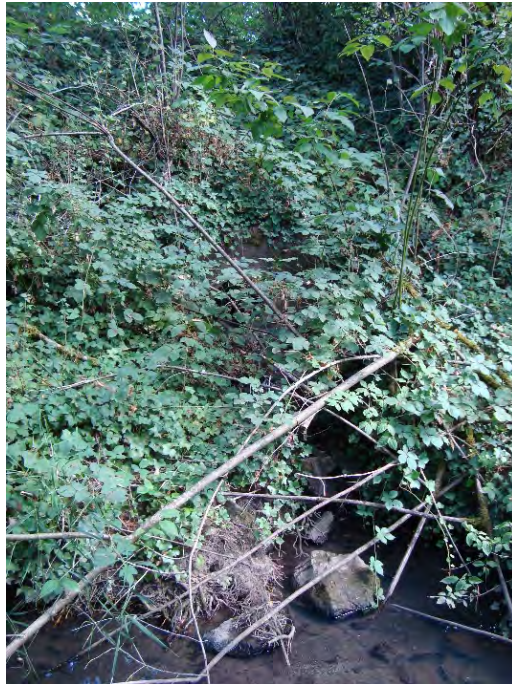
Photo number: H2-3

Description: Right bank outfall

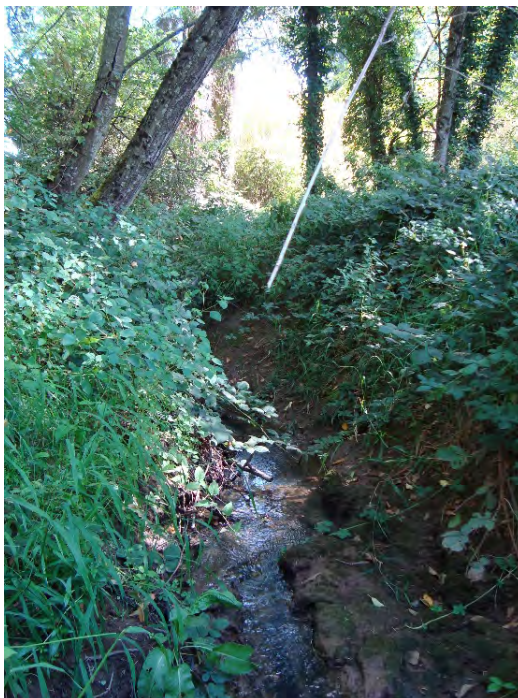
Photo number: H2-4

Description: Looking upstream, wide floodplain, banks 4- 5' high, width ~ 8 - 10 ', hard silt bed

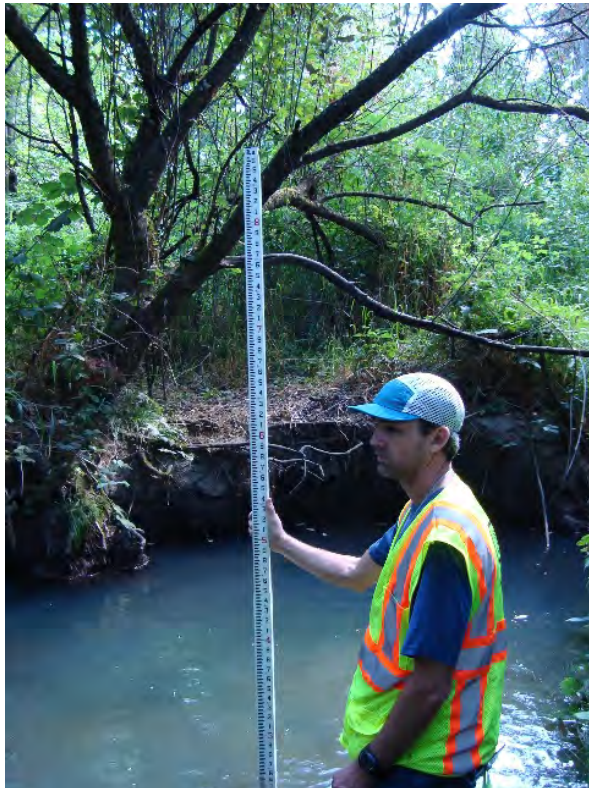
Site location: 600' upstream of SW Tualatin-Sherwood Road
Photo number: H2-6
Description: Erosion on outside bend (right bank)

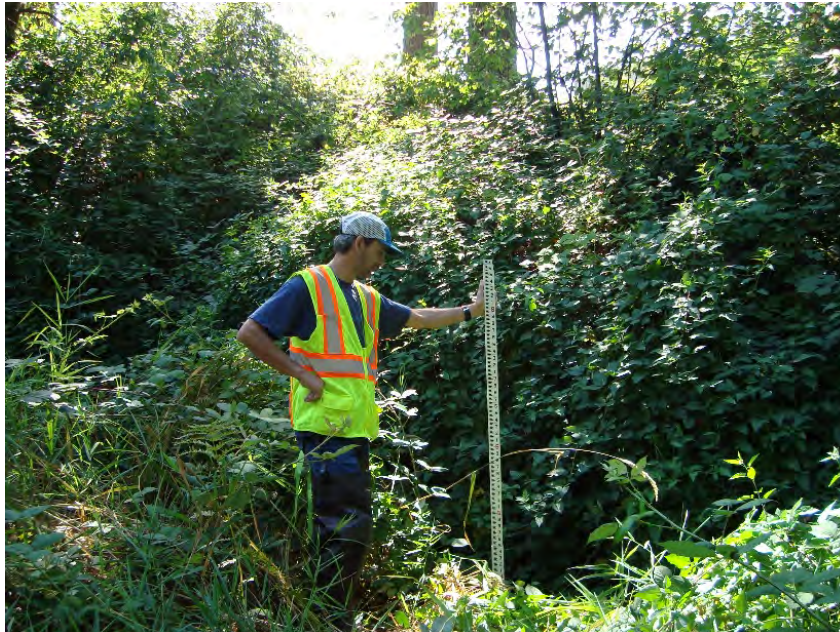
Site location: 650' upstream of SW Tualatin-Sherwood Road
Photo number: H2-7
Description: Channel location from top of bank (4' depth). Enveloped with blackberries and reed canary grass.

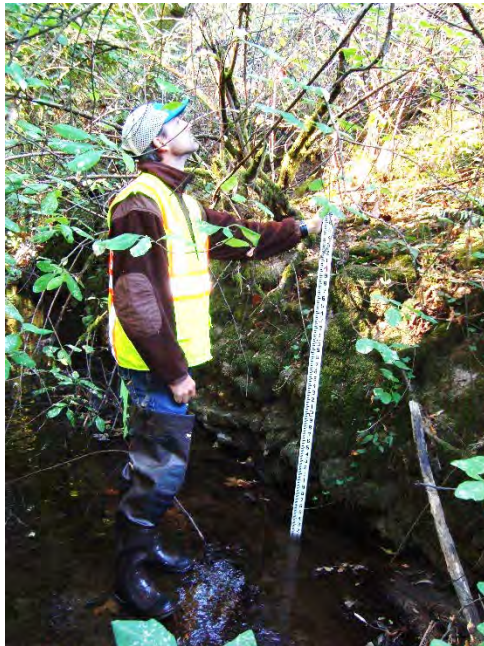
Photo number: H3-4

Description: Rock wall on left bank adjacent to roadway fill

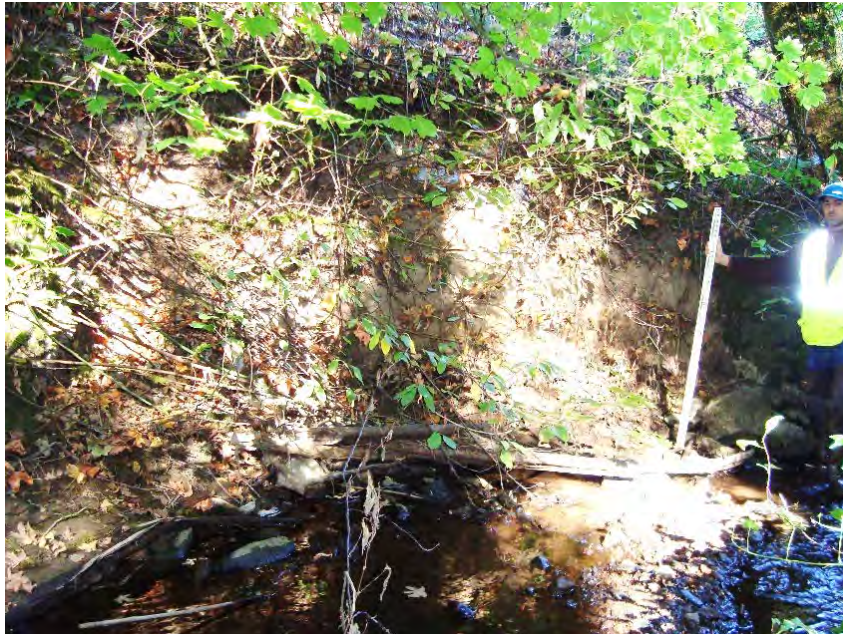
Photo number: H3-5

Description: Left bank failure, missing wall segment adjacent to SW 105th Ave., outside bend

CIP #20 Hedges Creek Stream Repair	Bank slope stabilization, infrastructure protection, and vegetation management	<ul style="list-style-type: none"> Project information and costs are included in the "Hedges Creek Stream Assessment, SW Ibach St. to SW 105th Ave.", February 2018, GreenWorks PC and OTAK, INC. Ongoing vegetation management reflected in programmatic project. Project cost (total): \$327,000. 	Y	Staff/consultant	<ul style="list-style-type: none"> Increased maintenance obligation or frequency due to be accounted for in programmatic project 	N/A	No related staffing cost estimate
CIP #21 Nyberg Water Quality Facility	Install regional WQ treatment facility at newly acquired City property	<ul style="list-style-type: none"> Engineering and permitting costs estimated at 35% of the construction cost. Assume consultant to complete. Construction administration (City staff) estimated at 10% of the construction cost. Project cost includes additional estimate for fees and mitigation. Project cost (total): \$2,037,000. 	Y	Staff/consultant	<ul style="list-style-type: none"> WQ facility maintenance Project to be performed by hired contractor Increased maintenance obligation or frequency to be accounted for in programmatic project 	N/A	Construction administration (total): \$123,000 (or 0.82 FTE)
