RE: Tree inventory and removal plan for Lu Pacific Development.

Lu Pacific Development ATTN: Teresa Long Proposed building construction at: 10005 SW Herman Rd Tualatin, OR 97062

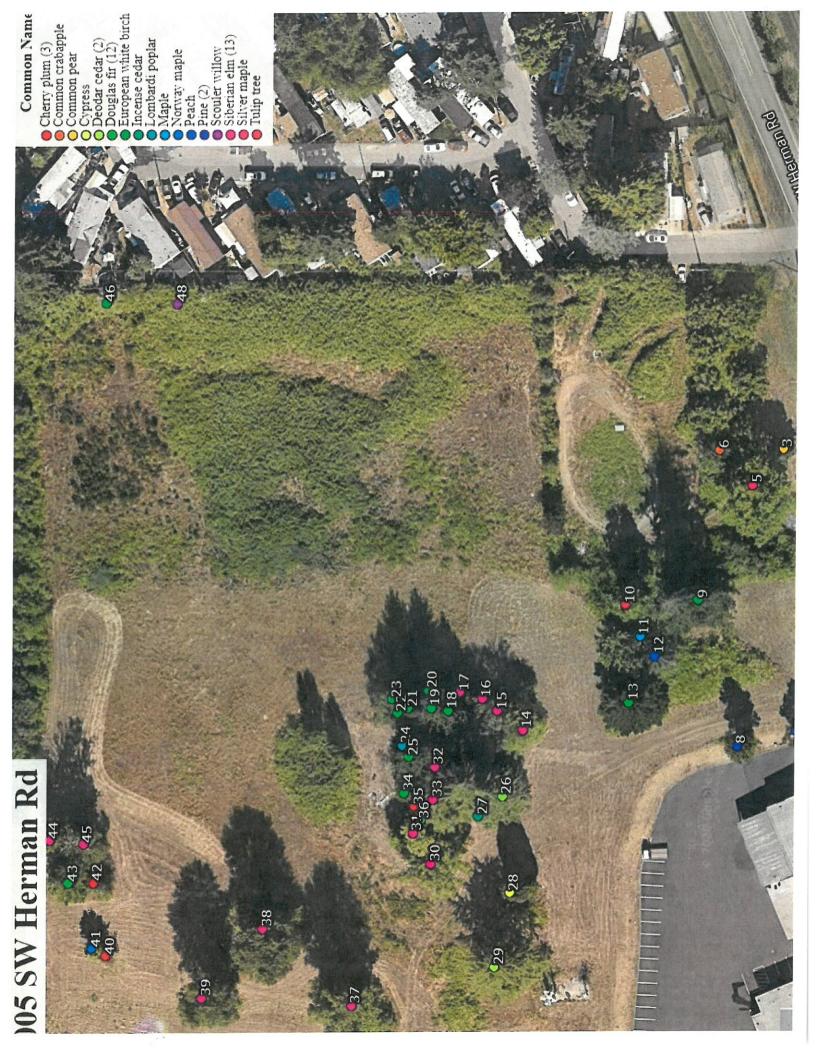
Attachment 2: Inventory Spreadsheet N/A: Tree Protection recommendations

.0.	2	5									•			1/1
N LOUILOS	LONDINGS	Judipuos	Hed Inds	Table Table	USIS HER	Tues Had	CUBIS HAD	LUBIS HAD	S HORS HERD	S (40)	Suten Cher	Online.	*DNIGUO;	Logensed
3 Common pear	Good	Good	П	17	1 1					15ft-30ft	Pyrus communis	45.3864142	45.3864142 -122.7791672	4
5 Silver maple	Very Poor	Very Poor	20-75%	34.71	16	25	18			50ft-75ft	c	45.38647543	45.38647543 -122.7792704 Remove	Remove
	Dead/Dying	Failed/Failing	20-75%	24						15ft-30ft		45.38654324	45.38654324 -122.7791699	
	Fair	Fair	<25%	18						N/A		45.38638574	45.38638574 -122.7799754 Pine beetle	Pine beetle
	Fair	Fair	25-50%	24						50ft-75ft	Pinus spp.	45.38650442	45.38650442 -122.7800197 Pine beetle	Pine beetle
9 Douglas fir	Poor	Fair	<25%	20						N/A	=	45.38658448	-122.7795999	45.38658448 -122.7795999 May have fir borer
10 Tulip tree	Good	Fair	<52%	18						N/A	Liriodendron tulipifera	45.38672966	-122.779613 Hangers	Hangers
	Poor	Poor	20-75%	16.25	10	80	10			N/A	Acer spp.	45.38670046	45.38670046 -122.7797042 Removal	Removal

Dead/Dying	Failed/Failing	>15%	26.98	18	8	12	14		15ft-30ft	Prunus persica	45.38667126	45.38667126 -122.7797592	
13 Douglas fir	Excellent	Excellent	<25%	28						30ft-50ft	nenziesii		45.38672139 -122.7798925	
14 Siberian elm	Fair	Poor	25-50%	34.23	20	14	24			30ft-50ft	Ulmus pumila		45.3869352 -122.7799703	
15 Siberian elm	Dead/Dying	Failed/Failing	>75%	24	20	14	24			50ft-75ft	Ulmus pumila	45.38698527	45.38698527 -122.7799153	
16 Siberian elm	Dead/Dying	Failed/Failing	>75%	24	20	14	24			50ft-75ft	Ulmus pumila	45.38701635	45.38701635 -122 7798804	
17 Siberian elm	Poor	Poor	25-50%	10						15ft-30ft	Ulmus pumila	45.38706062	45.38706062 -122.7798616	
18 Douglas fir	Good	Good	<25%	20						50ft-75ft	Pseudotsuga menziesii 45 38708416 -122 7799139	45 38708416	122.7799139	Poison del
19 Douglas fir	Good	Good	<25%	12						30ft-50ft	Pseudotsuga menziesii 45 38711807	45 38711807	-122 7799059	- CISCO - CISC
20 Douglas fir	Good	Good	<25%	14						30ft-50ft	Pseudotsuga menziesii 45 38712372	45 38712372

21 Douglas fir	Good	Good	<25%	18						30ft-50ft	Pseudotsina menziasii 45 38716422	45 38716422	-122 7799072	
22 Douglas fir	Good	Good	<25%	10						30ft-50ft	Pseudotsuga menziesii 45 38718588	45 38718588	4-122 7799206	
23 Douglas fir	Good	Good	<25%	80						30ft-50ft	Pseudotsuga menziesii 45.38719625	45.38719625	5 -122 7798804	
24 Lombardi poplar	Dead/Dying	Failed/Failing	>75%	48						30ft-50ft	Populus nigra	45.38717647	7 -122 7800132	Hazard
25 Douglas fir	Good	Poor	25-50%	28	8	12	24			30ft-50ft	Pseudotsuga menziesii		3 -122.7800469	
26 Deodar cedar	Good	Good	<25%	47.71	24	38	16			75ft-100ft	Cedrus deodara		45.38697549 -122.7801615	
27 Incense cedar	Good	Good		25.53	10	10	14	16		30ft-50ft	Calocedrus decurrens	45.38702353	3 -122,7802192	
28 Cypress	Good	Good	<25%	49.04	24	20	24	23	18	N/A	Cupressuss spp	45.38696036	45.38696036 -122.7804389	
29 Deodar cedar	Good	Good	<25%	30						50ft-75ft	Cedrus deodara	45.38698956	5 -122.7806522

40 Cherry plum	Very Poor	Very Poor	20-75%	12						15ft-30ft	Prunus cerasifera	45.38776956	45.38776956 -122.7806156	
41 Norway maple	Fair	Fair		10						15ft-30ft	Acer platanoides	45.38779782	2 -122 7805941	
42 Cherry plum	Dead/Dying	Failed/Failing		10						15ft-30ft	Prunus cerasifera	45.38779422		
43 Douglas fir	Good	Good	<25%	28						50ft-75ft	Pseudotsuga menziesii			
44 Siberian elm	Good	Good	<25%	22						50ft-75ft	Ulmus pumila	45,38788353		
45 Siberian elm	Very Poor	Very Poor	20-75%	27.78	16	10	4	12	16	75ft-100ft	Ulmus pumila	45.38781571		
European white birch Dead/Dying	Dond/Duing	The Man Africa Miles of	. 750											
	Deaning	raileo/railing	>12%	14.14	10	10				<15ft	Betula pendula	45.3877734

48 trees are recommended for removal for the proposed construction of the two buildings by Lu Pacific Development. The trees that are not directly impacted by this plan are number 7 and number 8. The Pines are in poor condition however and do not have a long life expectancy due to the Blue stain fungi caused by the Pine Borer Beetle. The recommendation for all trees is removal.
