MEMORANDUM

DATE:	November 16, 2022
то:	Chris Bradley (Tandem Property Management, Inc.)
FROM:	Todd Prager, RCA #597, ISA Board Certified Master Arborist
RE:	Tree Removal and Protection Plan Amendment for the Commons on the Tualatin Project

This report is an amendment to my tree removal and protection plan dated September 27, 2018 for the Commons on the Tualatin Project at 6645 SW Nyberg Lane in Tualatin.

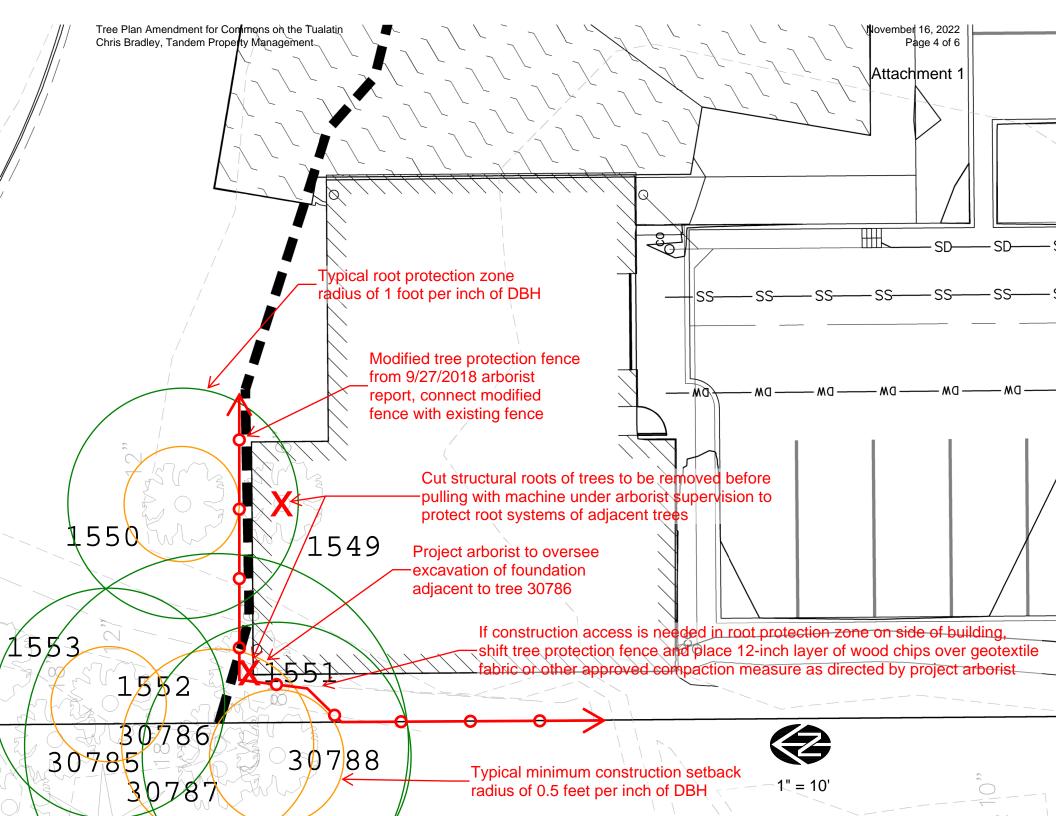
Enclosures: Attachment 1 – Site Plan with Tree Removal and Protection Attachment 2 – Tree Inventory Attachment 3 – Assumptions and Limiting Conditions

A storage shed (Building G) is proposed to be constructed at the north end of the site where there is a group of existing trees. A site plan with the proposed storage shed in relation to the existing trees is provided in Attachment 1. An inventory of the existing trees near the proposed shed is provided in Attachment 2.

Two trees, trees 1549 and 1551, are within the proposed storage shed footprint and are identified for removal as shown in Attachment 1. The remaining trees in the vicinity of the proposed storage shed will be retained and protected according to the recommendations in the next section of this report.
