## Appendix A: CIP Fact Sheets

Project Identifier	CIP #1
Project Name	Manhasset Storm System Improvements
Detailed Location	Manhasset Drive
Model File	HE_MA_ALT05.xp
Contributing Drainage Area	41.4 acres
Estimated Existing /Future Impervious %	64.0%/73.4%
Project Objective(s)	Increases System Capacity (Flood Control)

City of Tualatin  
Stormwater Master Plan  
Date: December 2017  
Project: Project 149233

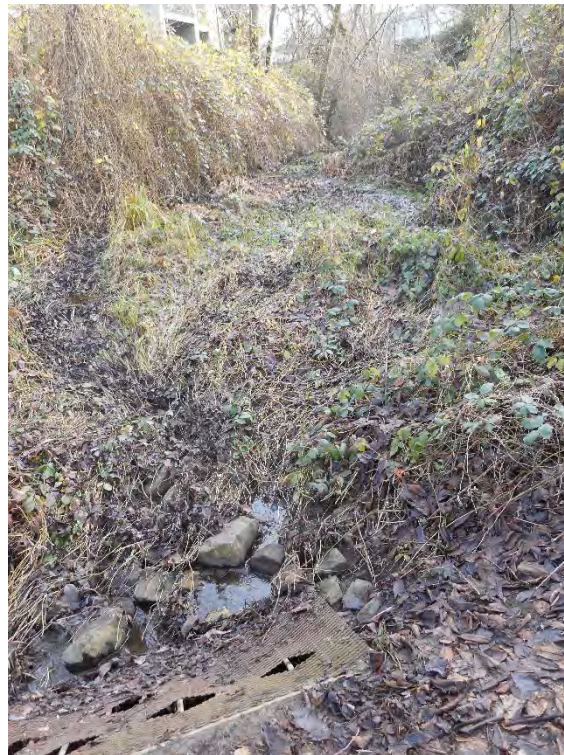
**Image 1. Grated inlet and open channel near Mohawk Apartments**

Downstream of the open channel, a new ditch inlet will be installed to replace the existing grated inlet. Limited earthwork and invasive vegetation removal will be conducted to regrade the channel and direct flow to the inlet. 170 LF of corrugated metal pipe will be removed and replaced with 170 LF of 36-inch-diameter HDPE pipe.

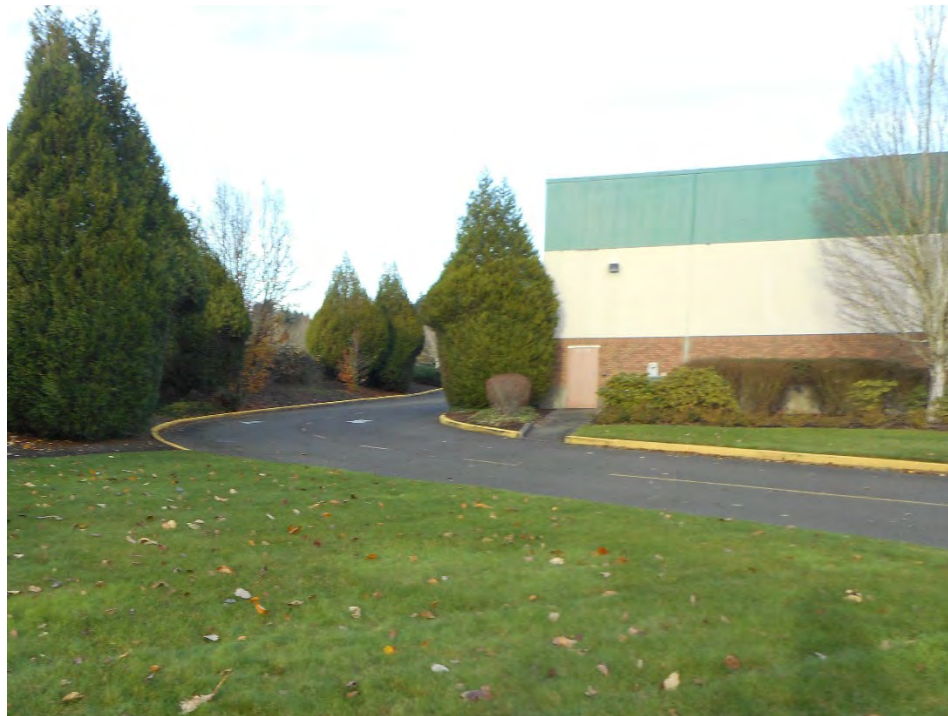
**Image 1. Location of proposed water quality manhole**

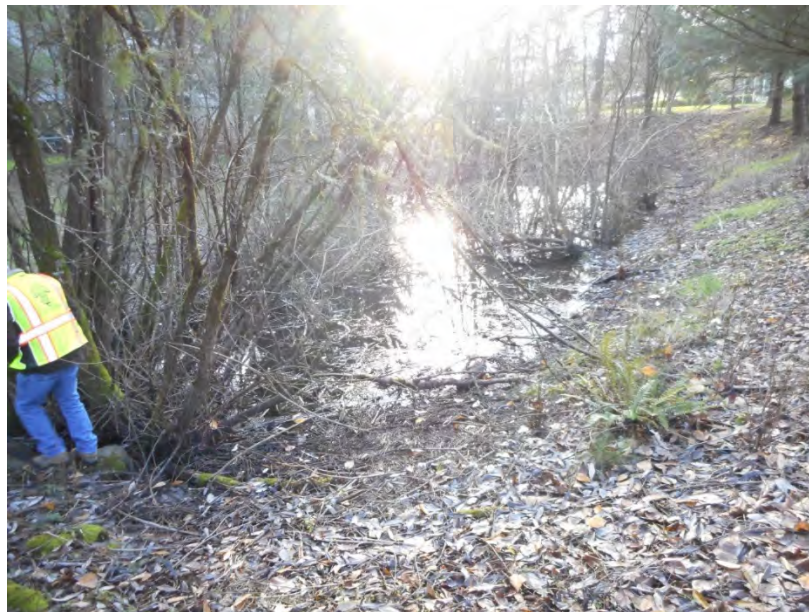
**Image 1. Vegetation and cottonwood trees growing in the water quality facility**

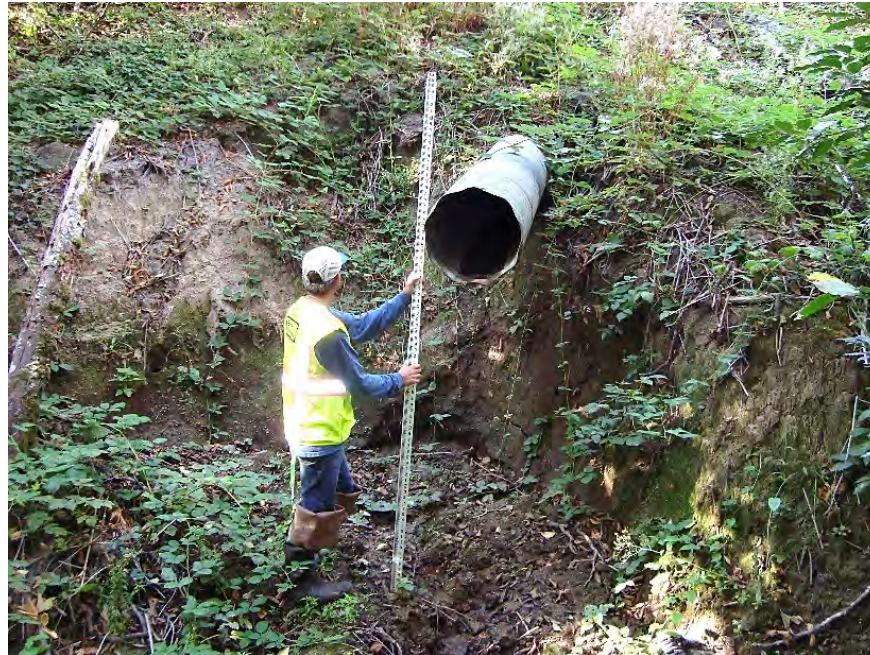
**Image 1. Perched outfall from Blake Street with severe bank failure**

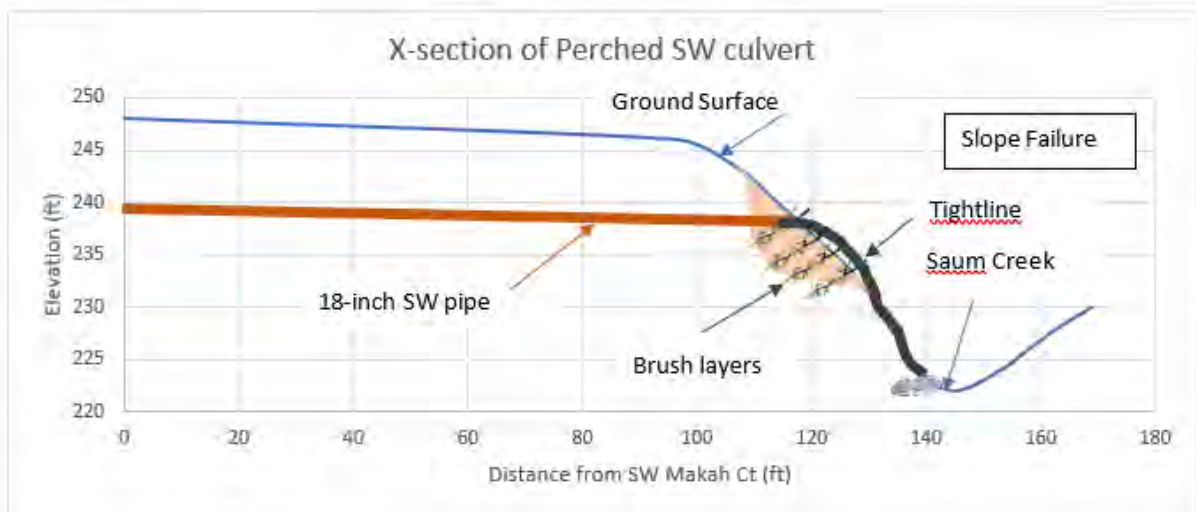
Figure 2. Hillslope Rehabilitation Option - Bioengineering with Brush Layering

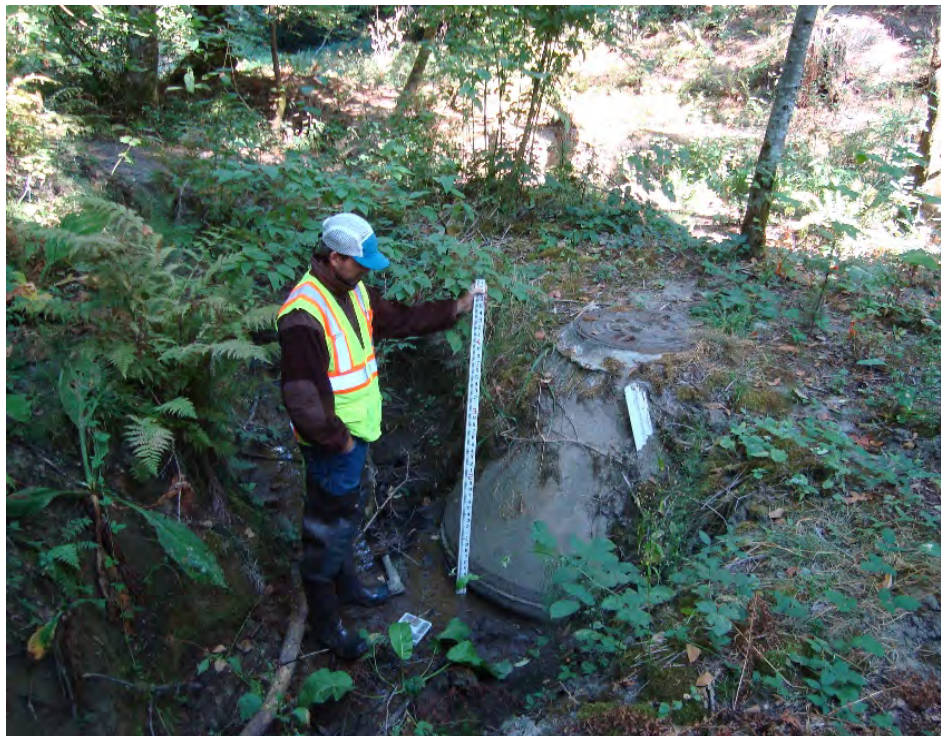
**Image 1. Location ‘M’ exposed sanitary manhole and incised tributary**

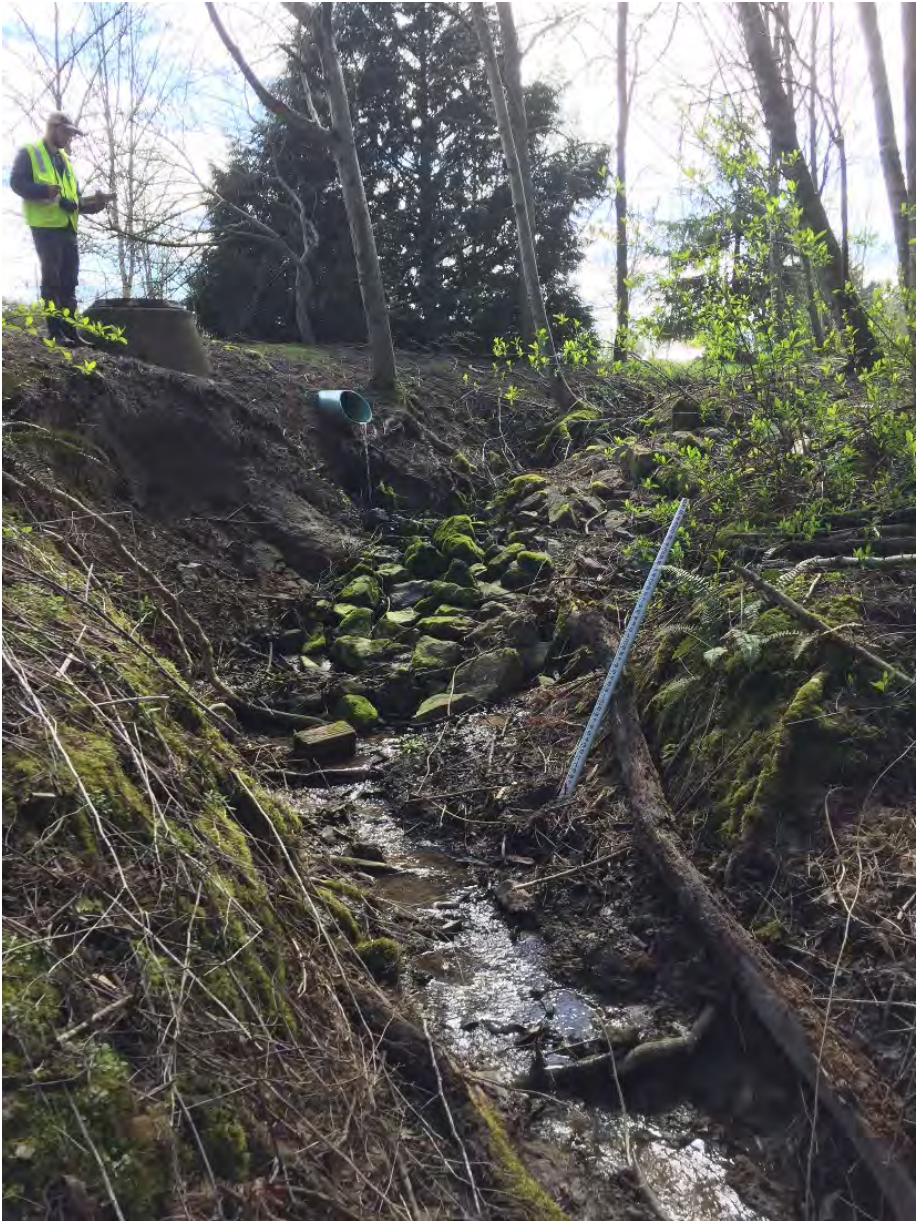
Image 2. Location 'N' outfall and channel erosion (photo provided by OTAK)
