CASE/FILE: AR17-0011 (Community Development Dept.: Planning Division)

PROPOSAL	Building improvements include: a 16,600-square-foot addition along the southern perimeter of the main high school extending from the south Main Entry east to the existing corridor near the Auditorium; a 2,000-square-foot addition to the Commons' north end; a 3,700-square-foot addition at the northeast corner of the main building; and a 3,200-square-foot expansion to the Career Technical Education (CTE) Wing. Improvements are also proposed for the athletic fields on the east side of the campus.
-----------------	--

TUALATIN HIGH SCHOOL RENOVATIONS AND ADDITIONS

22300 SW BOONES FERRY ROAD
TUALATIN, OREGON, WASHINGTON COUNTY

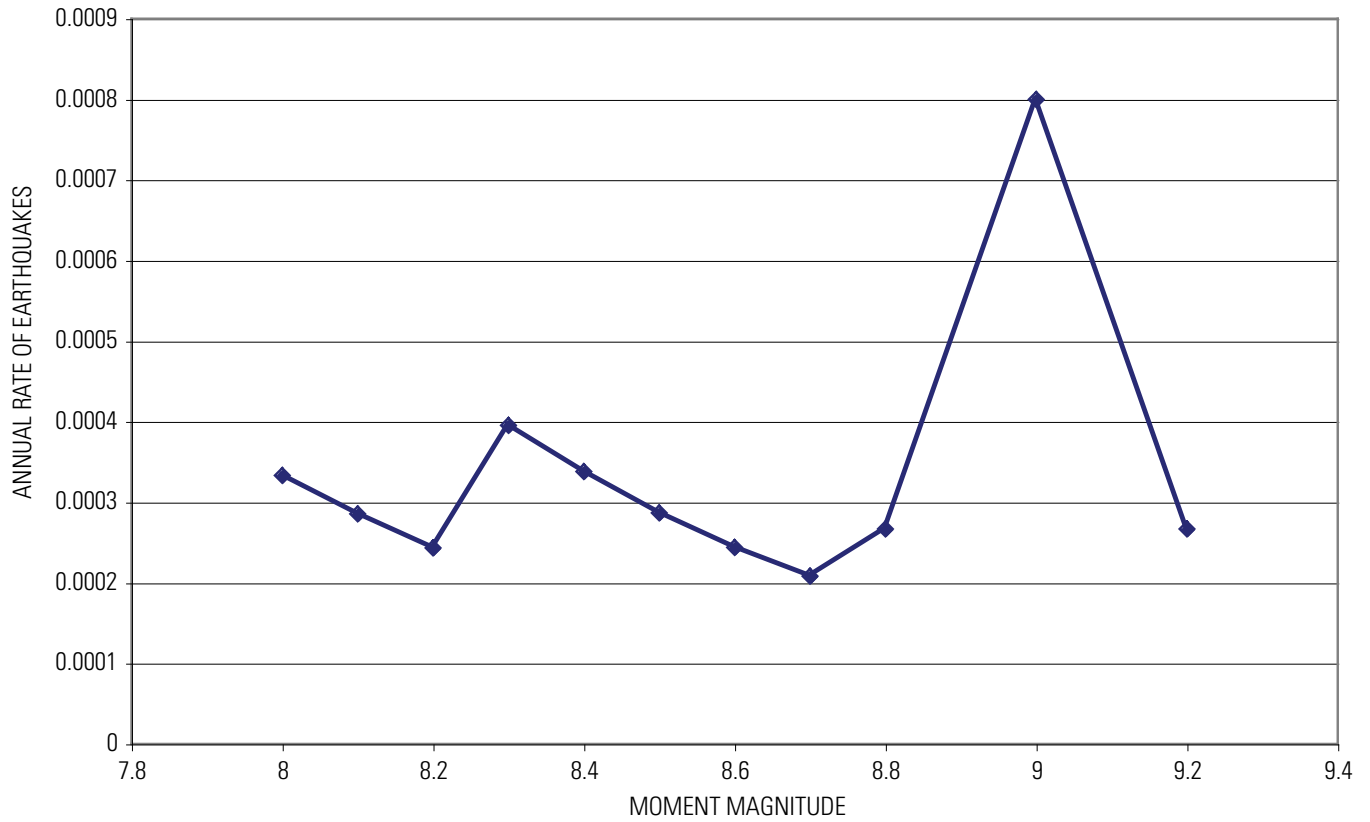
Figure 22. Magnitude-frequency distribution of the Cascadia subduction zone.

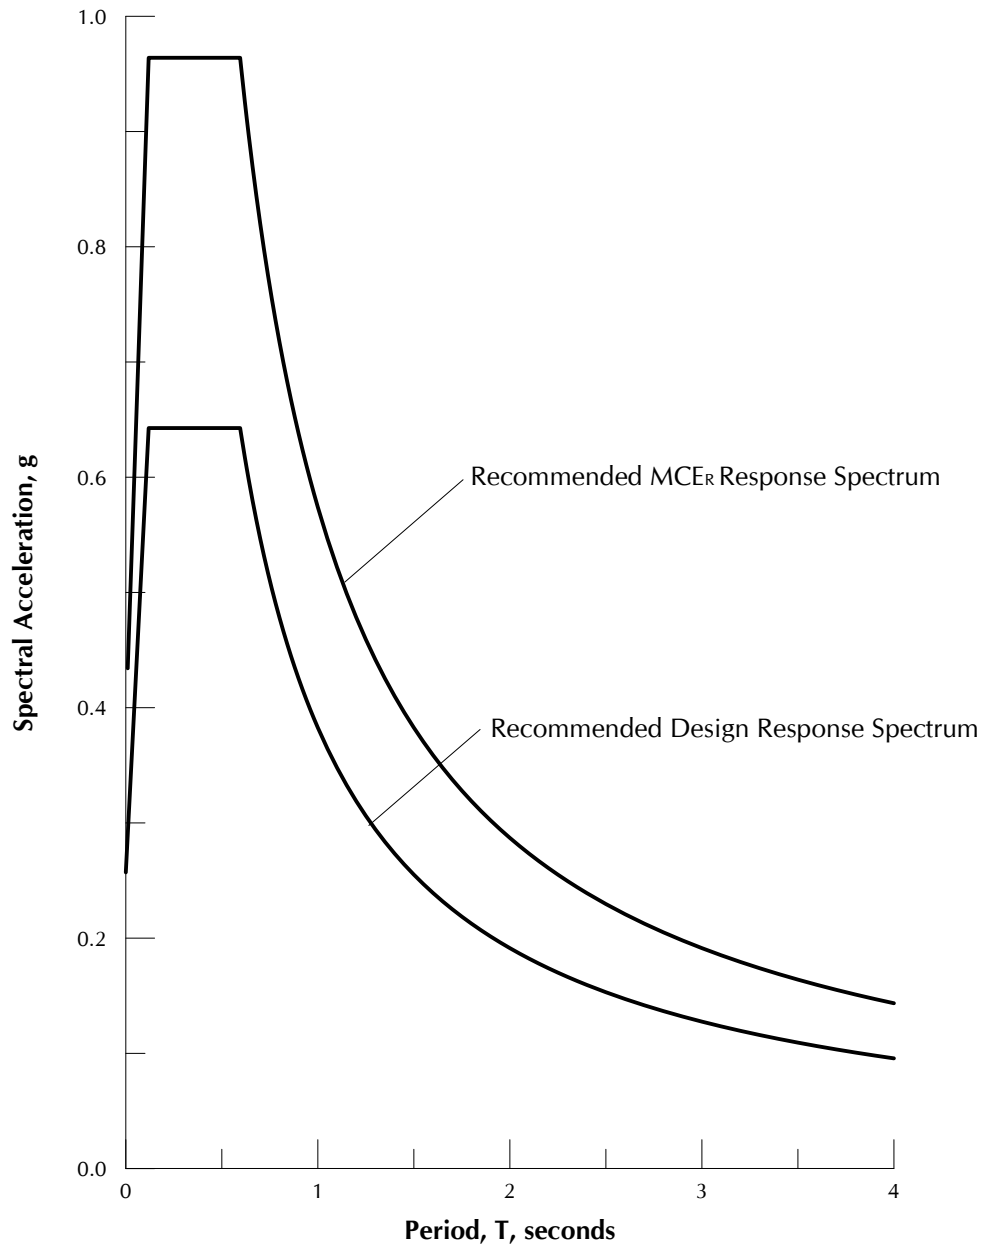
DETERMINISTIC VS. PROBABILISTIC
BEDROCK RESPONSE SPECTRA
(5% DAMPING)
