EXISTING CONDITIONS  
**SW IBACH ST**  
**SUBDIVISION**  
DEZ DEVELOPMENT LLC  
TUALATIN, OR

TREE REMOVAL AND PRESERVATION PLAN  
**SW IBACH ST**  
**SUBDIVISION**  
DEZ DEVELOPMENT LLC  
TUALATIN, OR

SITE PLAN  
**SW IBACH ST**  
**SUBDIVISION**  
DEZ DEVELOPMENT LLC  
TUALATIN, OR

COMPOSITE UTILITY PLAN  
**SW IBACH ST**  
**SUBDIVISION**  
DEZ DEVELOPMENT LLC  
TUALATIN, OR

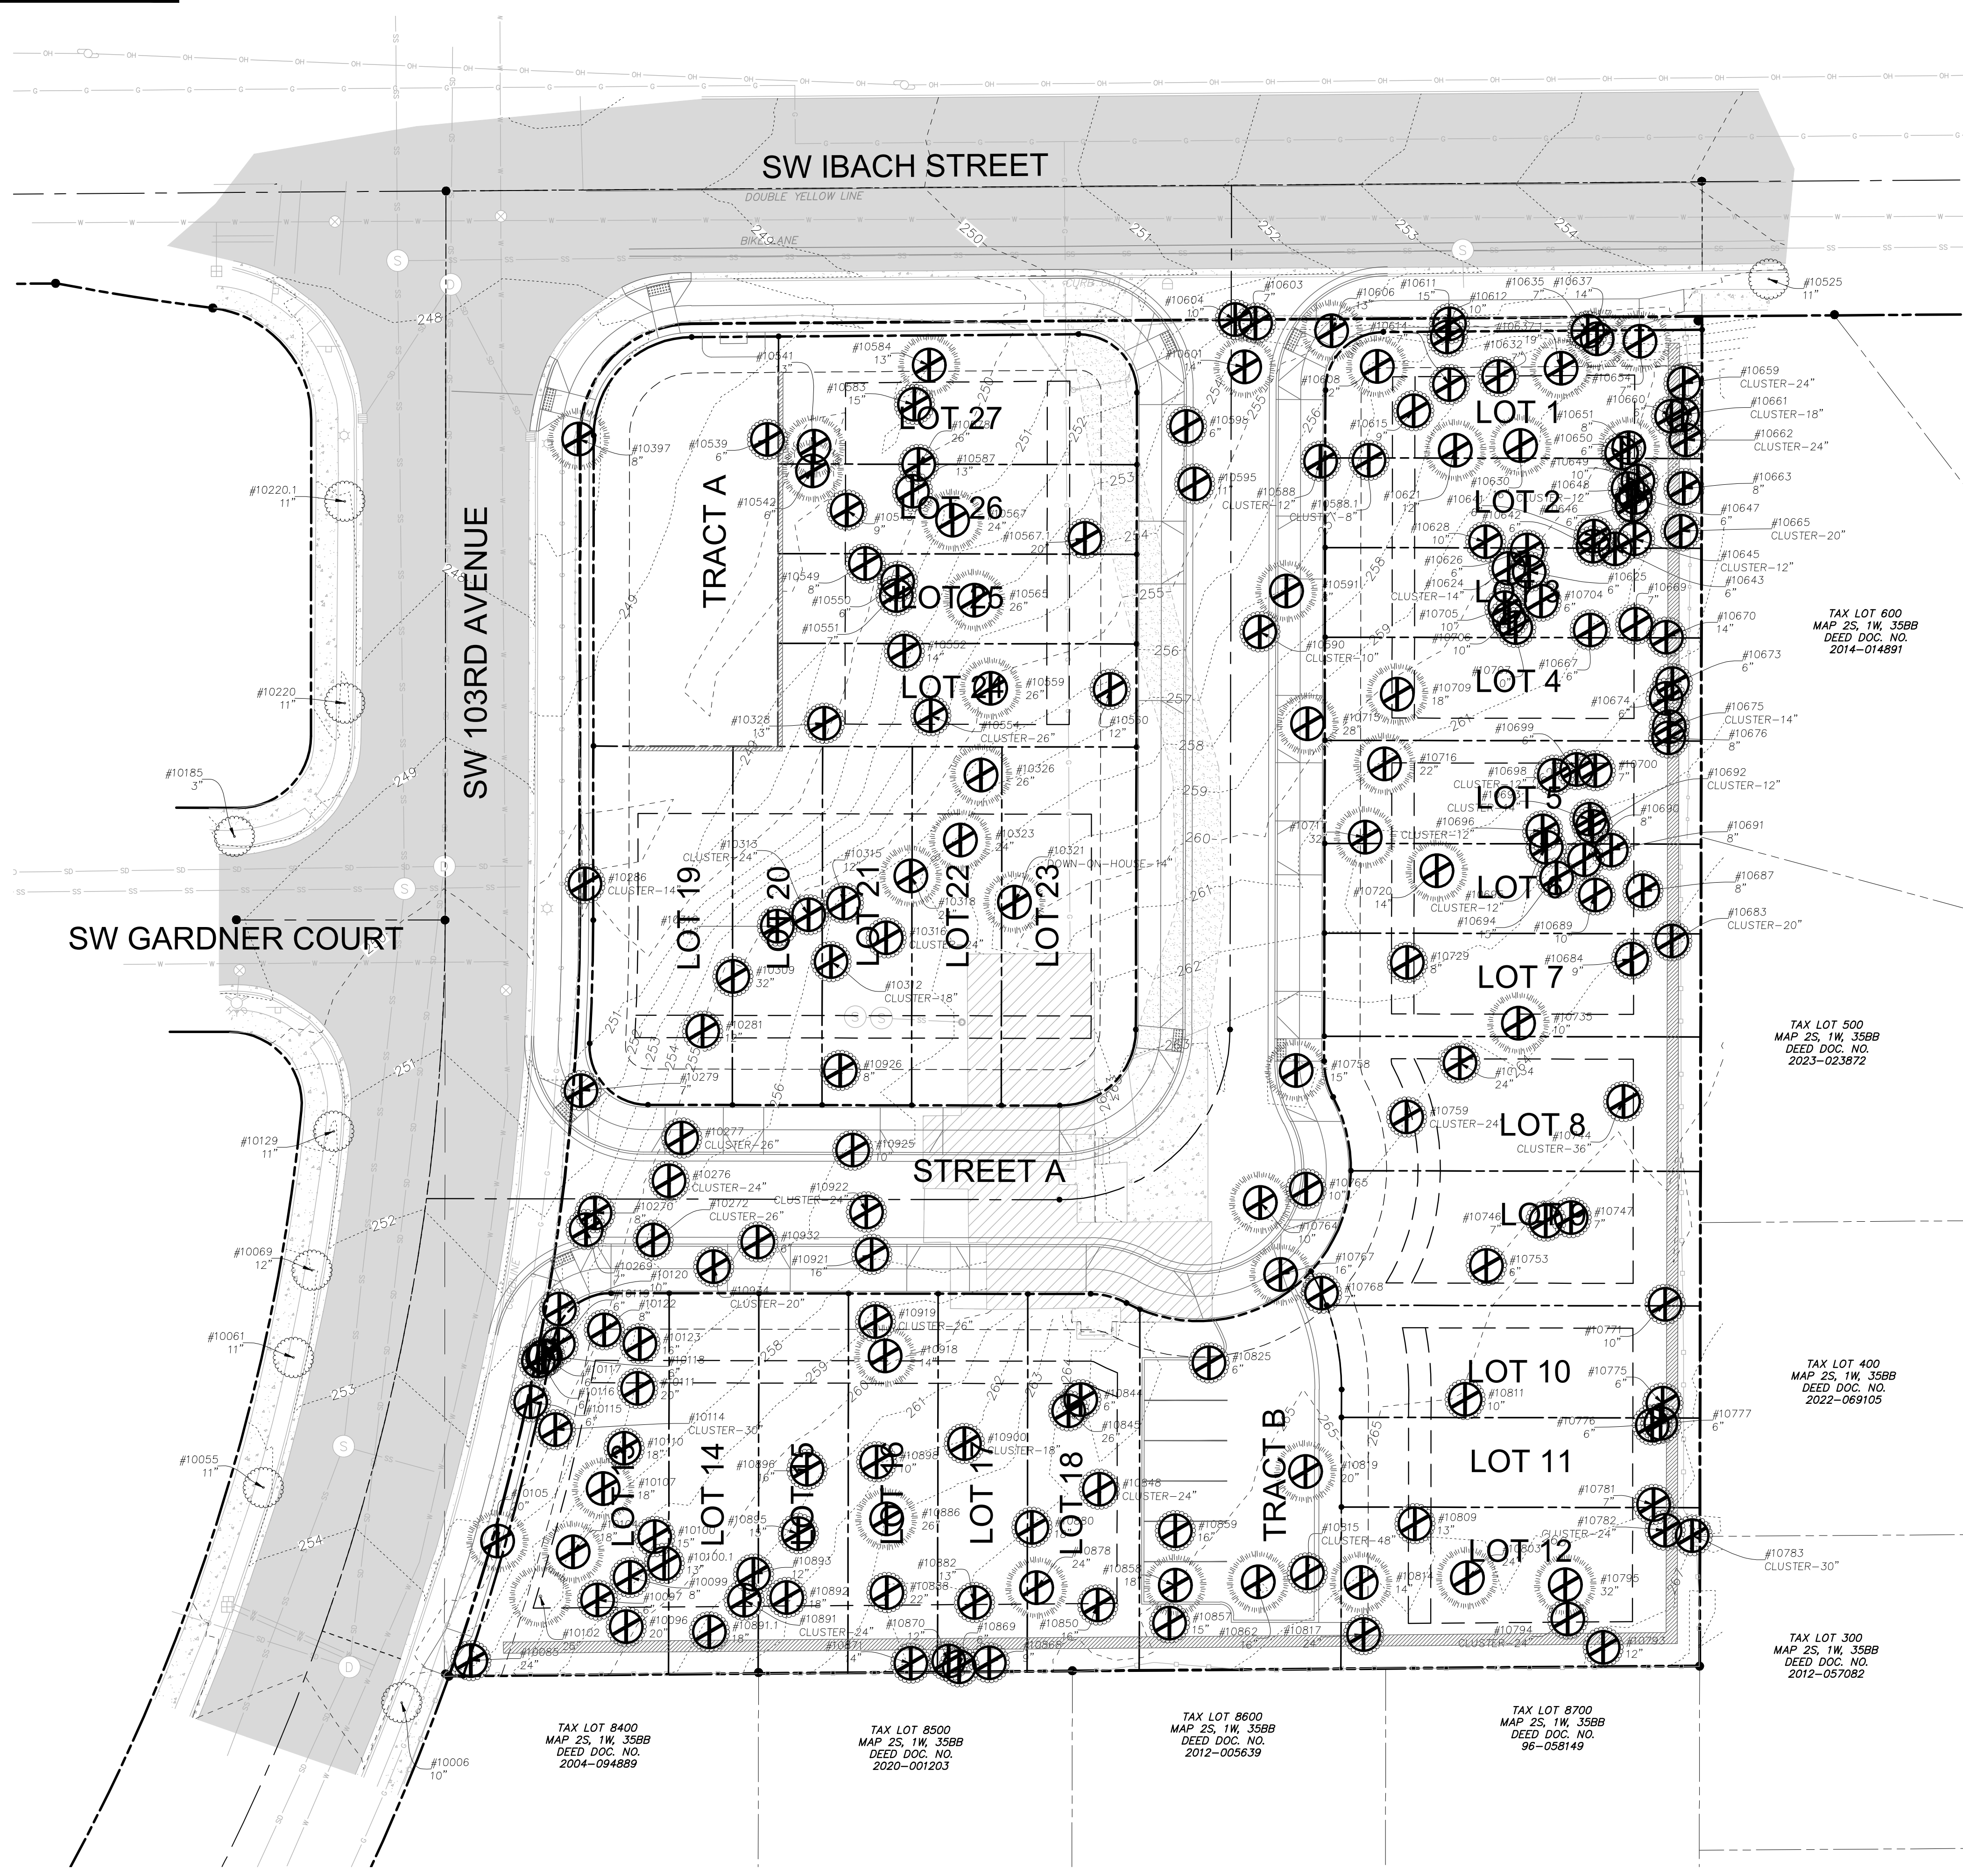
SHEET NUMBER  
**C110**

- EXISTING CONIFEROUS TREE
- EXISTING DECIDUOUS TREE
- TREE TO BE REMOVED

GENERAL TREE INVENTORY STATISTICS

| TOTAL TREE INVENTORY (IN PROJECT LIMITS): | 195 EA |
| TOTAL TREES RETAINED: | 1 EA |
| TOTAL TREES REMOVED: | 194 EA |

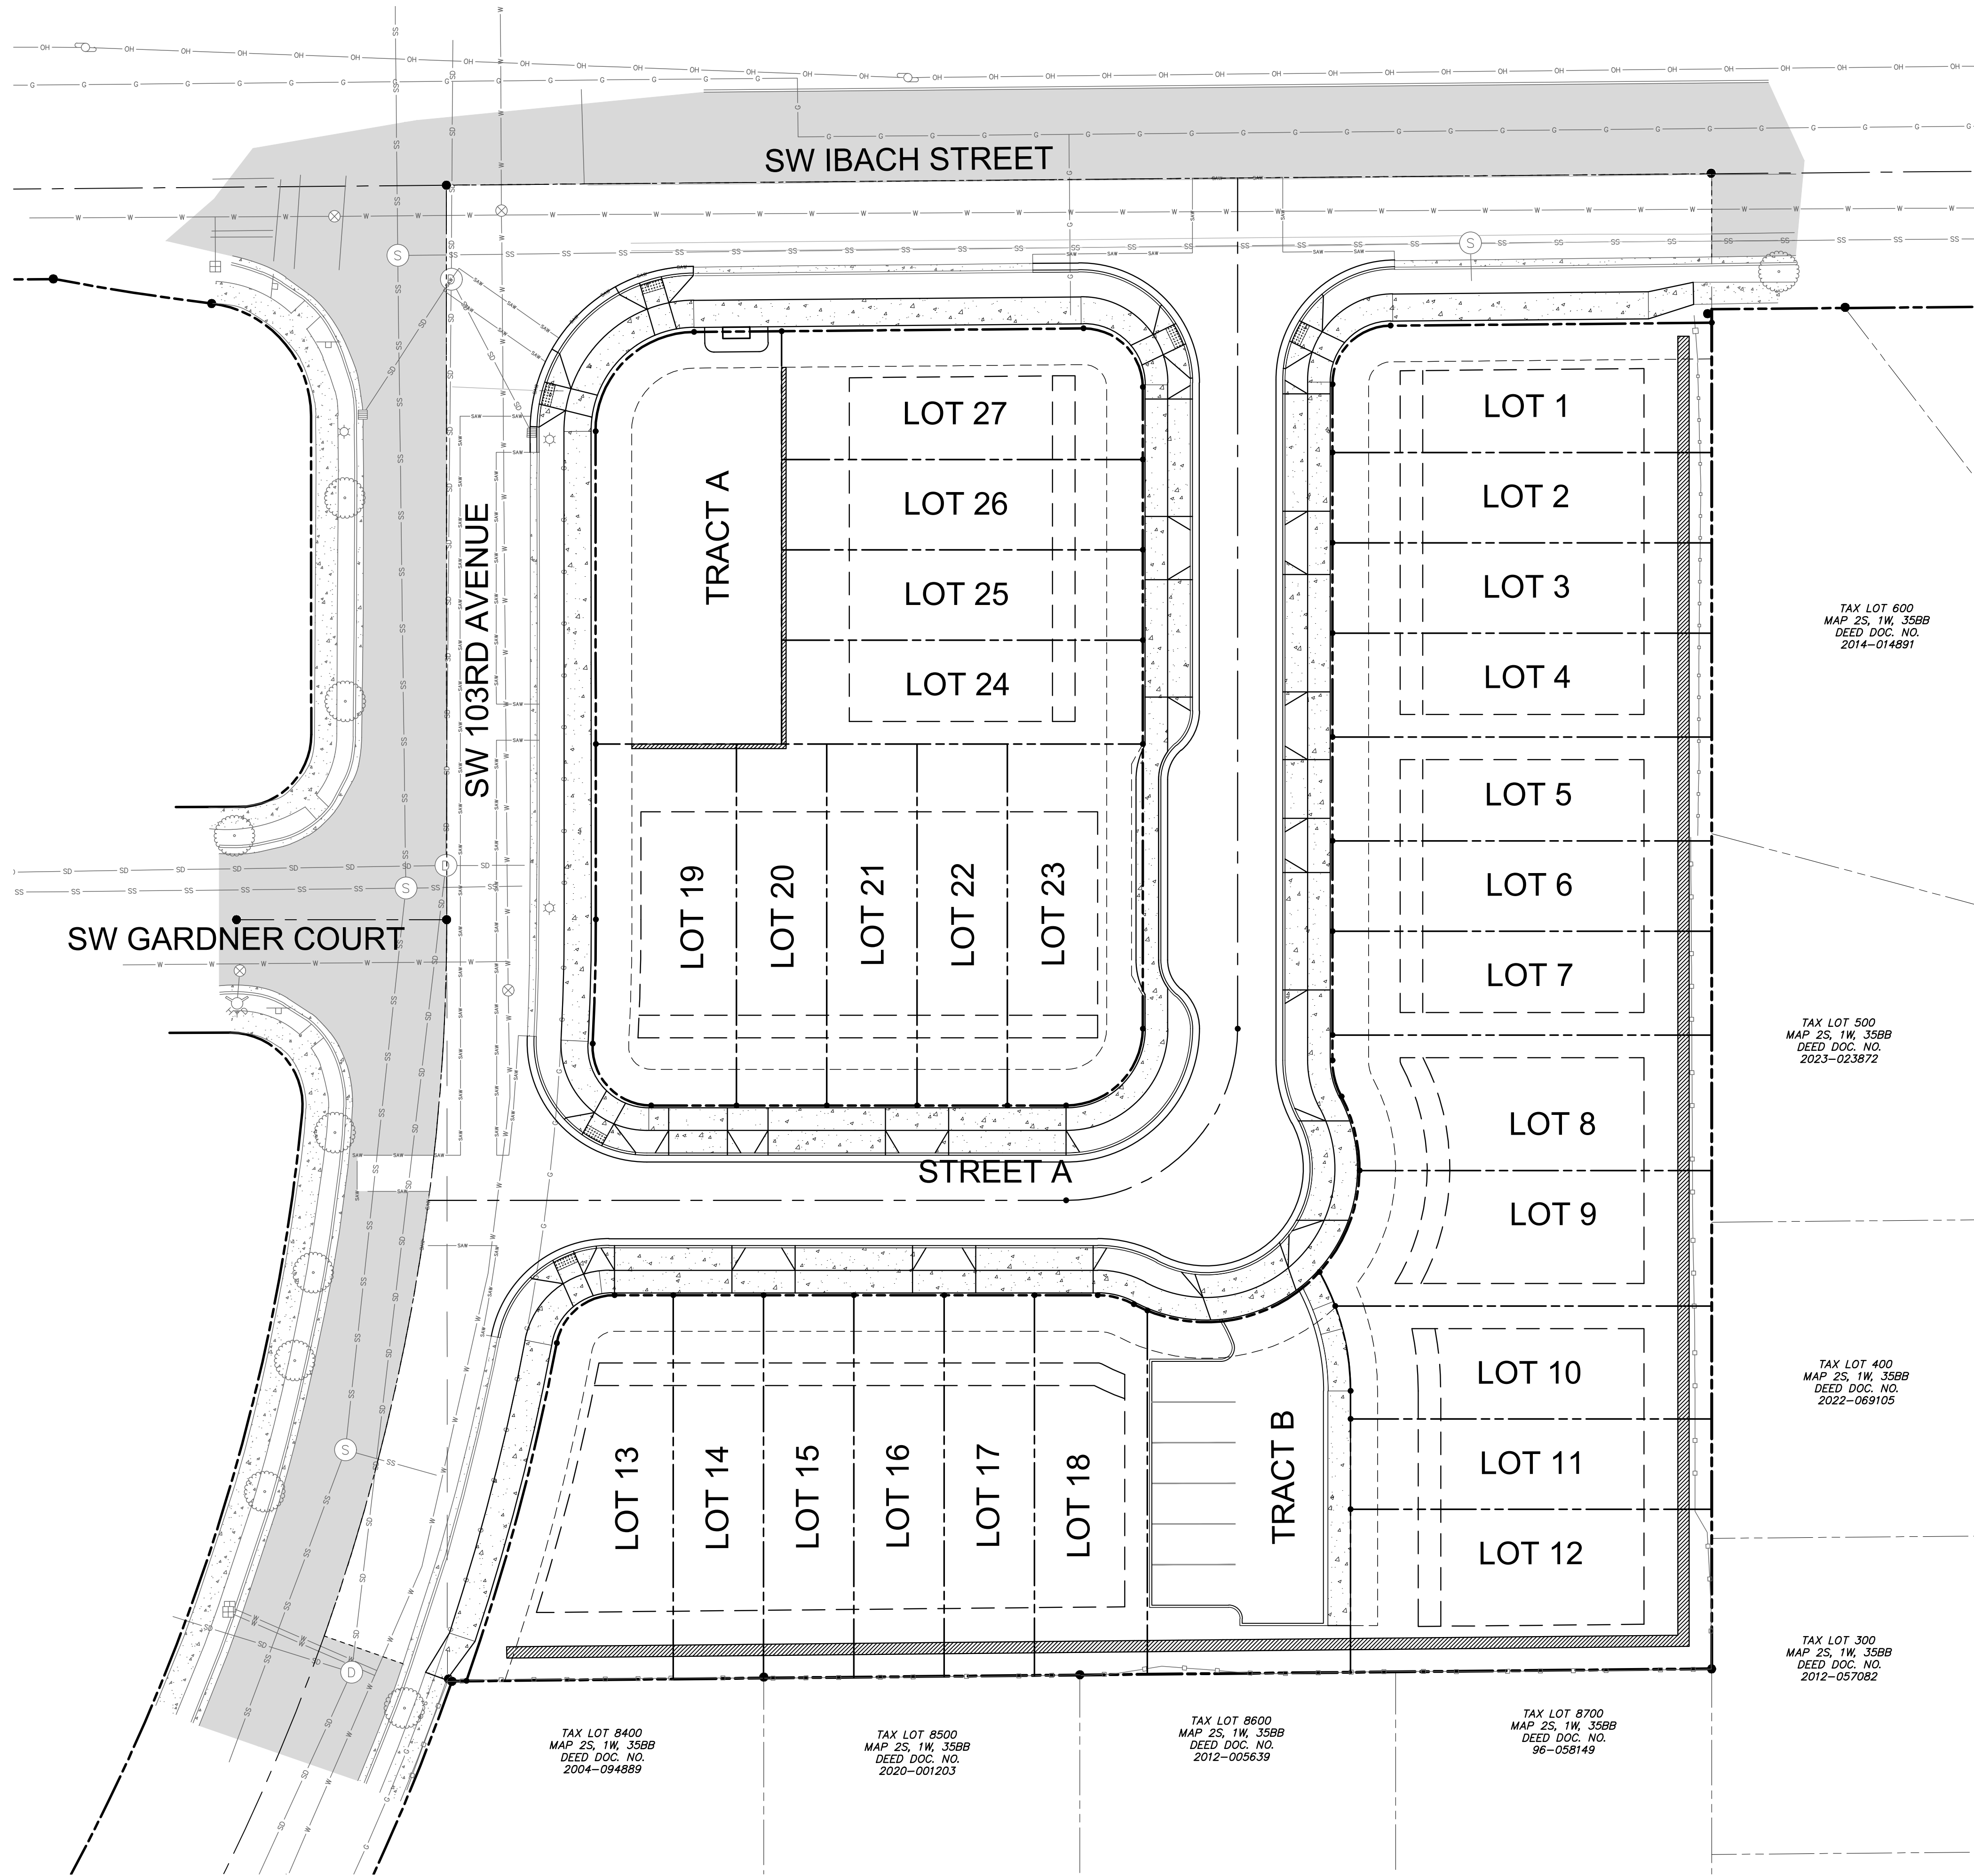
SHEET NUMBER  
**C200**

SITE PLAN  
**SW IBACH ST**  
**SUBDIVISION**  
DEZ DEVELOPMENT LLC  
TUALATIN, OR
