CITY FACILITIES STUDY

ALTERNATIVE ANALYSIS appendices

EXISTING FACILITIES ASSESSMENT

City of Tualatin
Community Services Building
Facility Condition Assessment

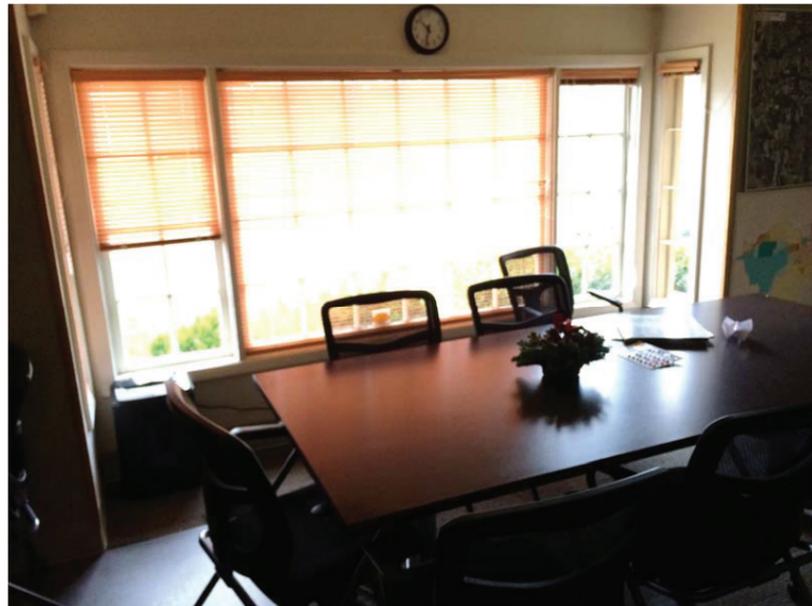
Figure B10.5A Office functions impose loads differently than residential use

B10.3.2	It should be confirmed whether during previous re-roofings additional plywood sheathing was added to improve diaphragm strength; this could be provided in upcoming re-roofing (refer to B30.1).	
B10.4	None	
B10.5.1	It should be confirmed that locations currently bearing large furniture or file storage loads are adequately supported on structure below.	
B10.5.2	It is recommended that loads be minimized and distributed where they are in the middle of rooms or not adjacent to major structural support below the floor.

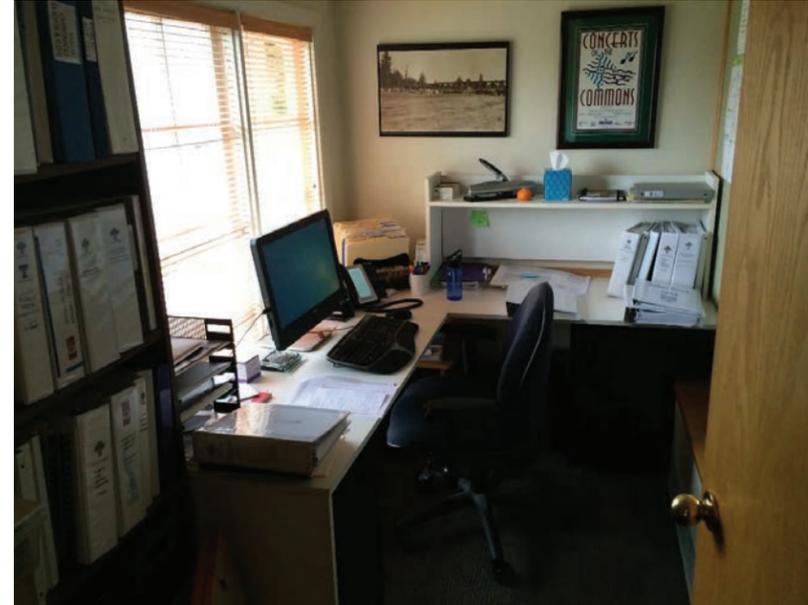
Figure B10.5B Office functions impose loads differently than residential use

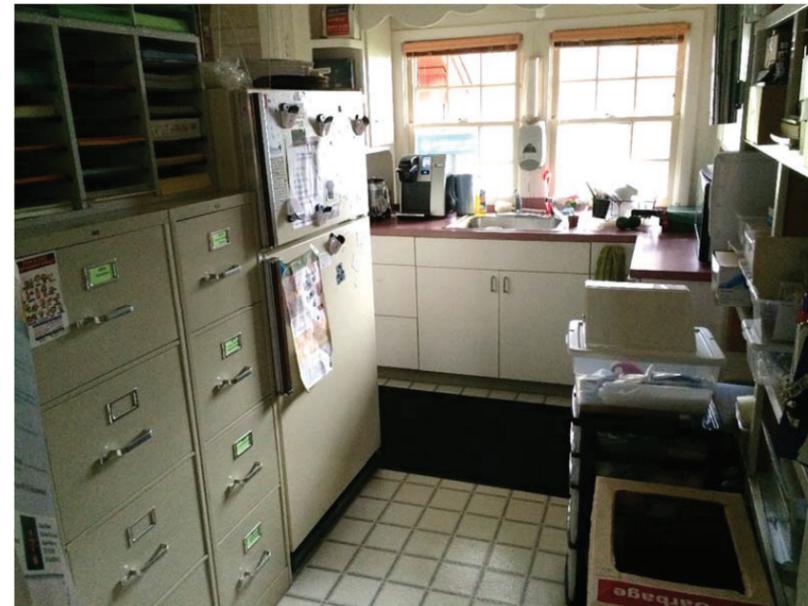
Figure B10.5C Office functions impose loads differently than residential use

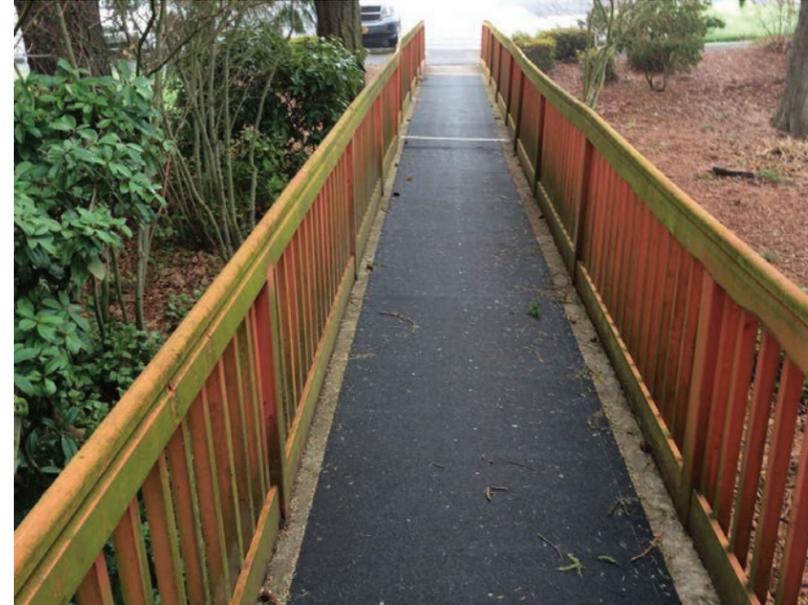
B30 – EXTERIOR HORIZONTAL ENCLOSURES (roofing, horizontal openings, etc.)		
Item		Comments/Findings
B30.1	Type and condition of roofing system	<ul style="list-style-type: none"> Roofing is three-tab asphalt shingles, which may be near the end of its life-span (10-15 years) It was observed that moss has grown on the east side. Refer to Figure B30.1
B30.2	Other issues	<ul style="list-style-type: none"> Flashings, vents, etc. all appear in acceptable condition Access to the roof was not available; observations were made from the ground level The roof at the Garage north of the building appeared to have been recently damaged, possibly by the early December windstorm or from actions by users of the skateboard park adjacent; Staff reported that the damage had been repaired (skateboard park users have sometimes accessed the roof by climbing on the power meter stanchions adjacent to the garage); several old skateboard decks had been thrown onto the roof of the garage; refer to Figure B30.2

Figure B30.1 Moss at east side of roof

Recommendations		
B30.1.1	Confirm age and life-span remaining for existing roofing; replace if necessary, possibly adding a layer of plywood sheathing if required to improve the structure's lateral force resistance (refer to B10.3). Replacement roofing with metal roofing system has been proposed in the City's Capital Improvement Plan.	
B30.2.1	Monitor conditions of flashings, vents, gutters, downspouts, etc.; recommend investigation for replacement as necessary at next reroofing. Staff indicated that following the inspection, the observed damage at the Garage roof had been repaired.

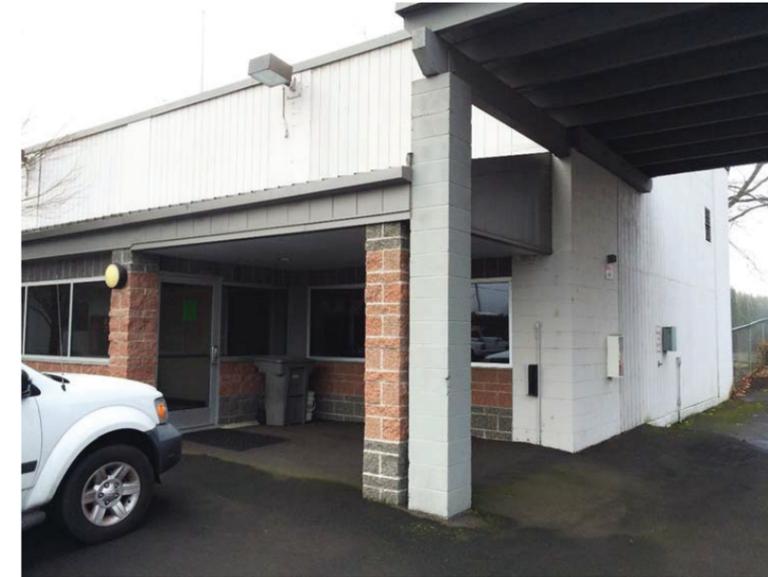
Figure B30.1A CMU corners and between former maintenance bays; T1-11 exterior plywood infill at front of building; split-faced CMU and aluminum storefront windows added for lobby

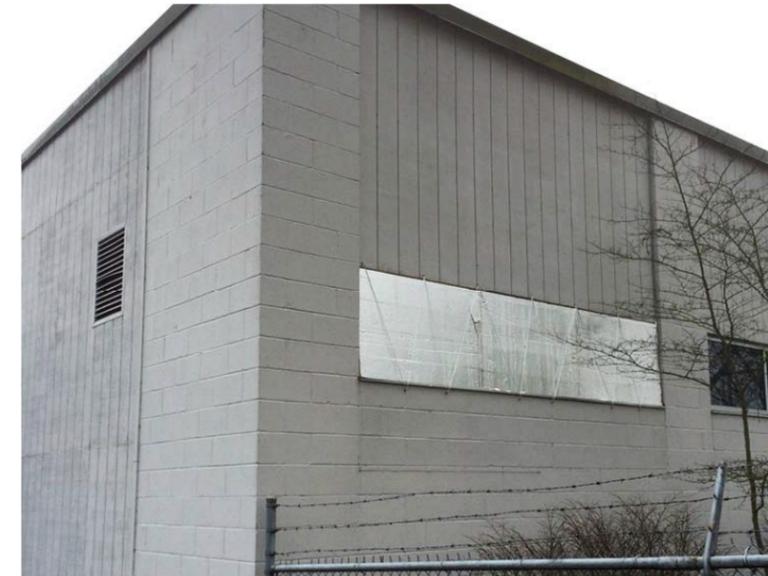
Figure B30.1B CMU corners and between former maintenance bays; T1-11 exterior plywood and CMU infill at rear of building; insulation added over west-facing windows (from Server room)

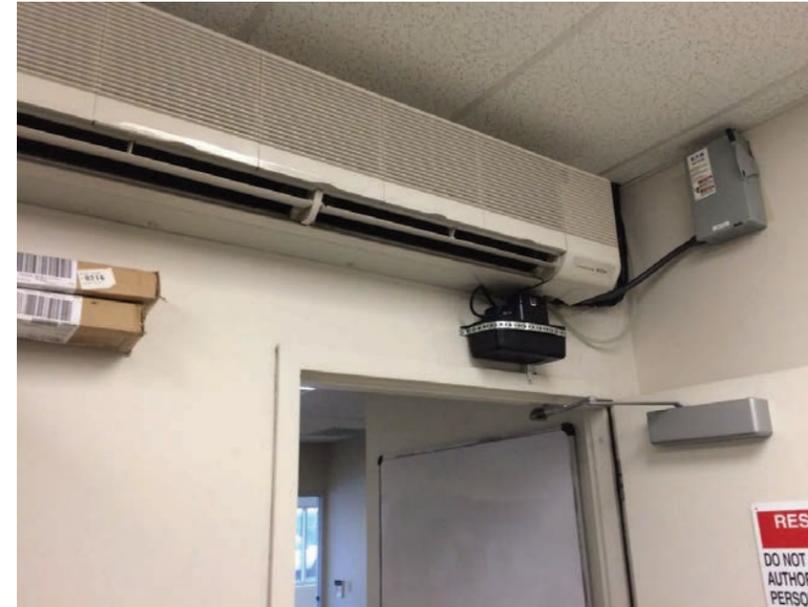
Figure D30.7 Split system HVAC at Server room; condensate pumped to disposal thru plenum

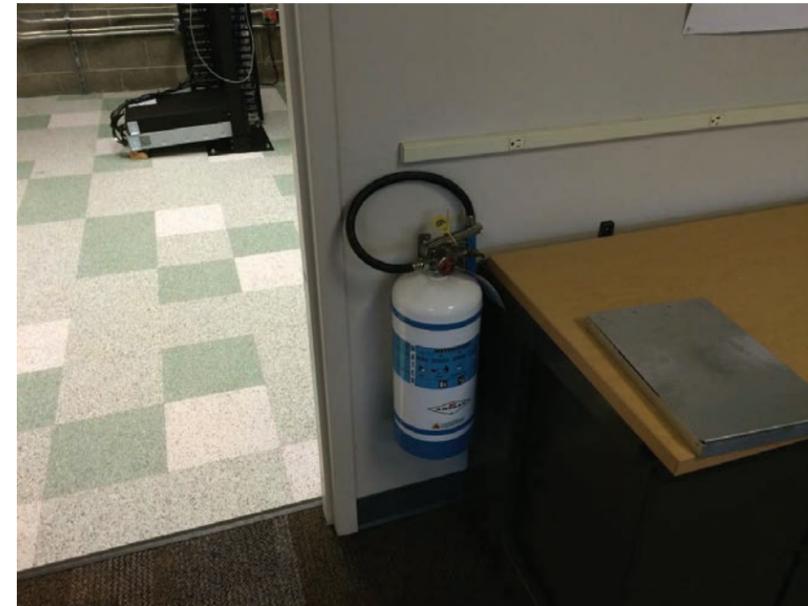
Figure D40.12 Water mist extinguisher

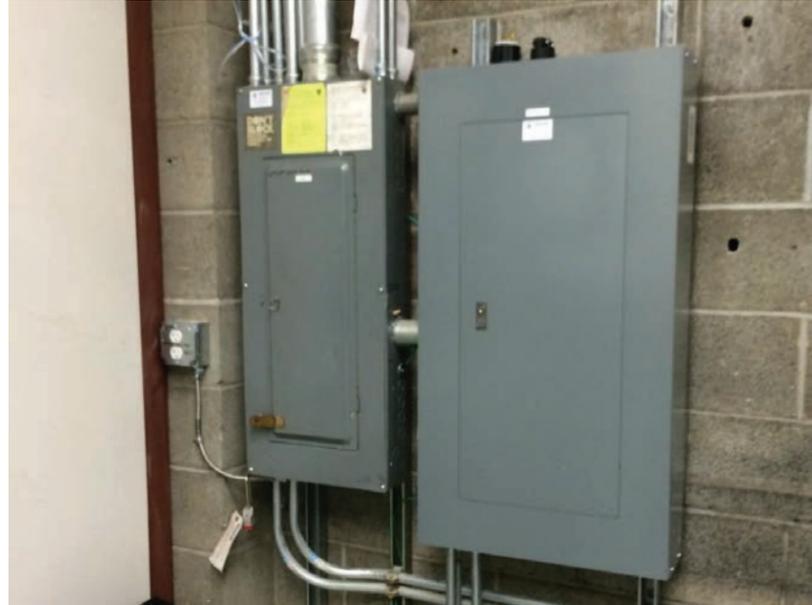
Figure D50.6 Panels F and FA for power to server racks and potentially devices/ loads in other spaces

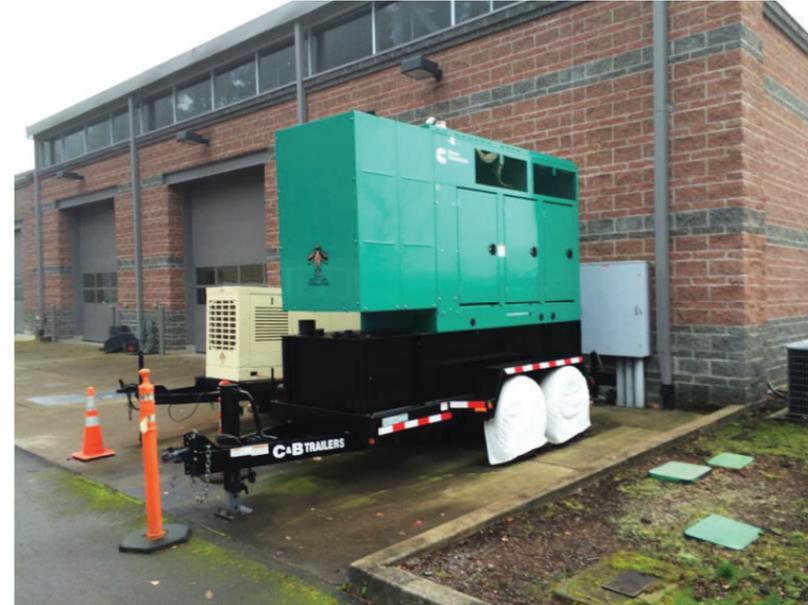
Figure D50.21 Trailer-mounted engine-generator set with base tank

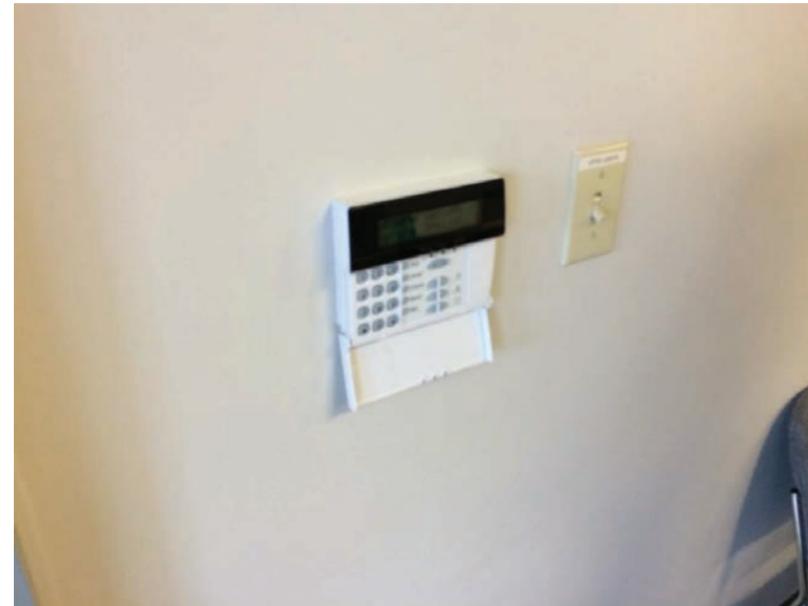
Figure G20.5 Punch key-coded alarm system within Information Services Office space

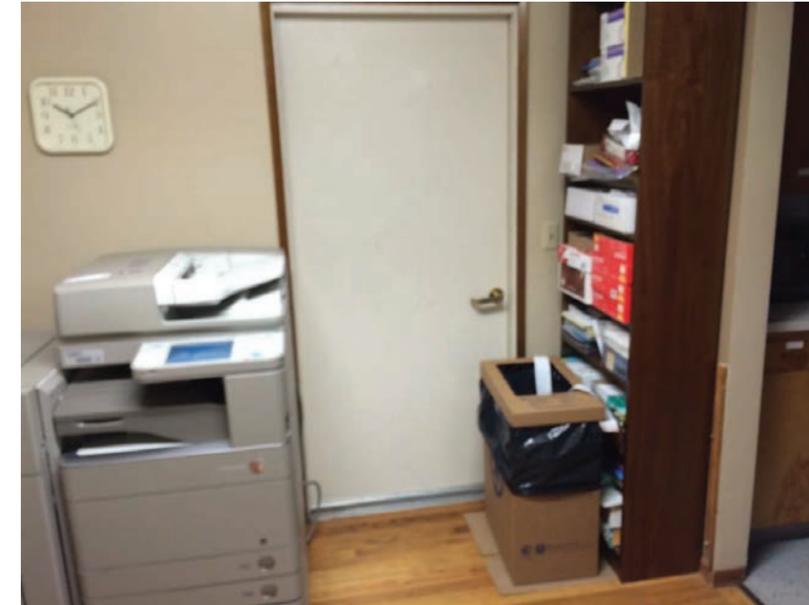
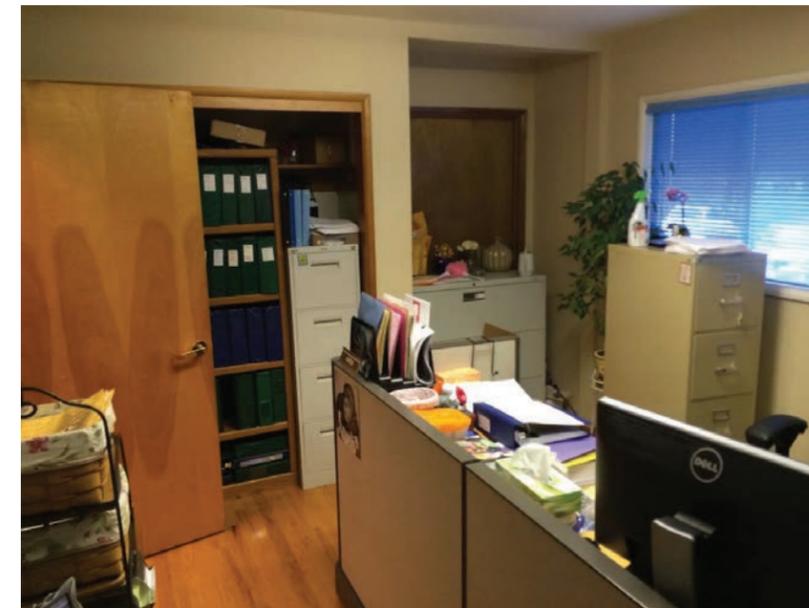
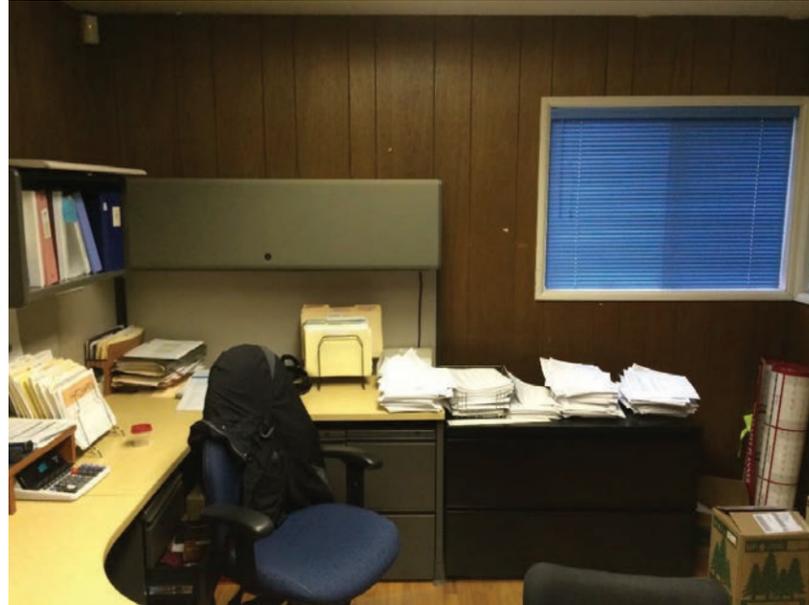
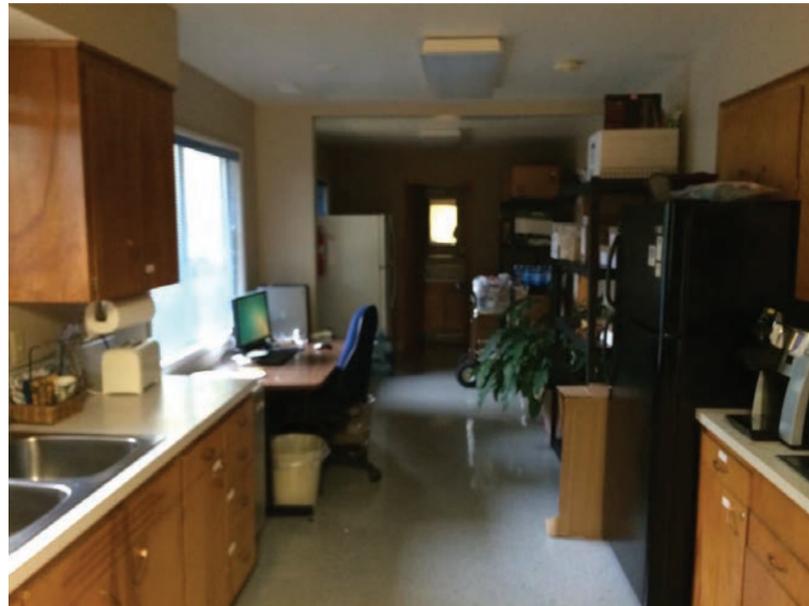
Figure B10.5A Office functions impose loads differently than residential use

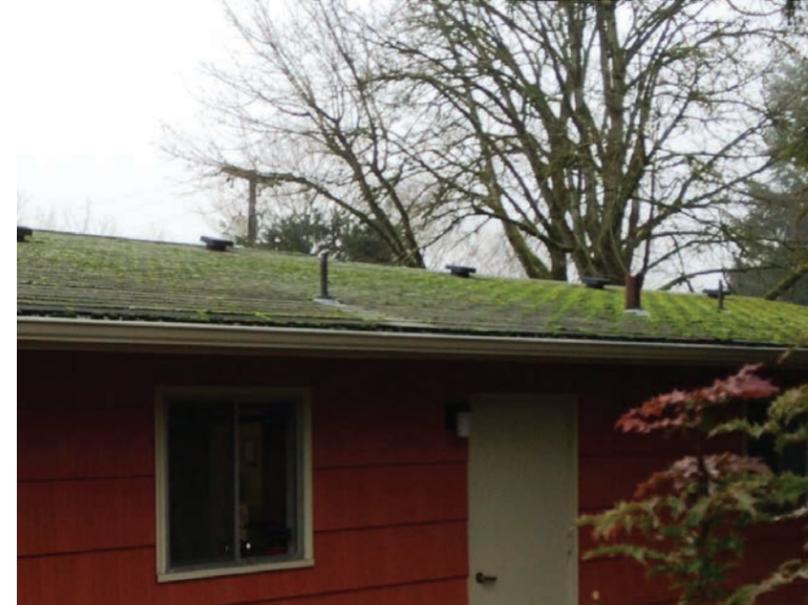
Figure B30.1 Moss at north roof

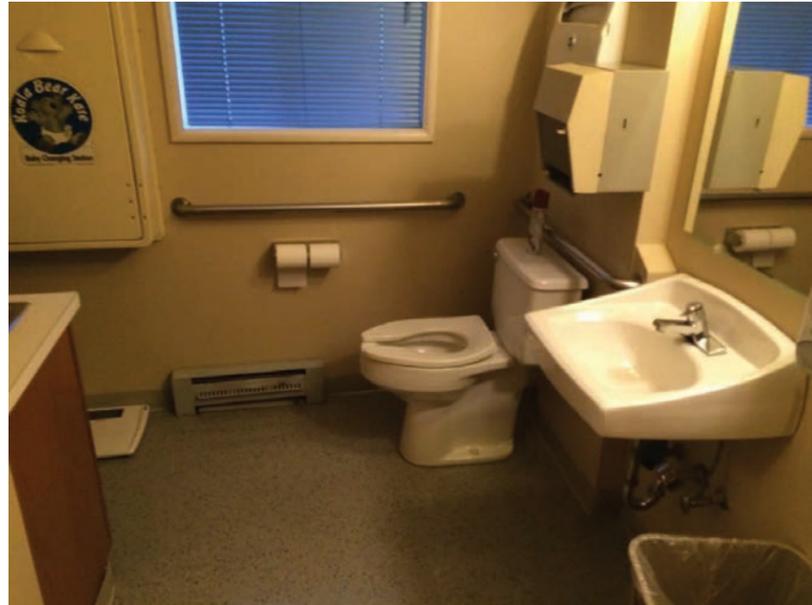
Figure C10.4B Accessible restroom conversion from residential

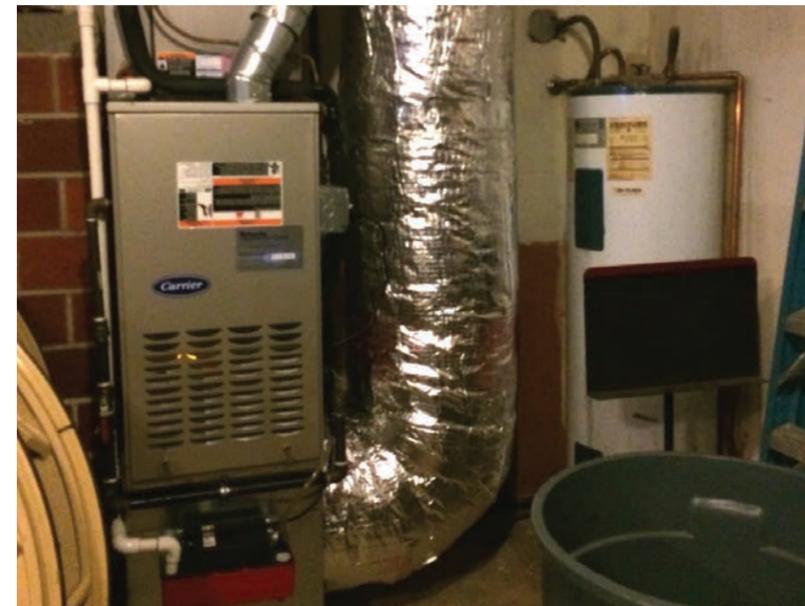
Figure D30.6 Air handler configuration; access compromised by storage

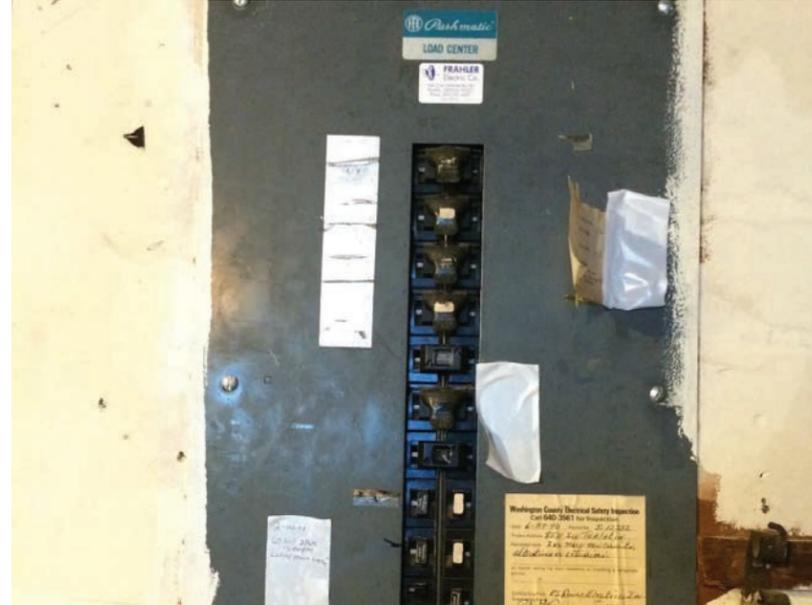
Figure D50.6 Original electrical panel with push button-type circuit breakers

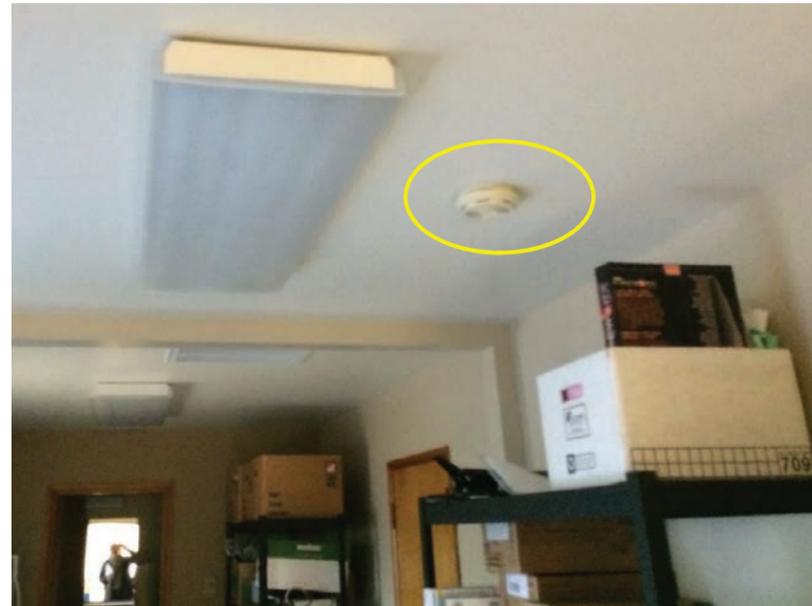
Figure D60.2 - Local, battery-operated residential type smoke detectors

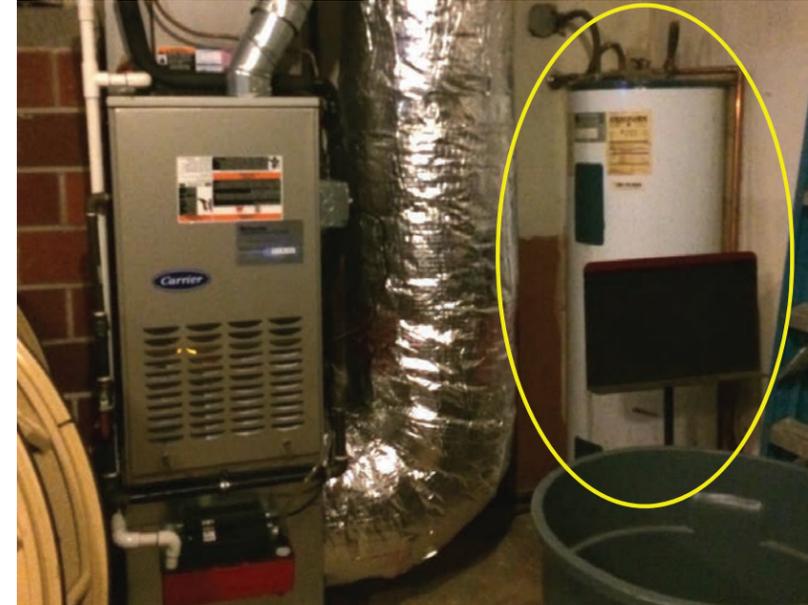
Figure E10.1 Water heater is not restrained for seismic forces

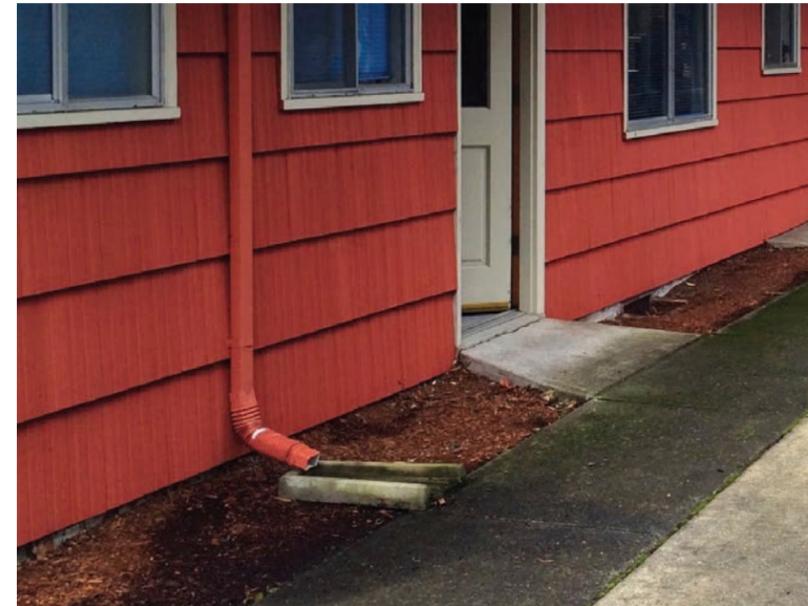
Figure G20.8 Soil and topping in contact with siding at rear (north)

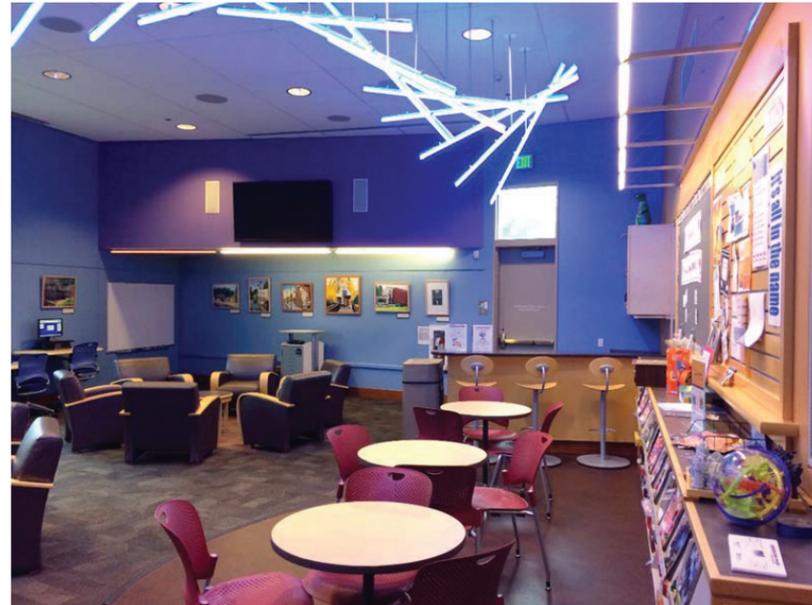
Figure C30.1E Interior finishes teen room within Library

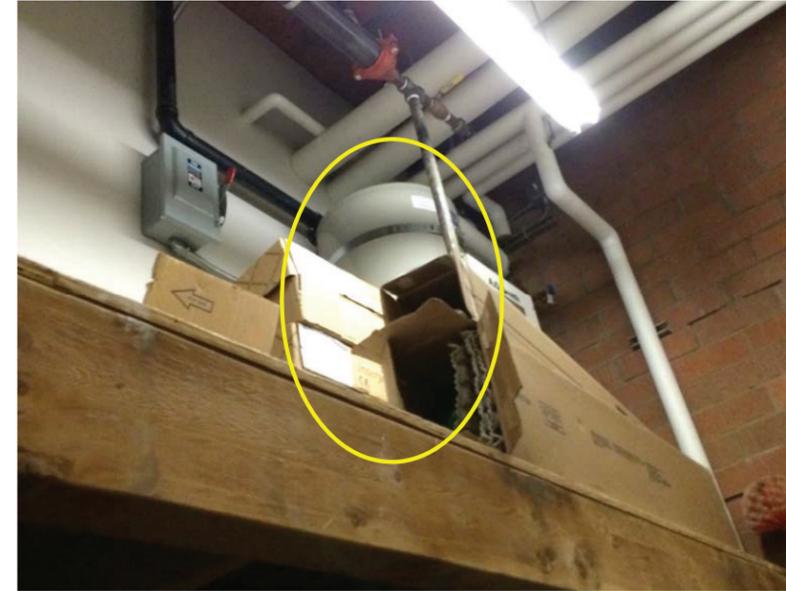
Figure D20.7 Water heater on wooden platform in Janitor room; appears to be seismically restrained; maintenance compromised by storage and limited access

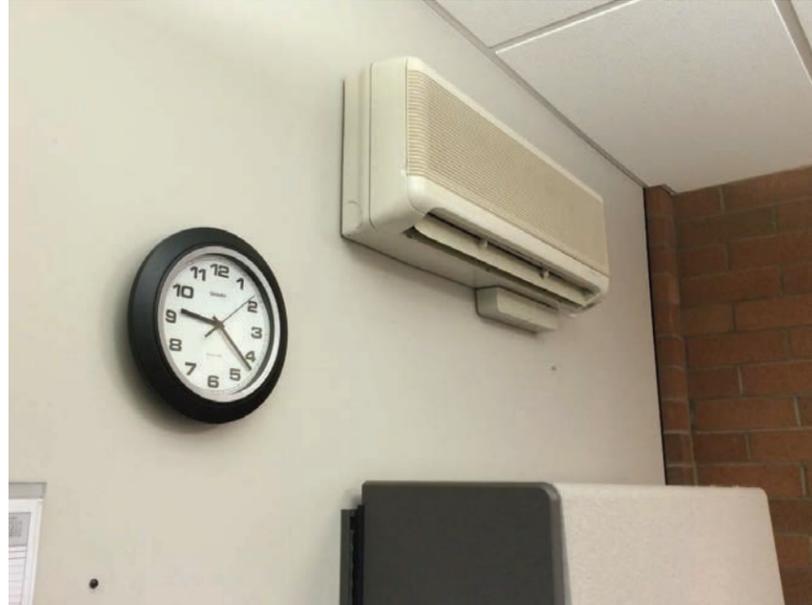
Figure D30.4B Remote split systems provided at south-facing offices in original portion of building

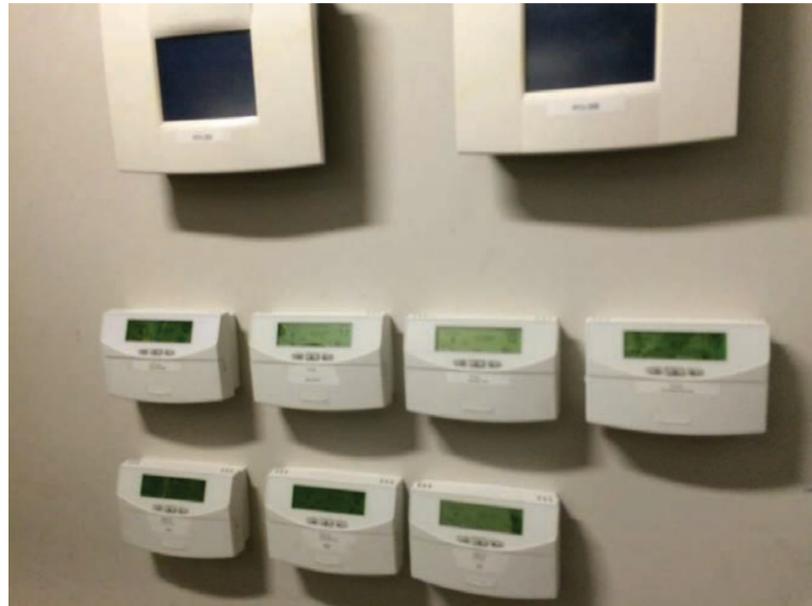
Figure D30.8 HVAC controls at Library

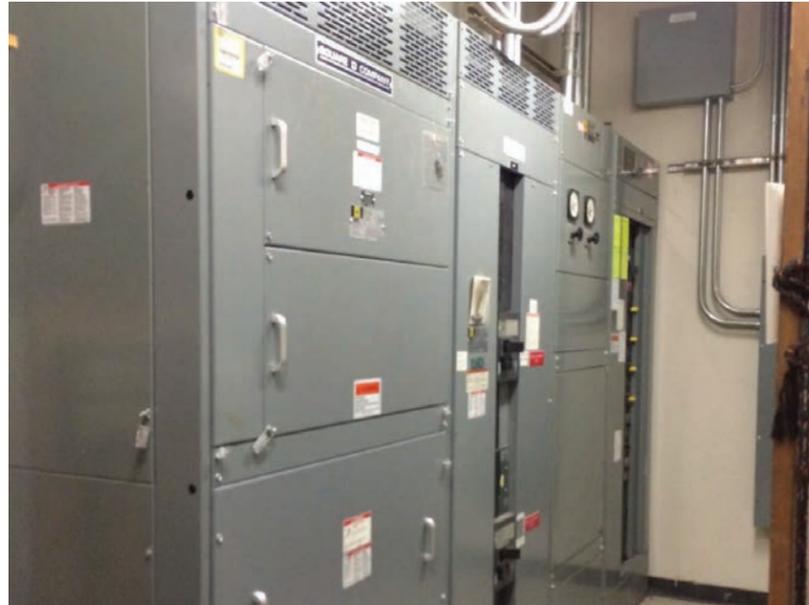
Figure D50.11 Main distribution equipment serves both portions of the facility from Electrical room

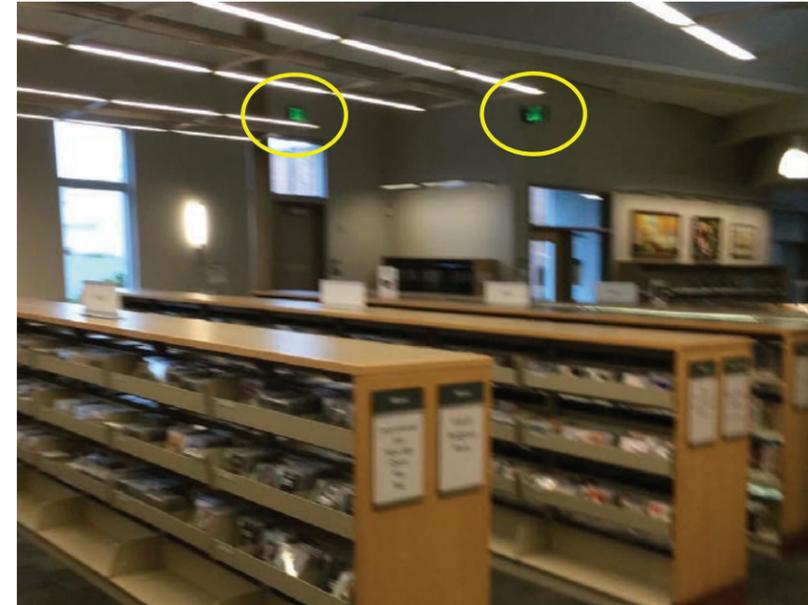
Figure D50.27 Typical exit signage is appropriately placed

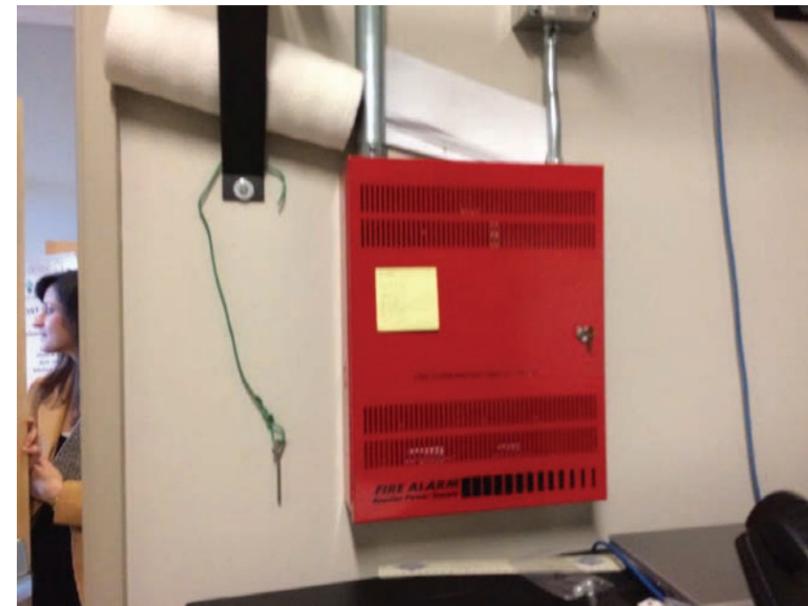
Figure D60.1 Main fire alarm panel in IDF room adjacent to Library Lobby

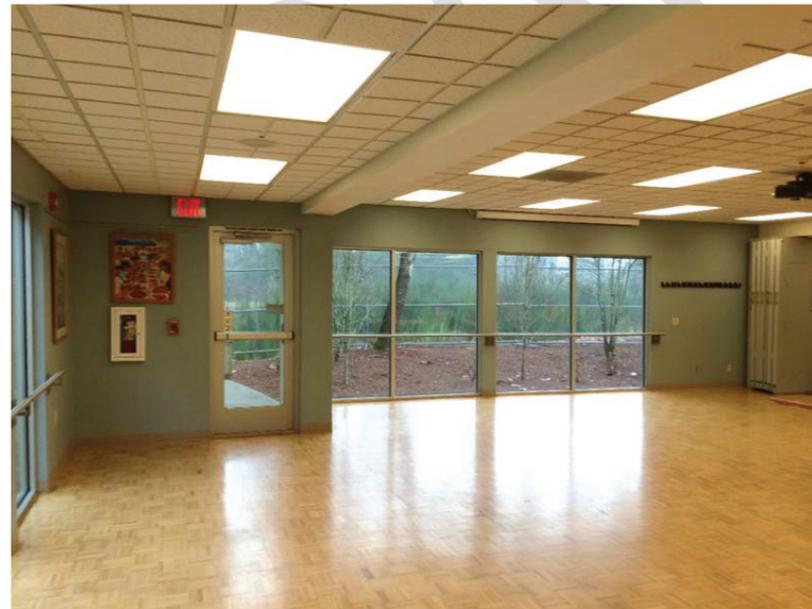
C30 – INTERIOR FINISHES		
Item		Comments/Findings
C30.1	General type and condition of finishes	<ul style="list-style-type: none"> • Wall finishes in Activity Room space are painted gypsum wallboard; movable wall panels with fabric-faced finish are used for sound control and to enclose the space for meeting activities • Floor finishes in Activity Room space are oak wood parquet flooring with clear finish; all flooring appears to be in good condition • Ceiling finishes are acoustic ceiling tile, with soffits of painted gypsum wallboard • Plastic laminate cabinetry and interior wood veneer doors are provided in the space
C30.2	Locations and cause of water intrusion/ leaks	• None were observed
C30.3	Other issues	• None
Recommendations		
C30.1	None	
C30.2	None	
C30.3	None

Figure C30.1A Interior finishes Activity Room space

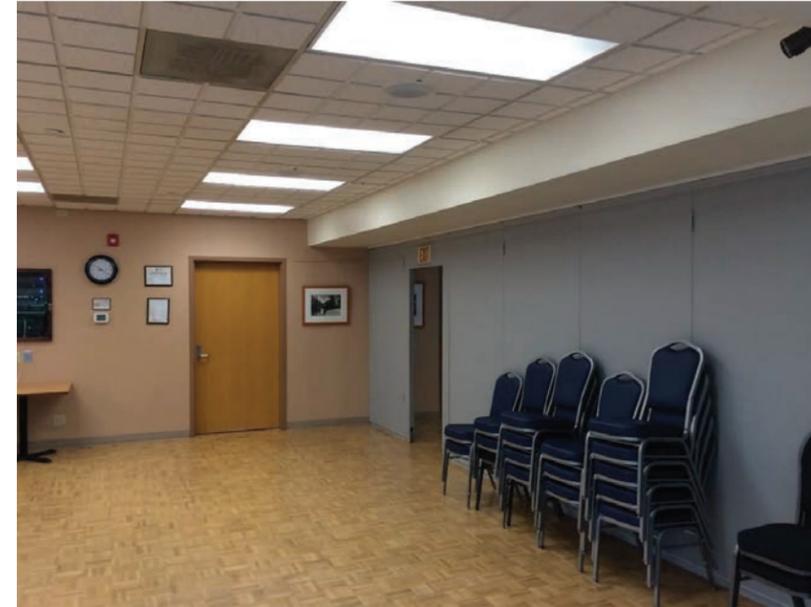
Figure C30.1B Interior finishes Activity Room space, including movable wall system (at right)

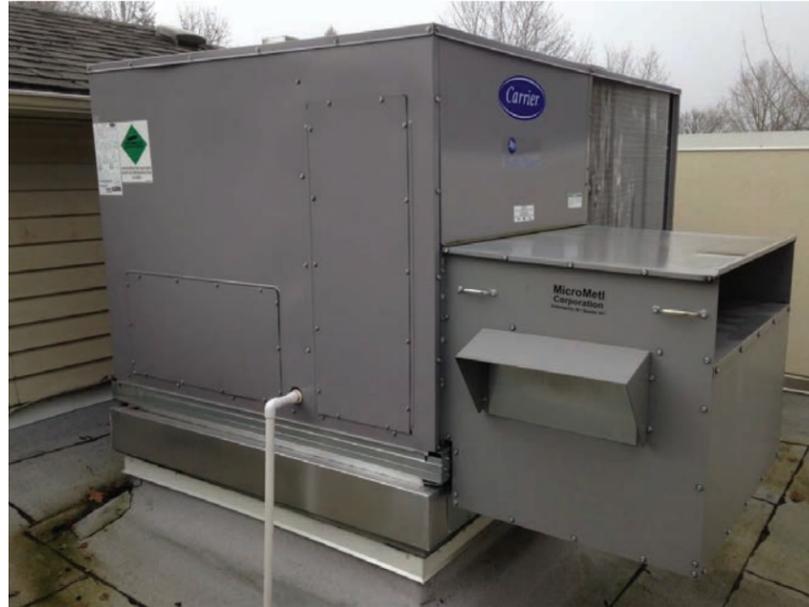
Figure D30.6 Staff photo of air handler configuration and access above Activity Room space

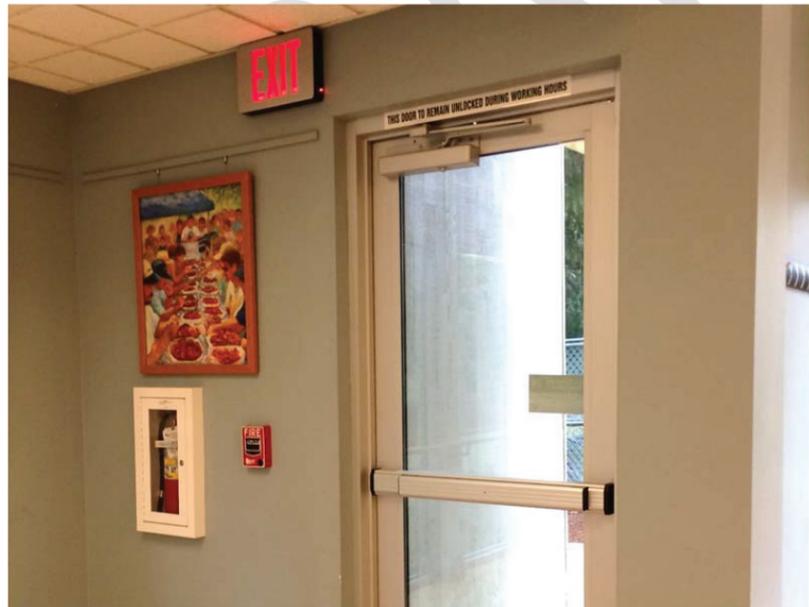
Figure D40.12 Fire extinguisher and fire alarm pull station adjacent to egress door

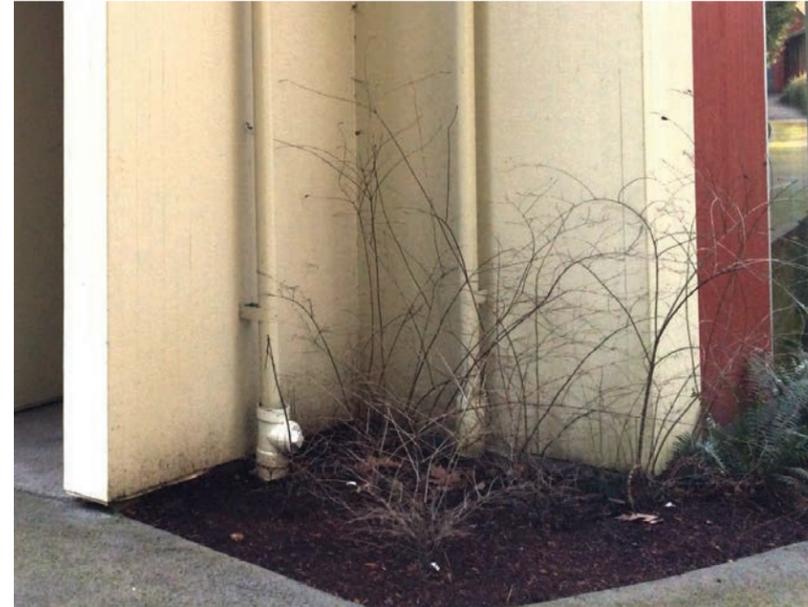
Figure G20.8 Soil and topping in contact with siding at rear (northeast corner)

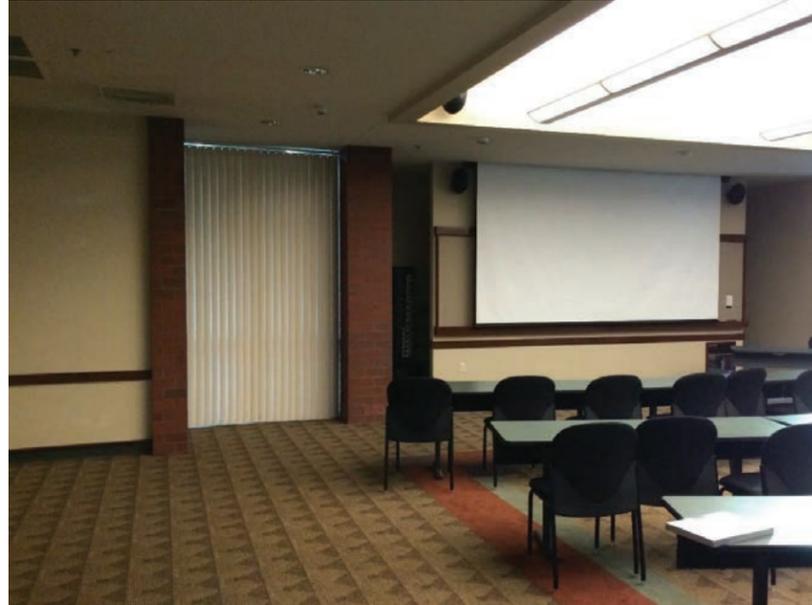
Figure C30.1A Interior finishes Training Room space

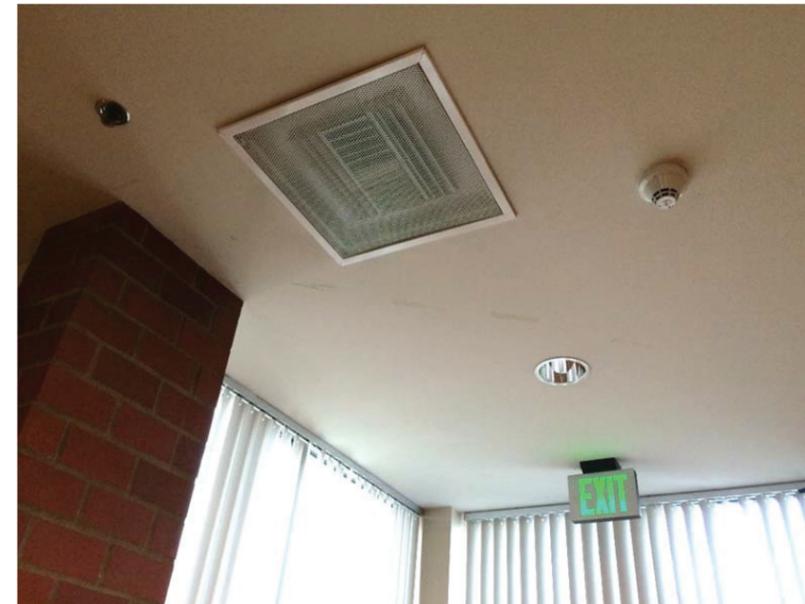
Figure D50.27 Typical exit signage; also typical fire detection and fire suppression
