City of Tualatin

CITY FACILITIES STUDY

FACILITIES ASSESSMENTS *report*

YOST GRUBE HALL
ARCHITECTURE

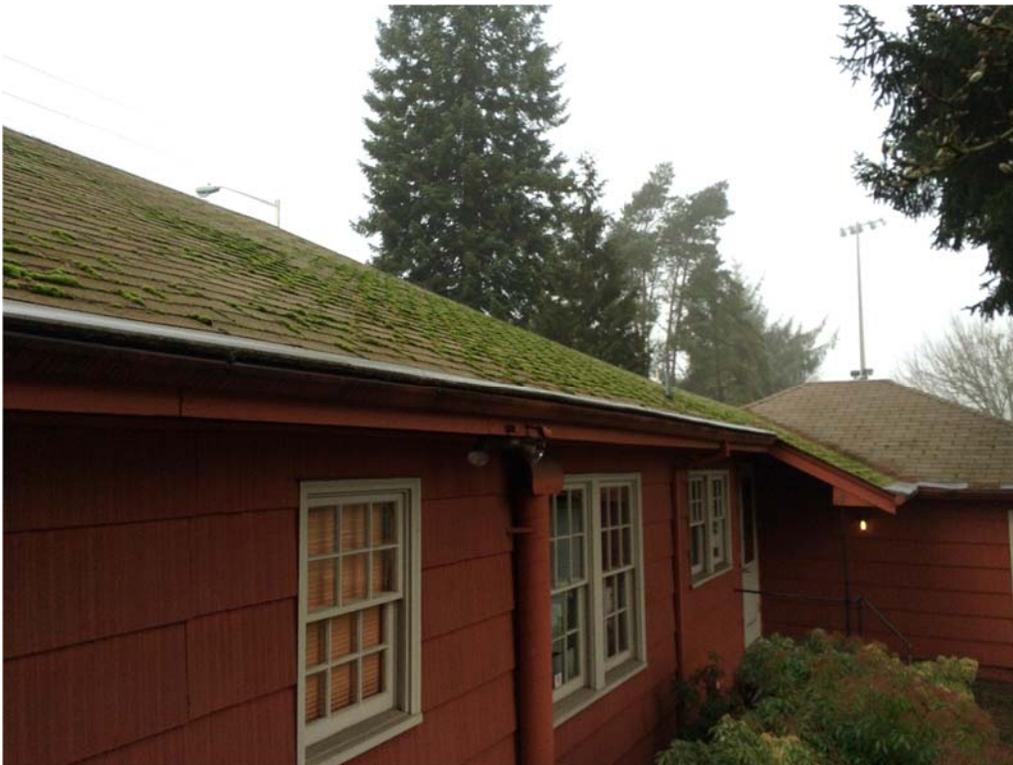
B30 – EXTERIOR HORIZONTAL ENCLOSURES (roofing, horizontal openings, etc.)		
Item		Comments/Findings
B30.1	Type and condition of roofing system	<ul style="list-style-type: none"> • Roofing is three-tab asphalt shingles, which may be near the end of its life-span (10-15 years) • It was observed that moss has grown on the east side. Refer to Figure B30.1
B30.2	Other issues	<ul style="list-style-type: none"> • Flashings, vents, etc. all appear in acceptable condition • Access to the roof was not available; observations were made from the ground level • The roof at the Garage north of the building appeared to have been recently damaged, possibly by the early December windstorm or from actions by users of the skateboard park adjacent; Staff reported that the damage had been repaired (skateboard park users have sometimes accessed the roof by climbing on the power meter stanchions adjacent to the garage); several old skateboard decks had been thrown onto the roof of the garage; refer to Figure B30.2

Figure B30.1 Moss at east side of roof

Recommendations		
B30.1.1	Confirm age and life-span remaining for existing roofing; replace if necessary, possibly adding a layer of plywood sheathing if required to improve the structure’s lateral force resistance (refer to B10.3). Replacement roofing with metal roofing system has been proposed in the City’s Capital Improvement Plan.	
B30.2.1	Monitor conditions of flashings, vents, gutters, downspouts, etc.; recommend investigation for replacement as necessary at next reroofing. Staff indicated that following the inspection, the observed damage at the Garage roof had been repaired.

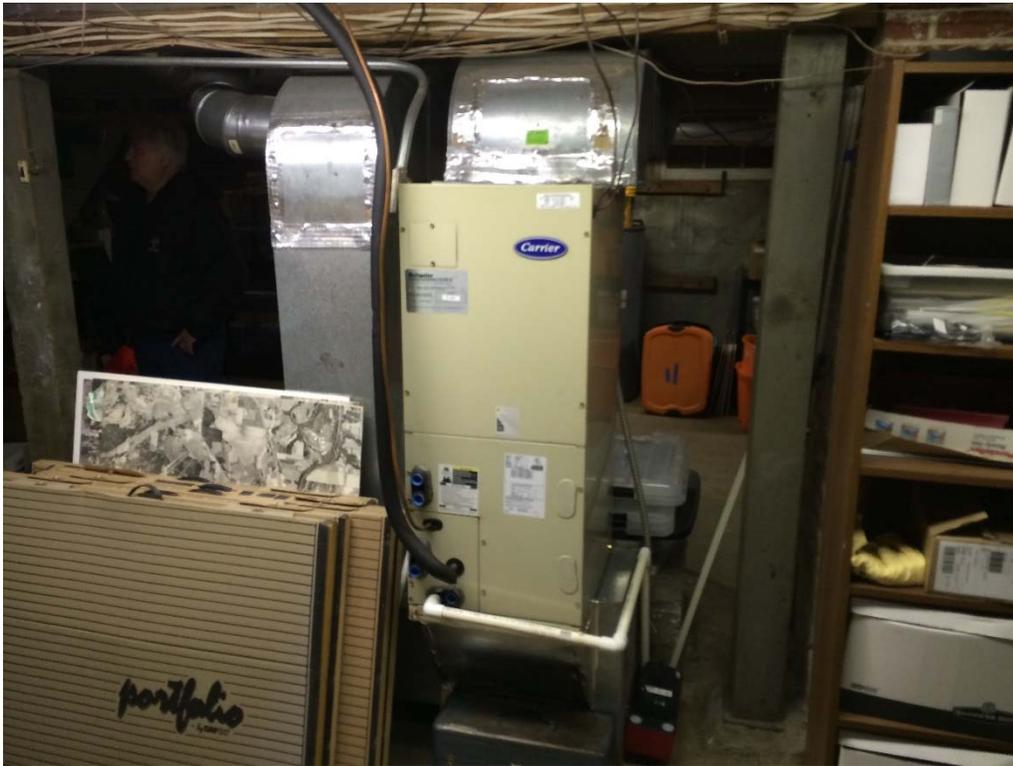
Figure D30.6 Air handler configuration and access at Basement

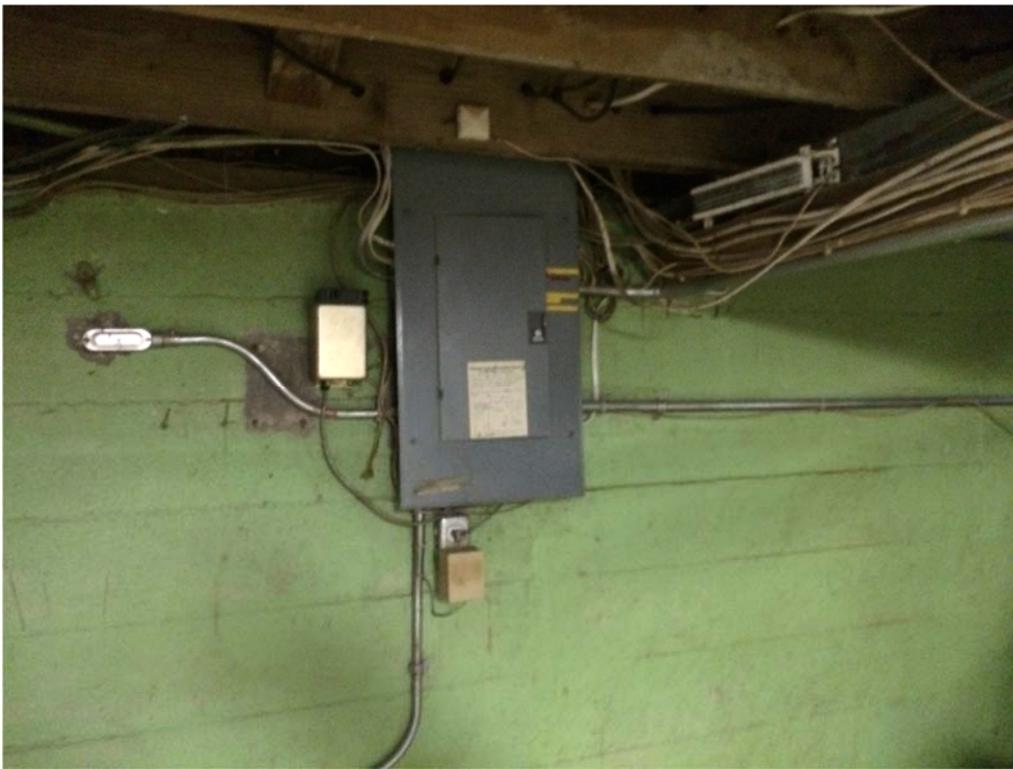
Figure D50.6 Electrical panel at Basement

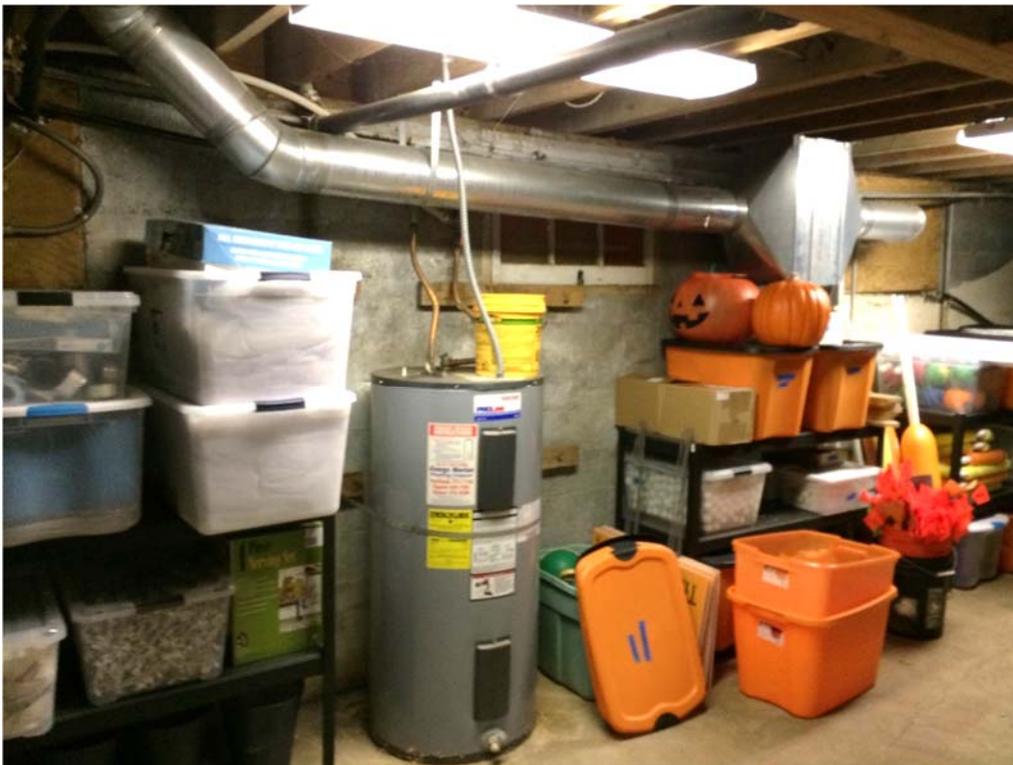
Figure E10.1 Water heater is restrained for seismic forces; clearances could be compromised

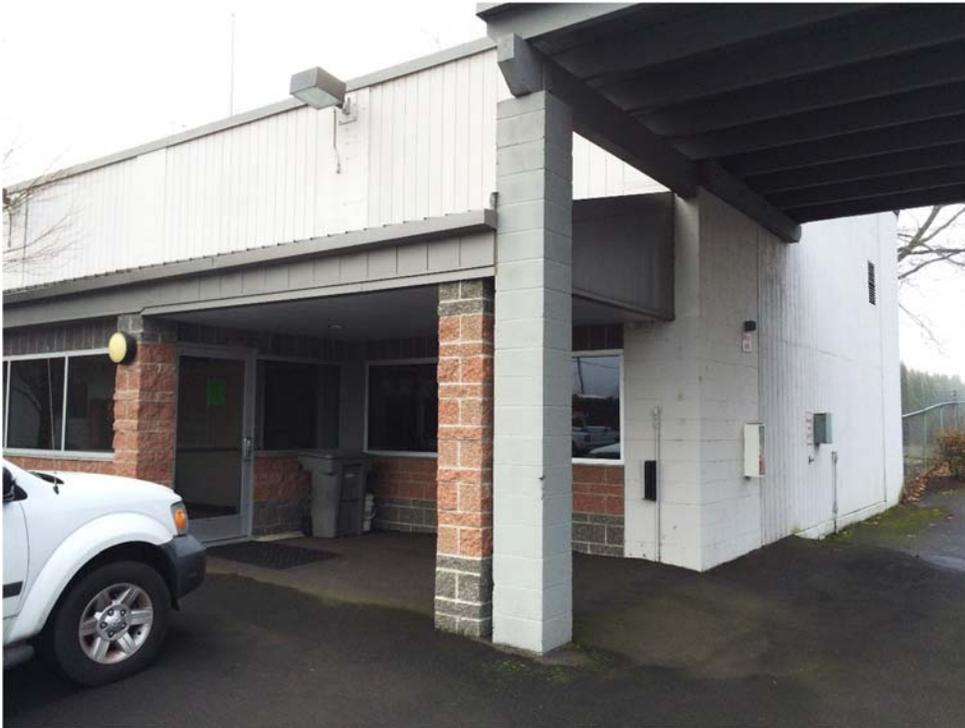
Figure B30.1A CMU corners and between former maintenance bays; T1-11 exterior plywood infill at front of building; split-faced CMU and aluminum storefront windows added for lobby

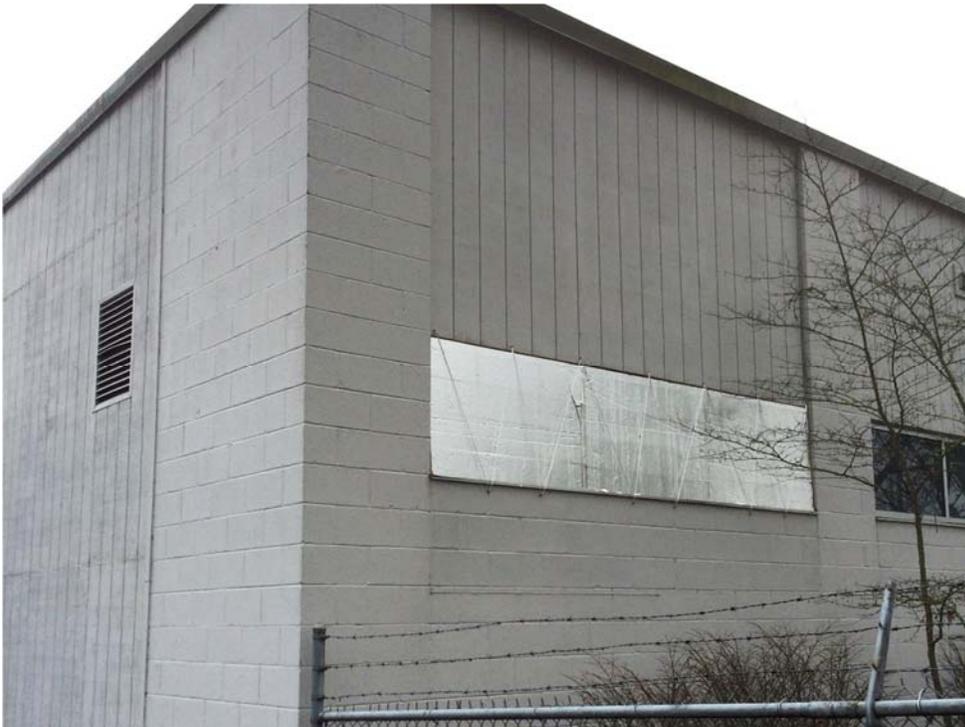
Figure B30.1B CMU corners and between former maintenance bays; T1-11 exterior plywood and CMU infill at rear of building; insulation added over west-facing windows (from Server room)

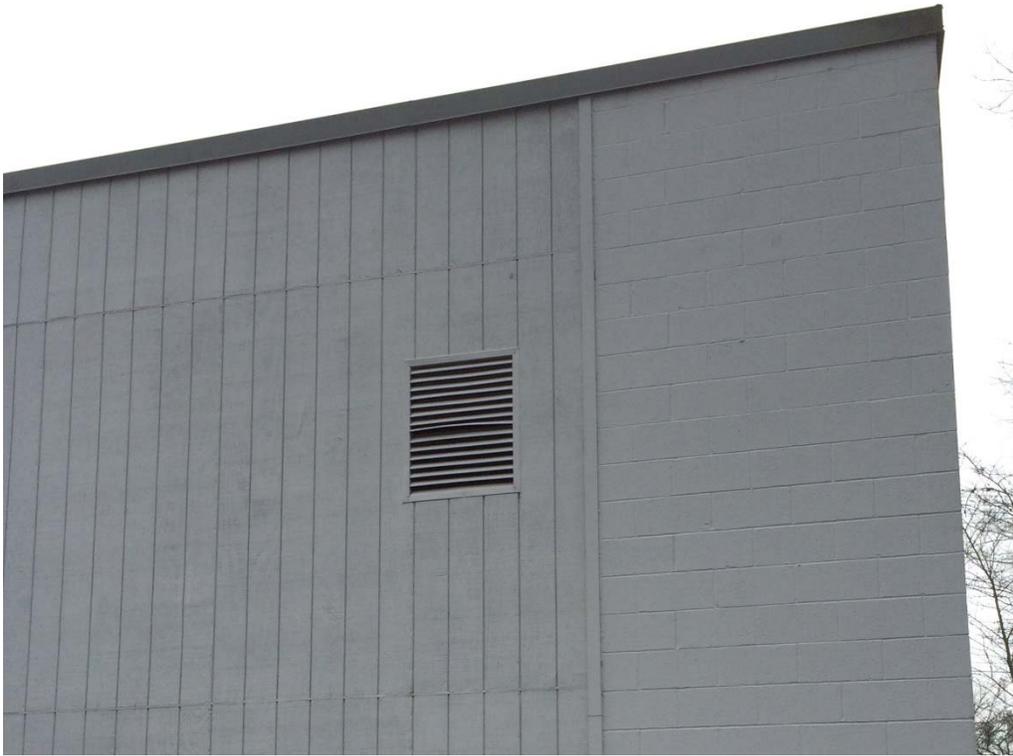
Figure B30.1C Louver at north is disused, staff noted that capped at interior

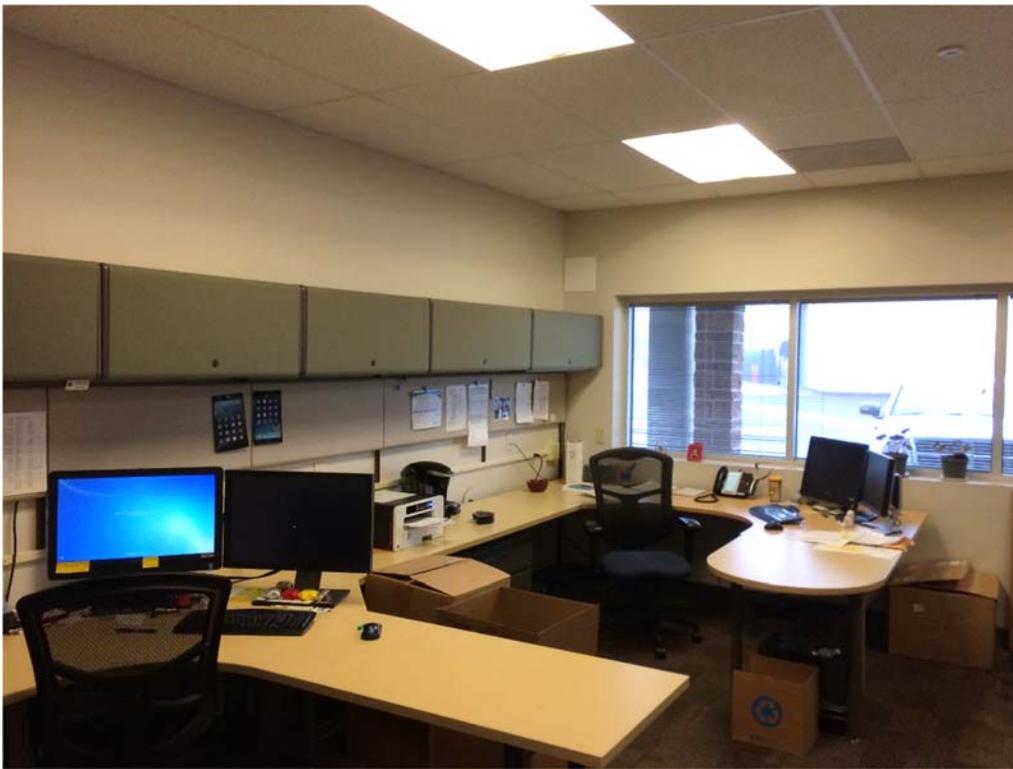
Figure C30.1 Interior finishes at IT space

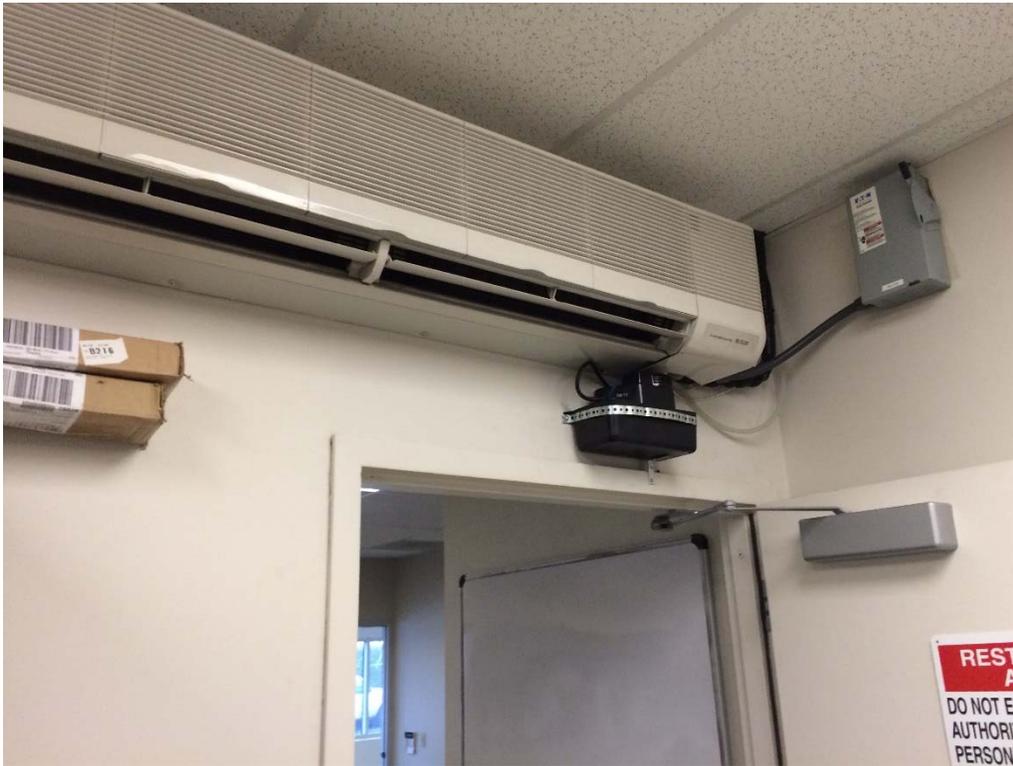
Figure D30.7 Split system HVAC at Server room; condensate pumped to disposal thru plenum

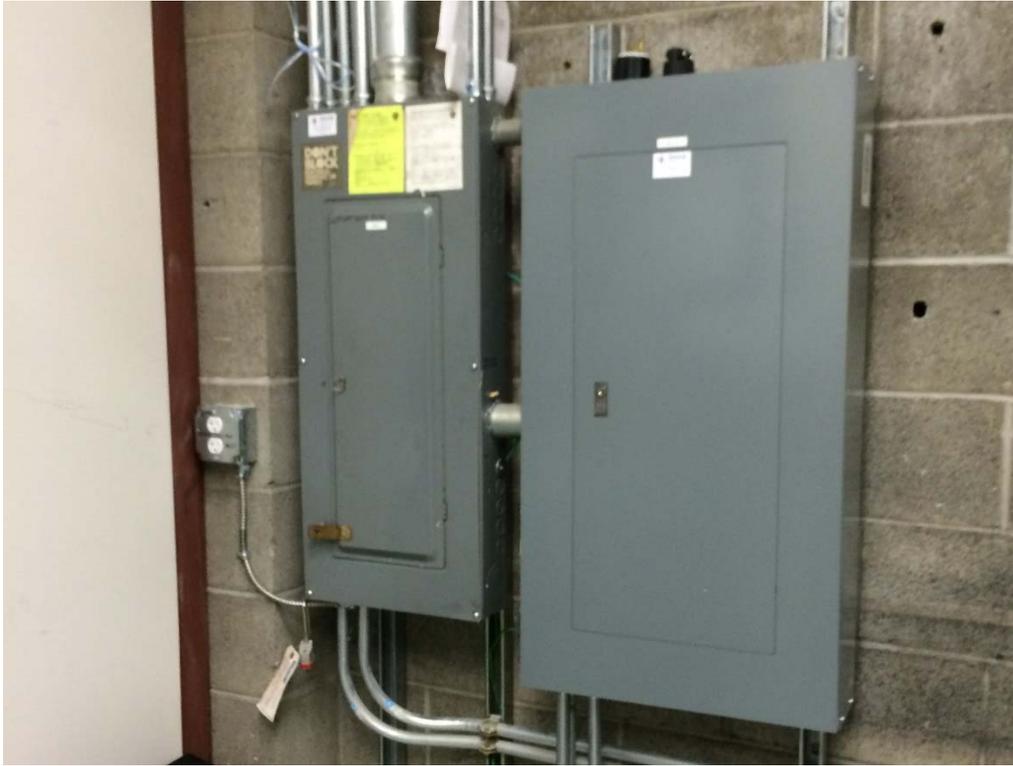
Figure D50.6 Panels F and FA for power to server racks and potentially devices/ loads in other spaces

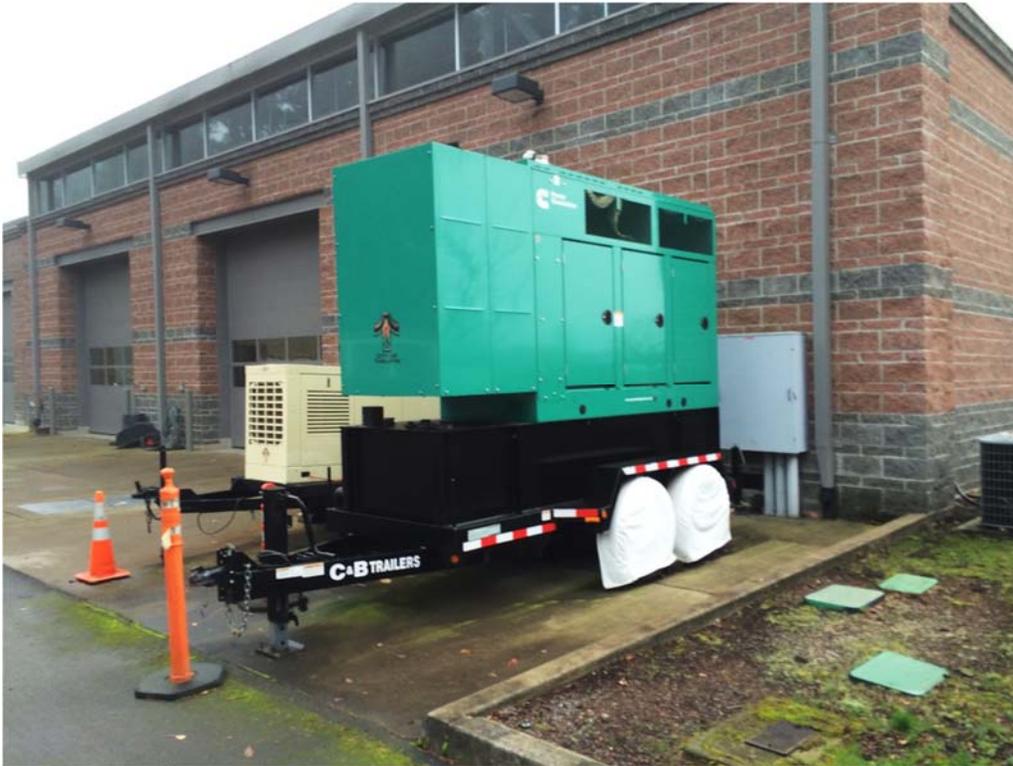
Figure D50.21 Trailer-mounted engine-generator set with base tank

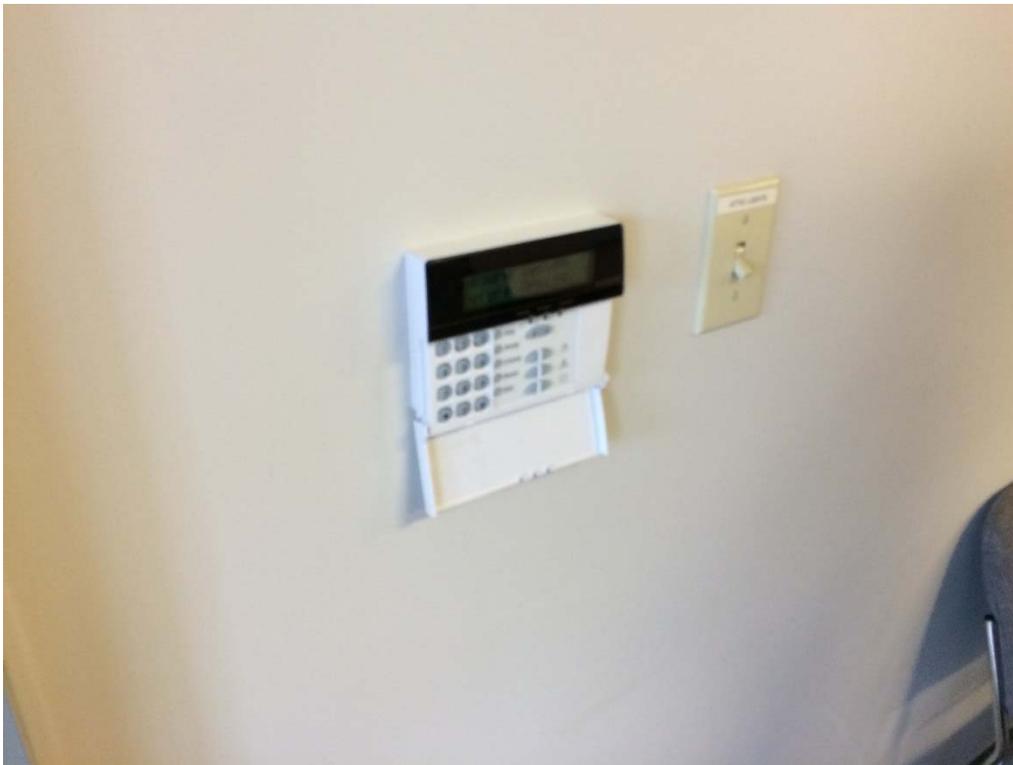
Figure G20.5 Punch key-coded alarm system within Information Services Office space

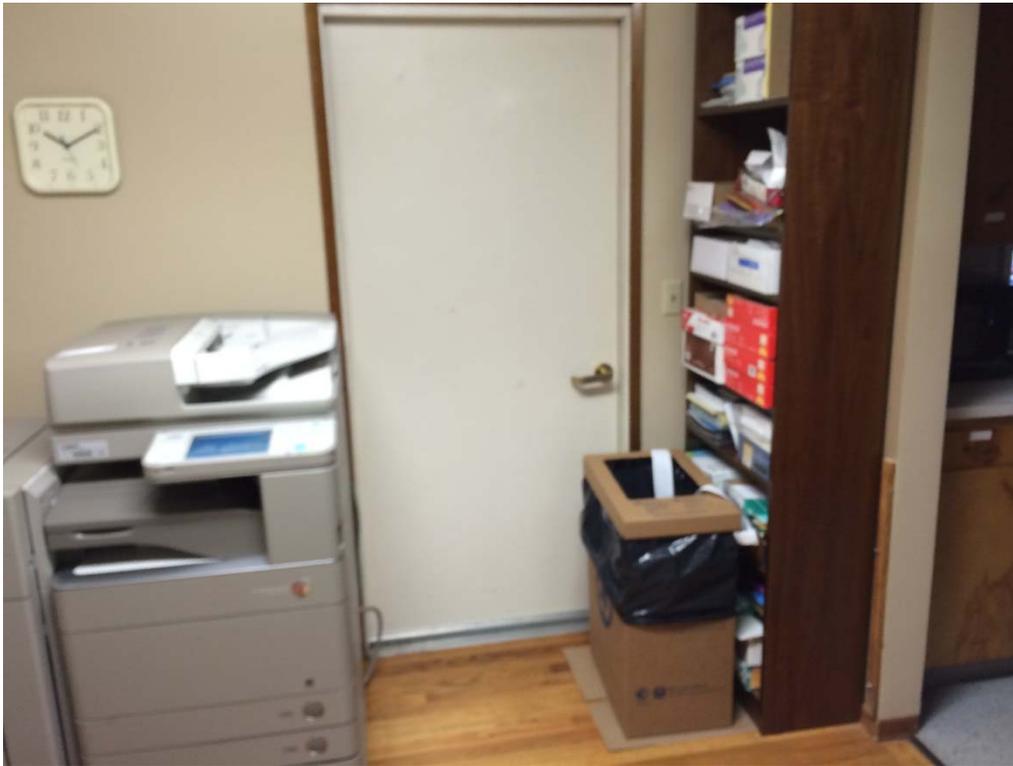
B10.5	If building has been remodeled, note the current use as compared to design loads.	<ul style="list-style-type: none"> Original function was as single-family residence; current function is as office space. It was observed that at several locations, storage and shelving may be imposing loads

that could be in excess of design loads; the crawlspace was not accessed in order to confirm locations of structure.
Recommendations		
B10.1	None	
B10.2	None	
B10.3.1	It should be confirmed whether during previous re-roofings additional plywood sheathing was added to improve diaphragm strength; this could be provided in upcoming re-roofing (refer to B10.4).	
B10.3.2	It should be confirmed whether Code required anchorage of wall framing and sill plates was required for the change of occupancy/ use from single-family residential to commercial office; this could be added.	
B10.4	None	
B10.5.1	It should be confirmed that locations currently bearing large furniture or file storage loads are adequately supported on structure below. It is recommended that loads be minimized and distributed where they are in the middle of rooms or not adjacent to major structural support below the floor.

Figure B10.5A Office functions impose loads differently than residential use

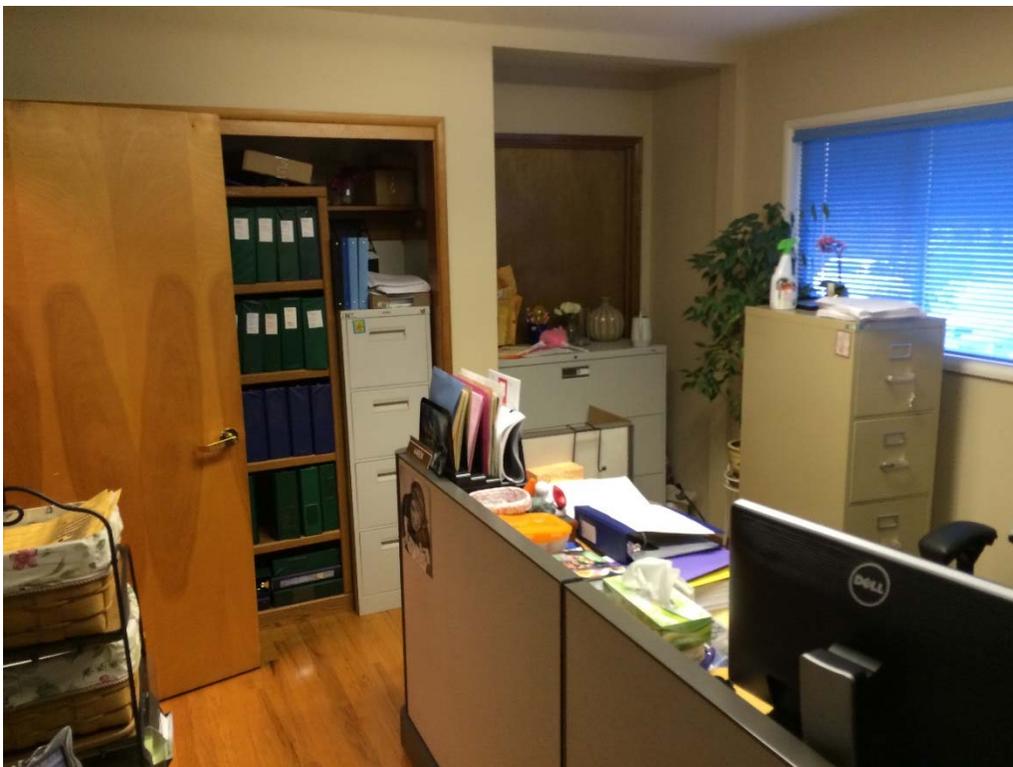
Figure B10.5B Office functions impose loads differently than residential use

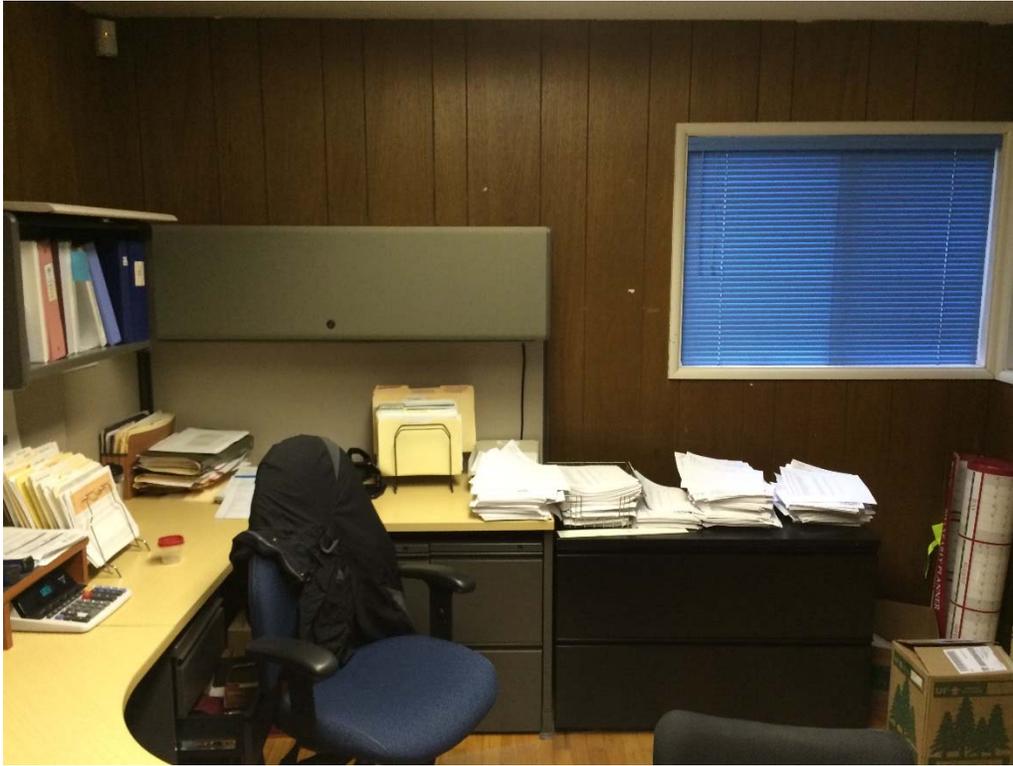
Figure B10.5C Office functions impose loads differently than residential use

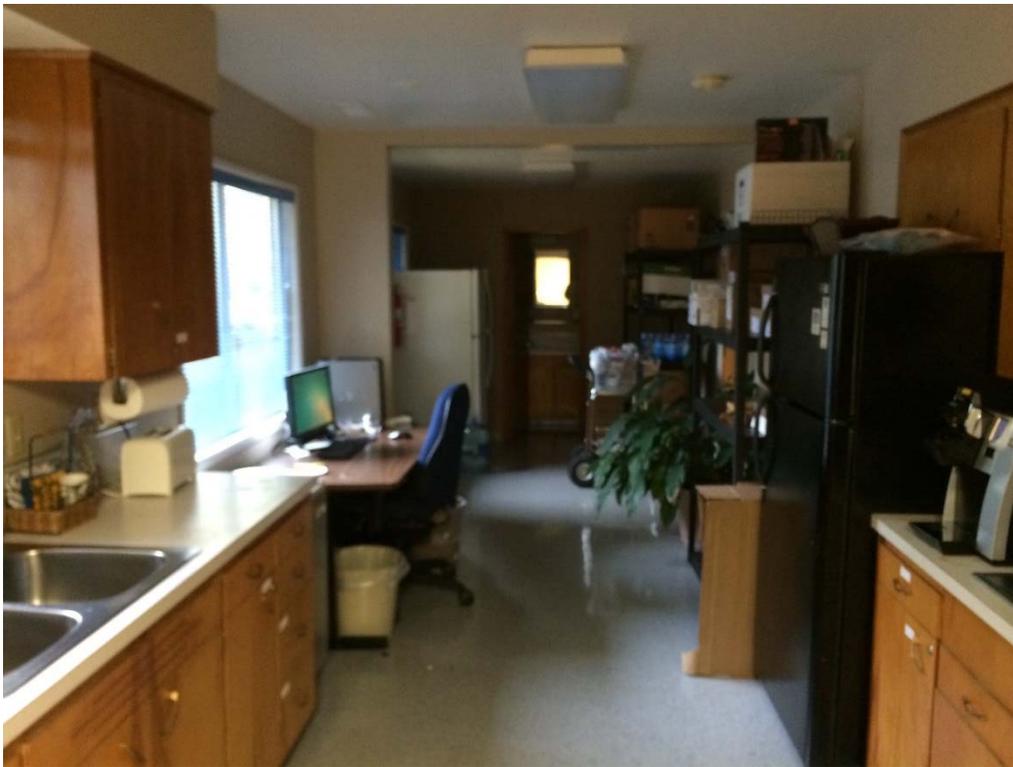
Figure B10.5D Office functions impose loads differently than residential use

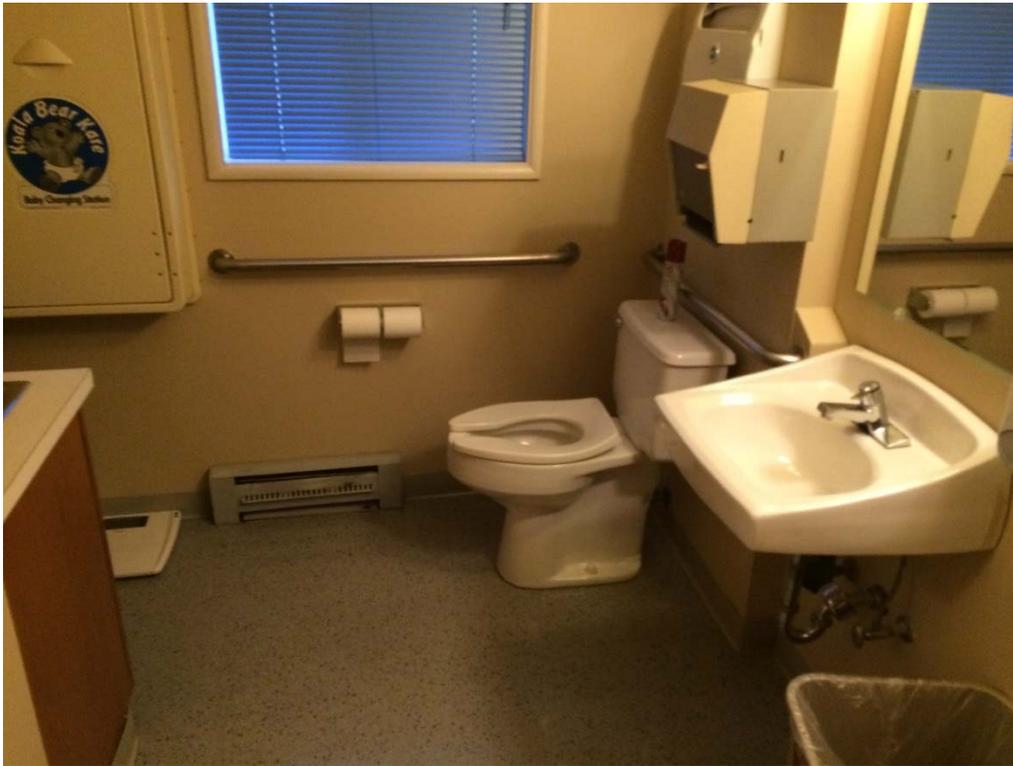
Figure C10.4B Accessible restroom conversion from residential

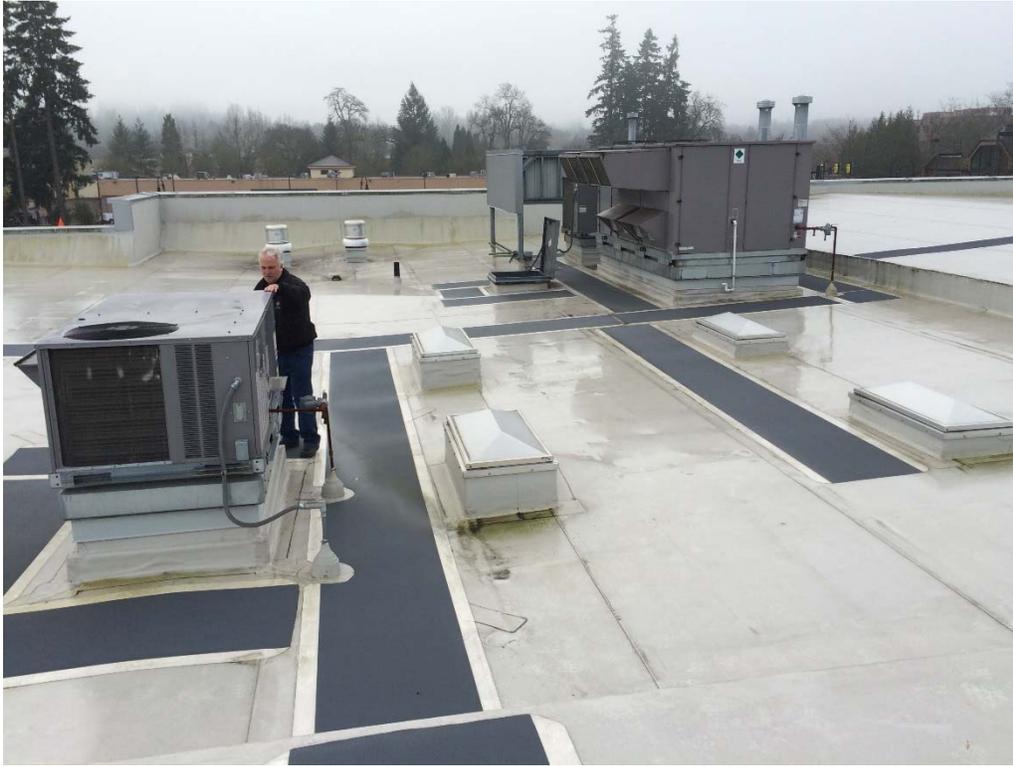
Figure B30.1 Rooftop conditions observed

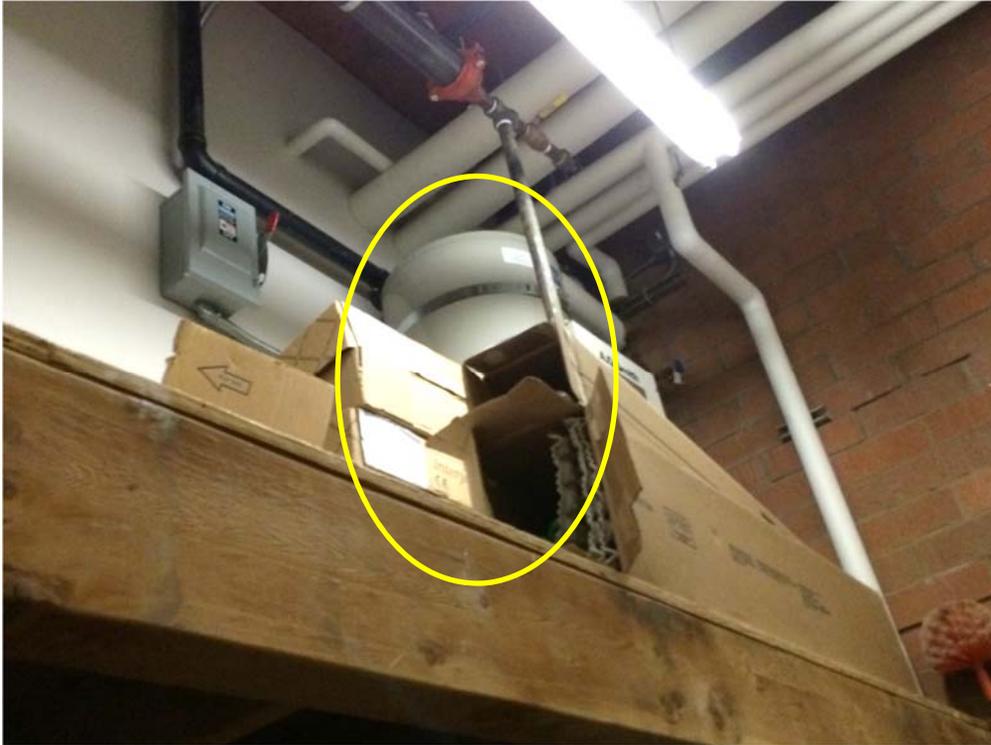
Figure D20.7 Water heater on wooden platform in Janitor room; appears to be seismically restrained; maintenance compromised by storage and limited access

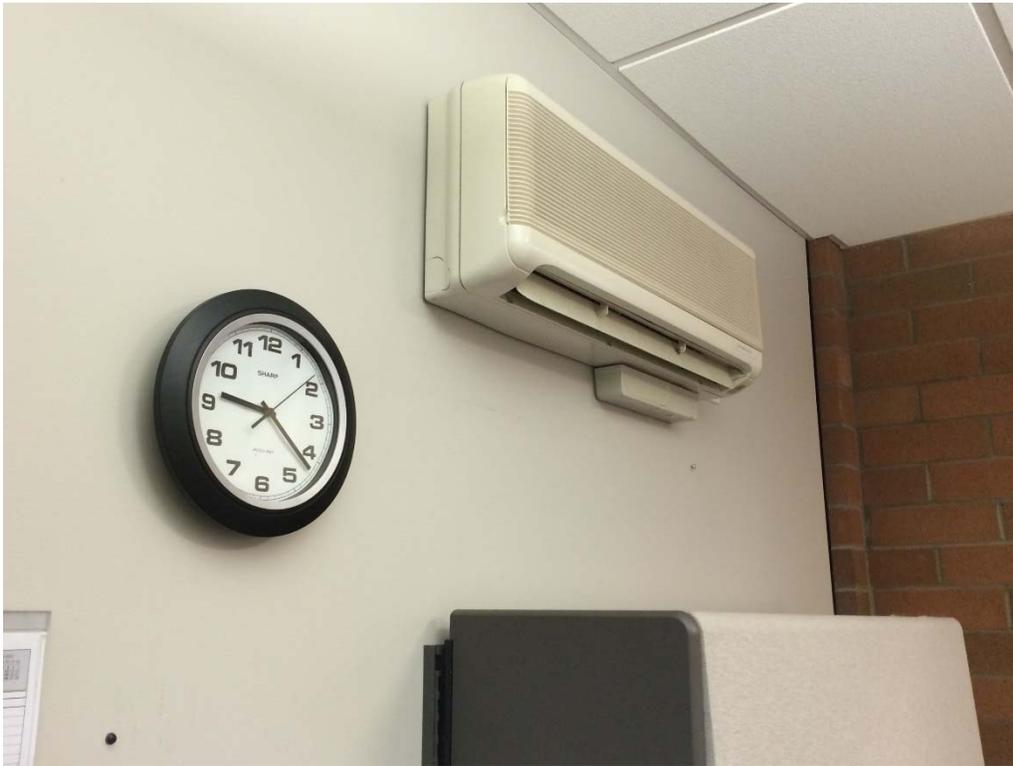
Figure D30.4B Remote split systems provided at south-facing offices in original portion of building

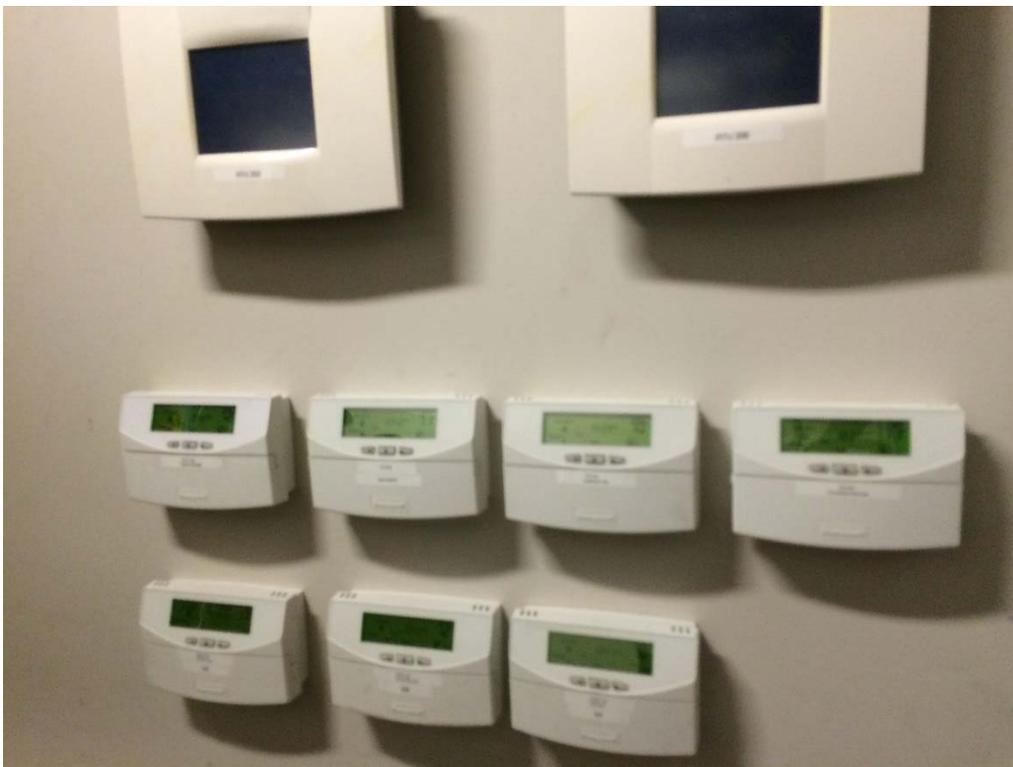
Figure D30.8 HVAC controls at Library

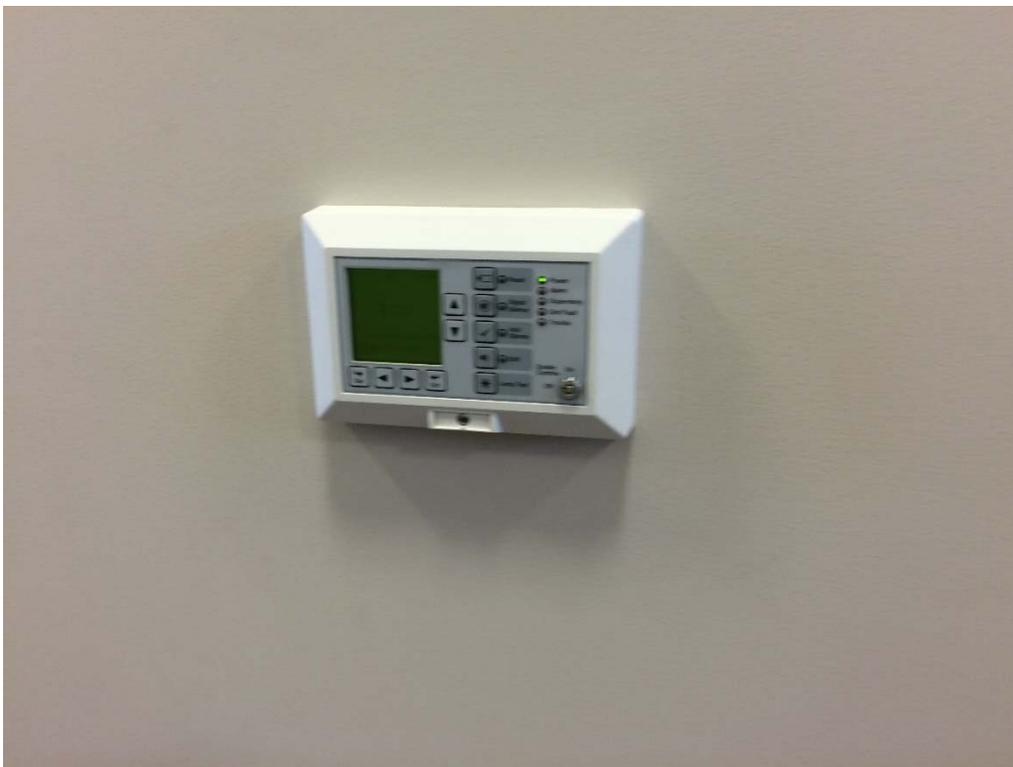
Figure D40.12 Fire alarm remote annunciator at Lobby

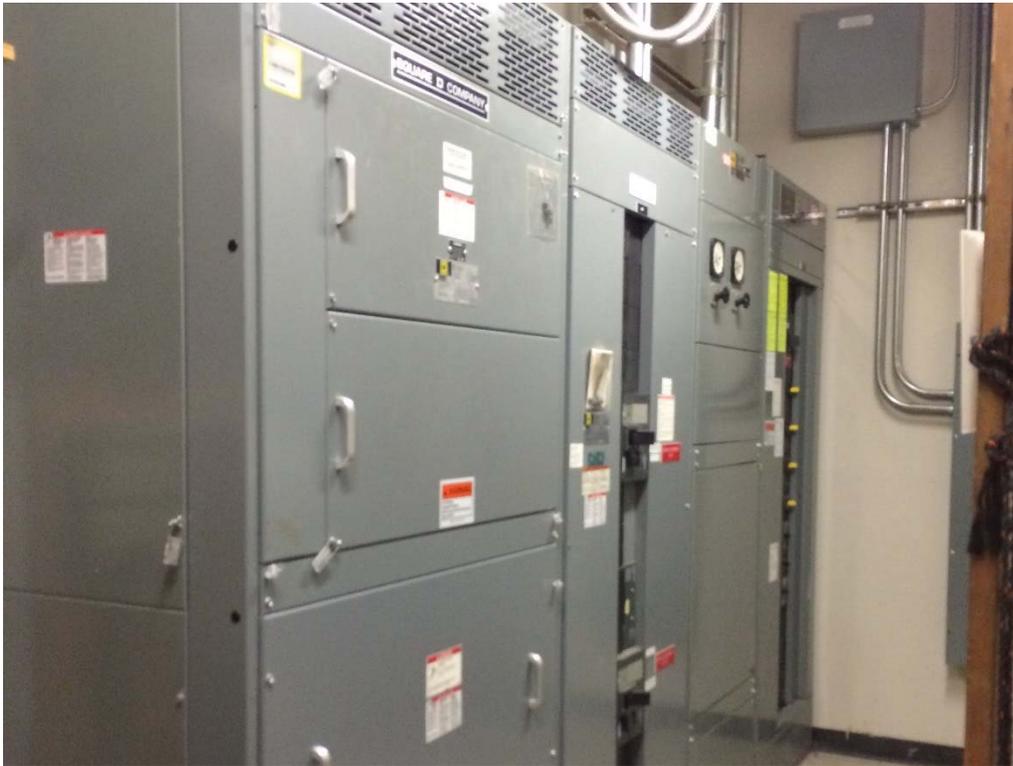
Figure D50.11 Main distribution equipment serves both portions of the facility from Electrical room

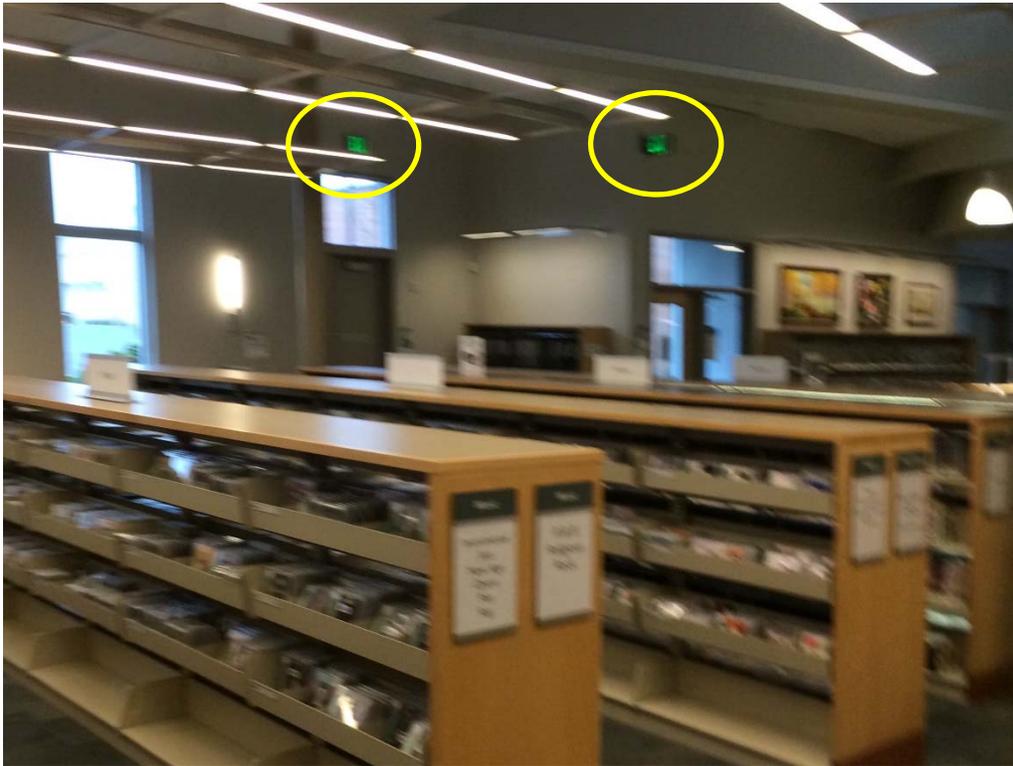
Figure D50.27 Typical exit signage is appropriately placed

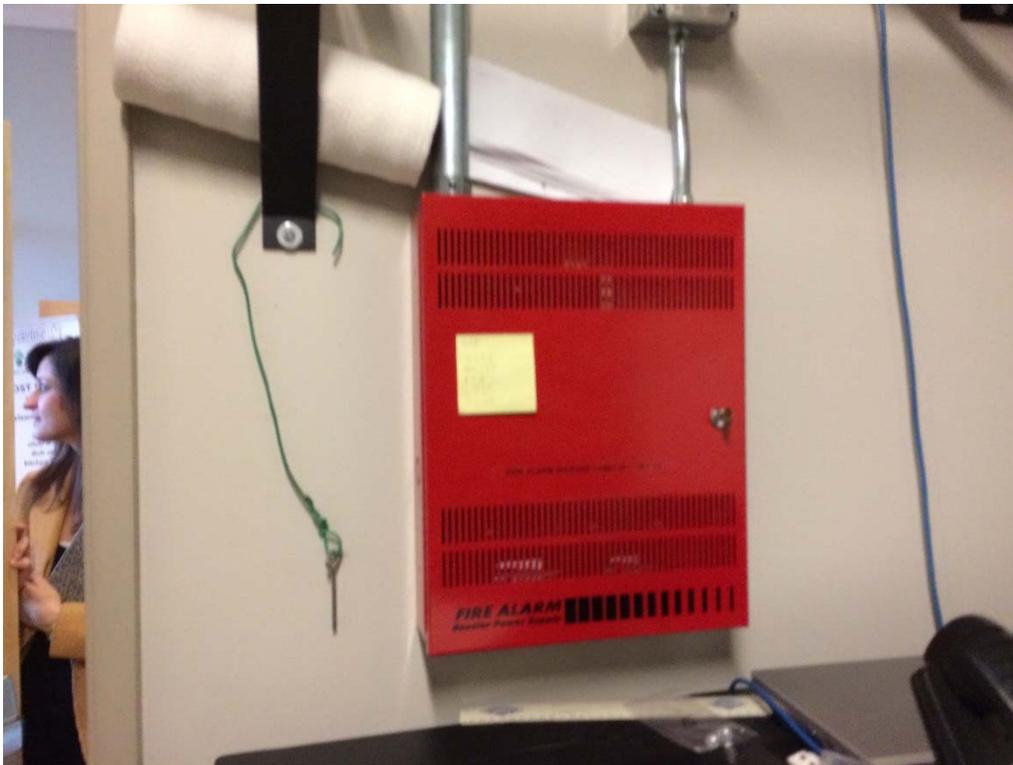
Figure D60.1 Main fire alarm panel in IDF room adjacent to Library Lobby

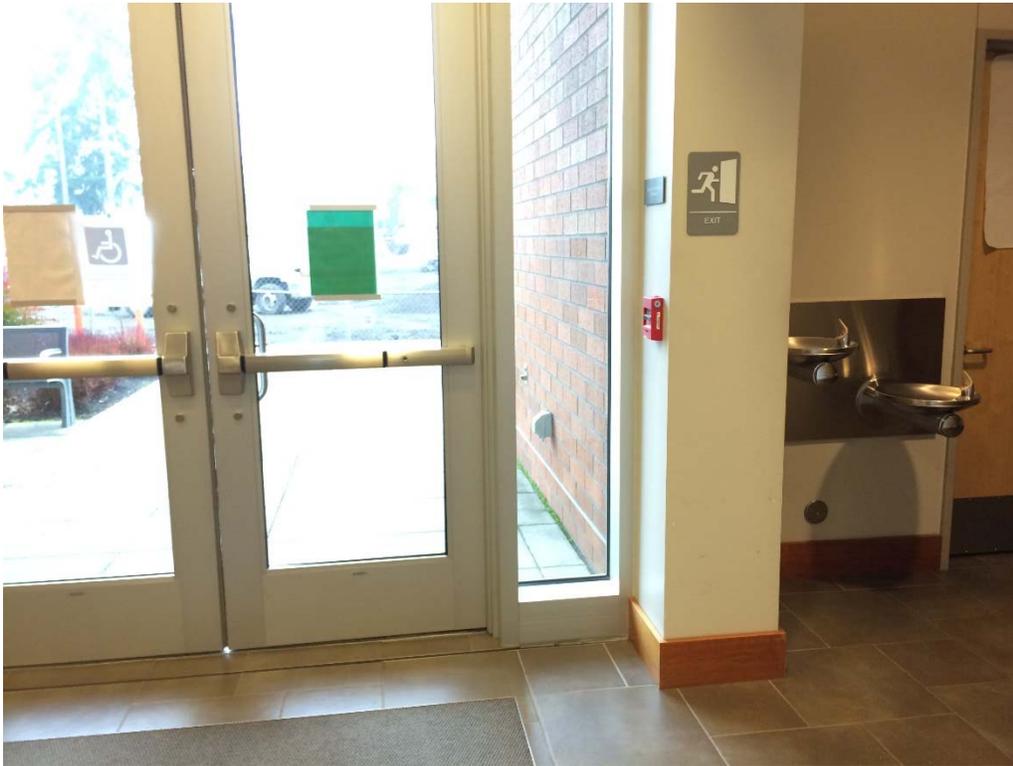
Figure D60.3 Typical fire alarm pull at building entrance/ egress doors

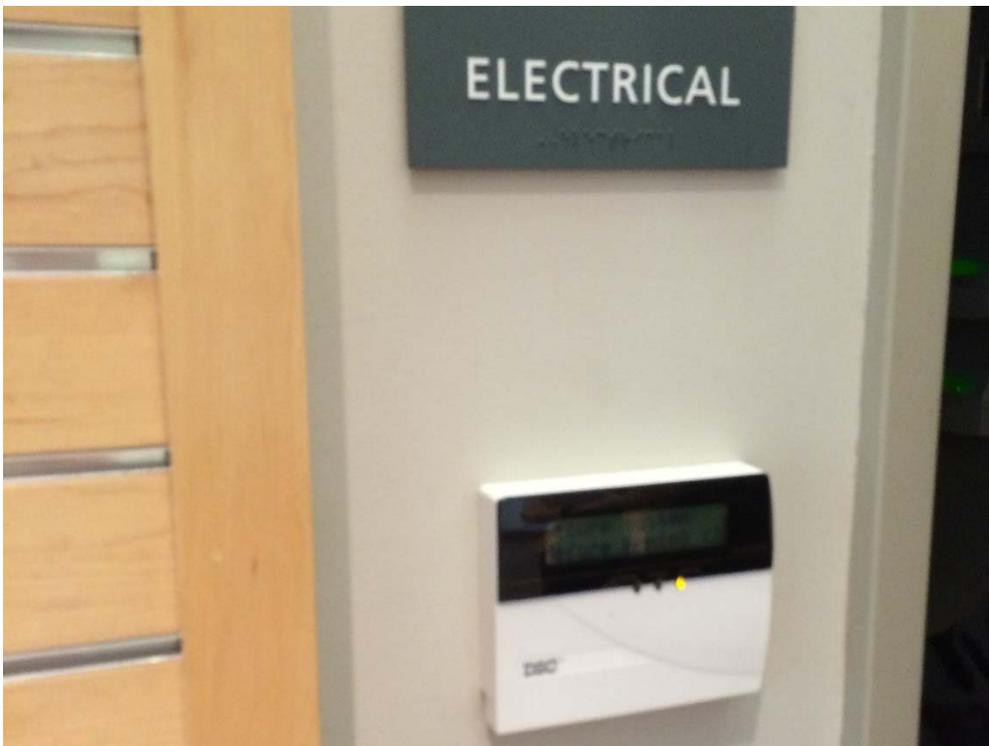
Figure G20.3A Security alarm remote keypad at Library Lobby adjacent to Electrical Room door

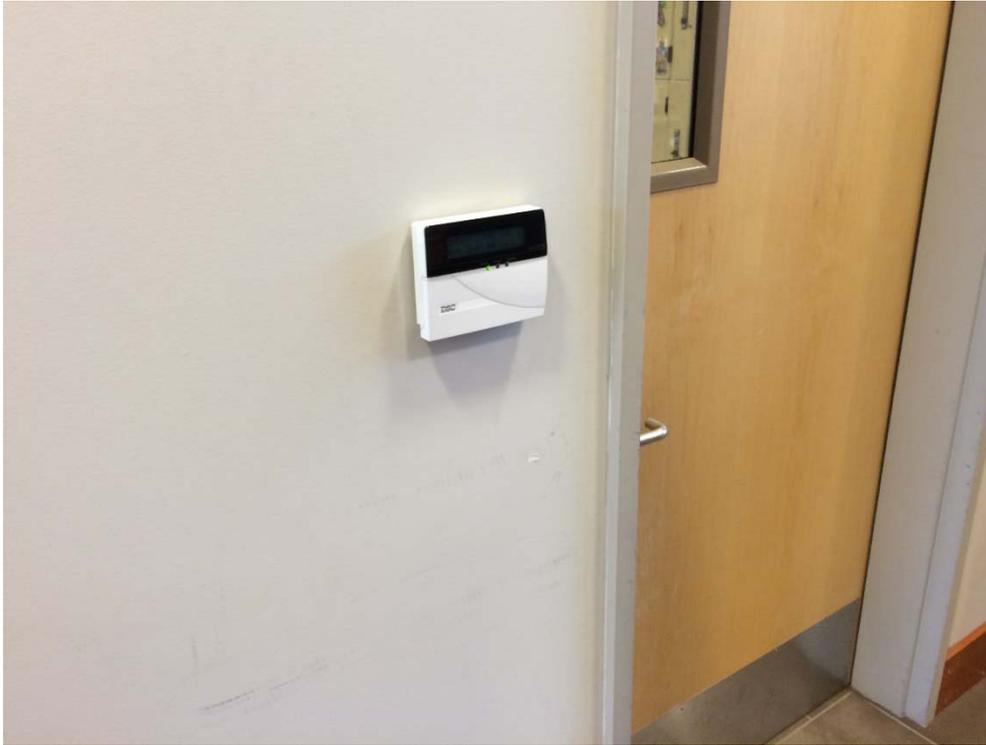
Figure G20.3B Security alarm remote keypad at City offices Lobby adjacent to door from City Offices Lobby to Library Work Room
