City of Tualatin

CITY FACILITIES STUDY

FACILITIES ASSESSMENTS *report*

YOST GRUBE HALL
ARCHITECTURE

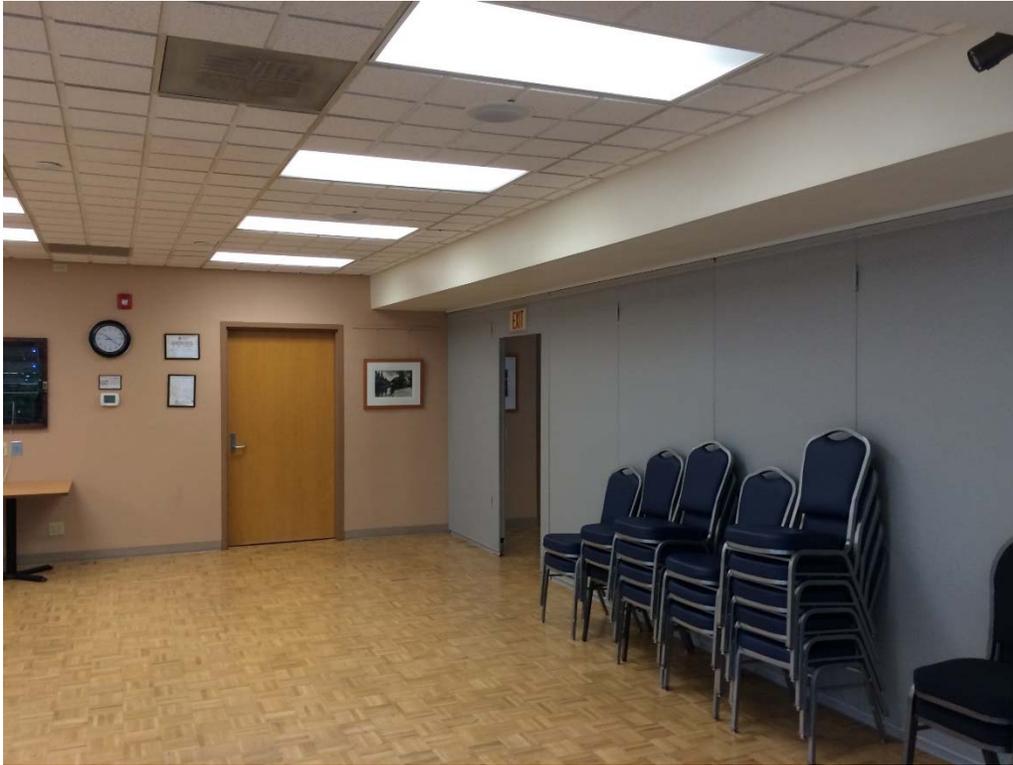
C30 – INTERIOR FINISHES		
Item		Comments/Findings
C30.1	General type and condition of finishes	<ul style="list-style-type: none"> • Wall finishes in Activity Room space are painted gypsum wallboard; movable wall panels with fabric-faced finish are used for sound control and to enclose the space for meeting activities • Floor finishes in Activity Room space are oak wood parquet flooring with clear finish; all flooring appears to be in good condition • Ceiling finishes are acoustic ceiling tile, with soffits of painted gypsum wallboard • Plastic laminate cabinetry and interior wood veneer doors are provided in the space
C30.2	Locations and cause of water intrusion/ leaks	<ul style="list-style-type: none"> • None were observed
C30.3	Other issues	<ul style="list-style-type: none"> • None
Recommendations		
C30.1	None	
C30.2	None	
C30.3	None

Figure C30.1A Interior finishes Activity Room space

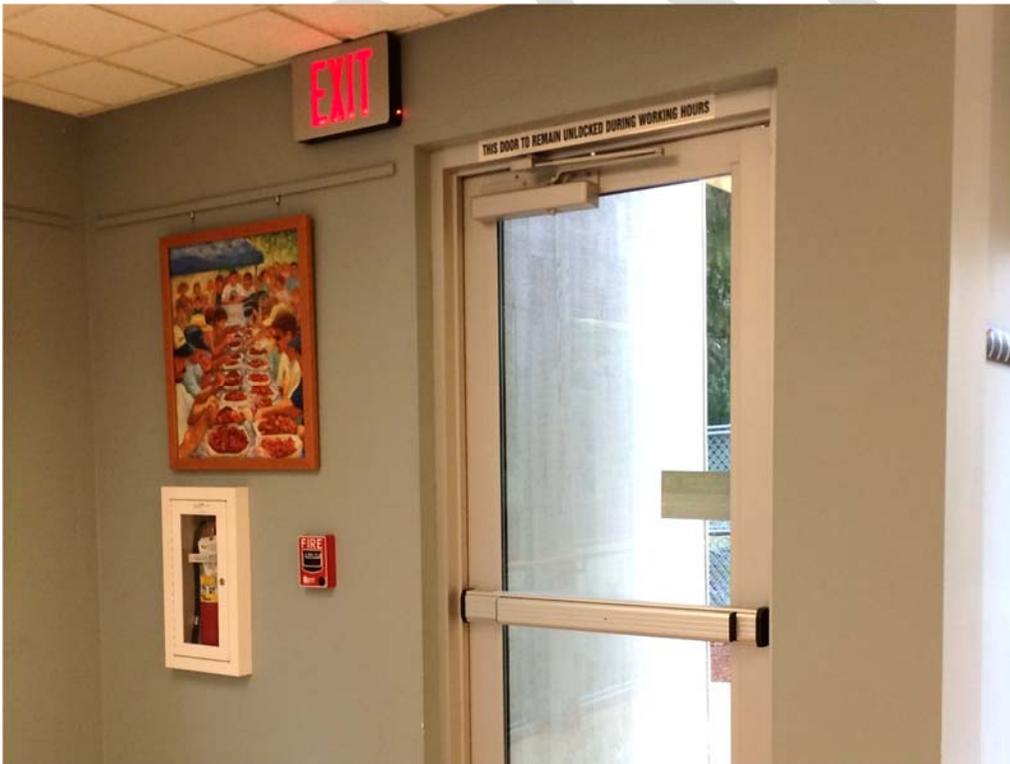
D40 – FIRE PROTECTION		
Item		Comments/Findings
D40.1	Fire suppression system	<ul style="list-style-type: none"> • None
D40.2	Water service, backflow prevention	<ul style="list-style-type: none"> • N/A
D40.3	System pressure	<ul style="list-style-type: none"> • N/A
D40.4	Standpipes	<ul style="list-style-type: none"> • N/A
D40.5	Fire pump	<ul style="list-style-type: none"> • N/A
D40.6	Fire sprinkler pipe condition	<ul style="list-style-type: none"> • N/A
D40.7	FDC	<ul style="list-style-type: none"> • N/A
D40.8	Fire sprinkler zoning	<ul style="list-style-type: none"> • N/A
D40.9	Flow monitoring and alarm	<ul style="list-style-type: none"> • N/A
D40.10	On-site water source	<ul style="list-style-type: none"> • N/A
D40.11	Test records	<ul style="list-style-type: none"> • N/A
D40.12	Condition of fire hose or fire extinguishers	<ul style="list-style-type: none"> • Fire hose is not provided (not required by Code; not encouraged by Fire Dept.) • Fire extinguishers is located in space, adjacent to rear egress; observed to have up-to-date inspection

Figure D30.6 Staff photo of air handler configuration and access above Activity Room space

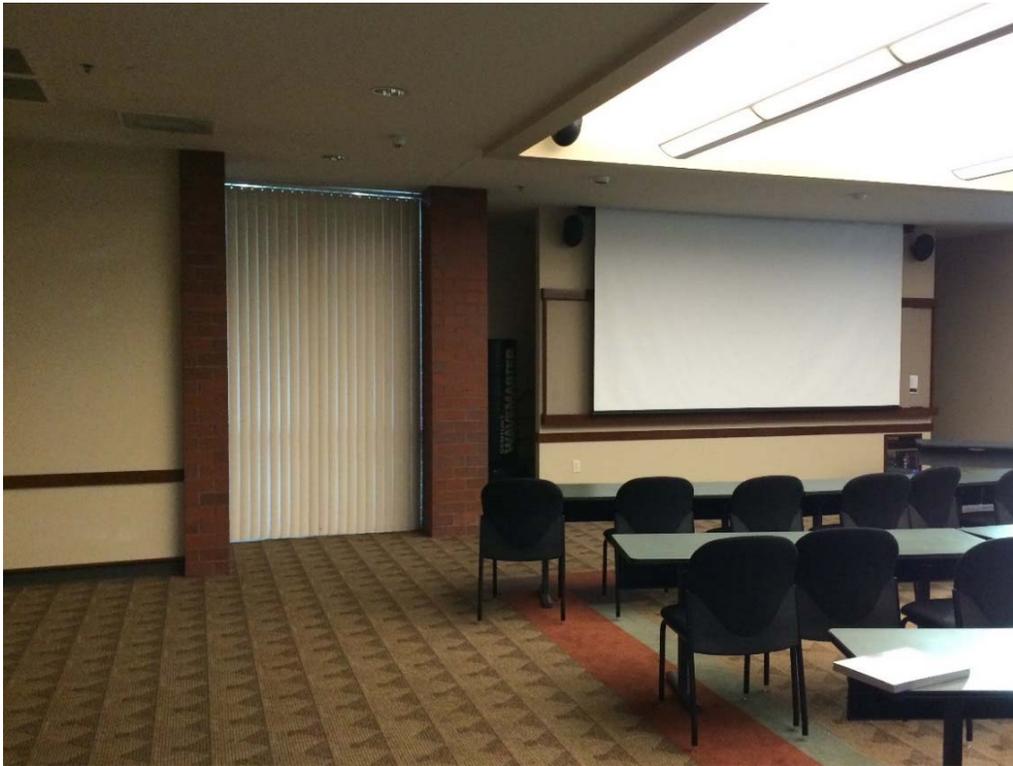
Figure C30.1A Interior finishes Training Room space

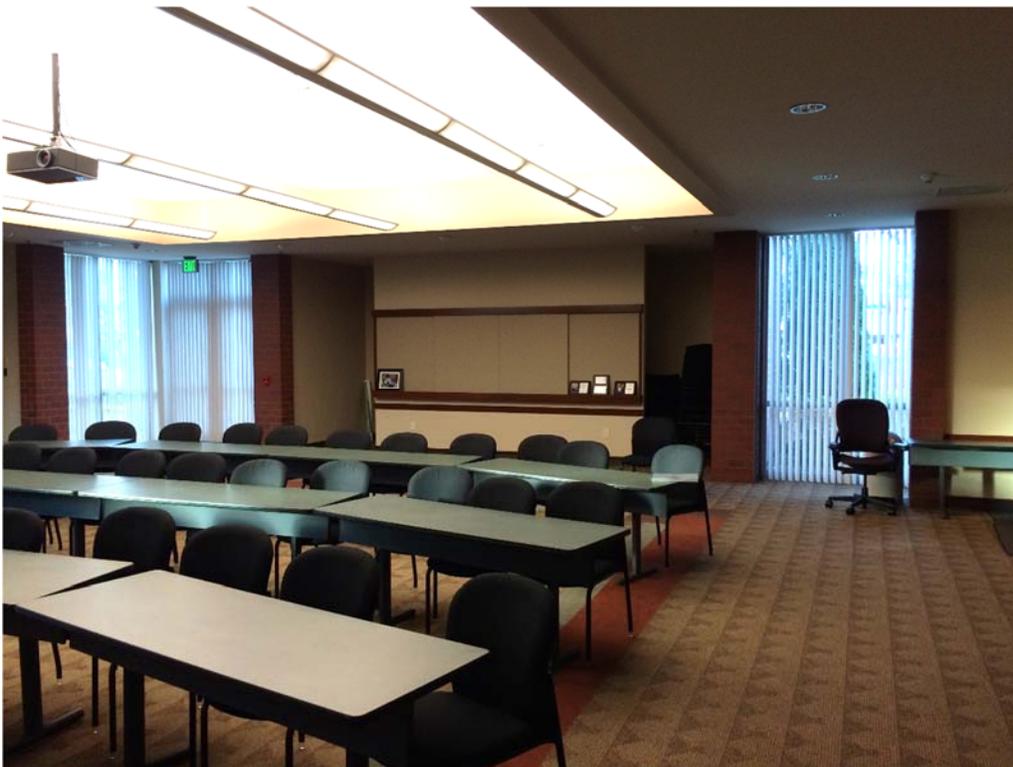
Figure C30.1B Interior finishes Training Room space

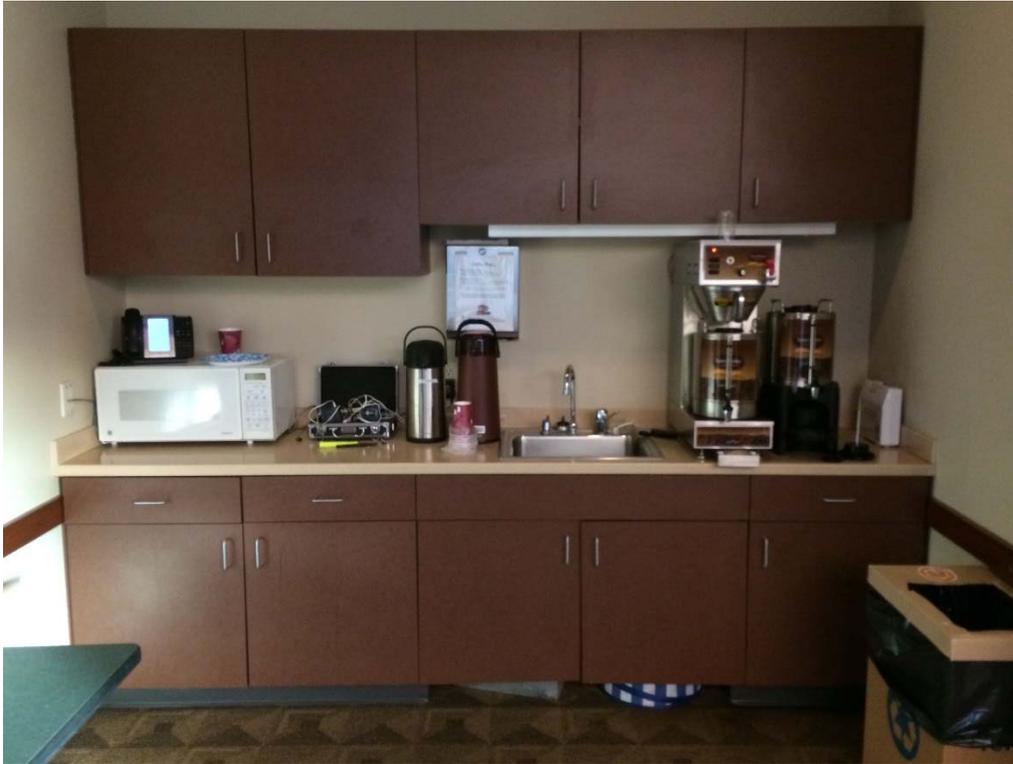
Figure C30.1C Interior finishes at kitchenette within Training Room space

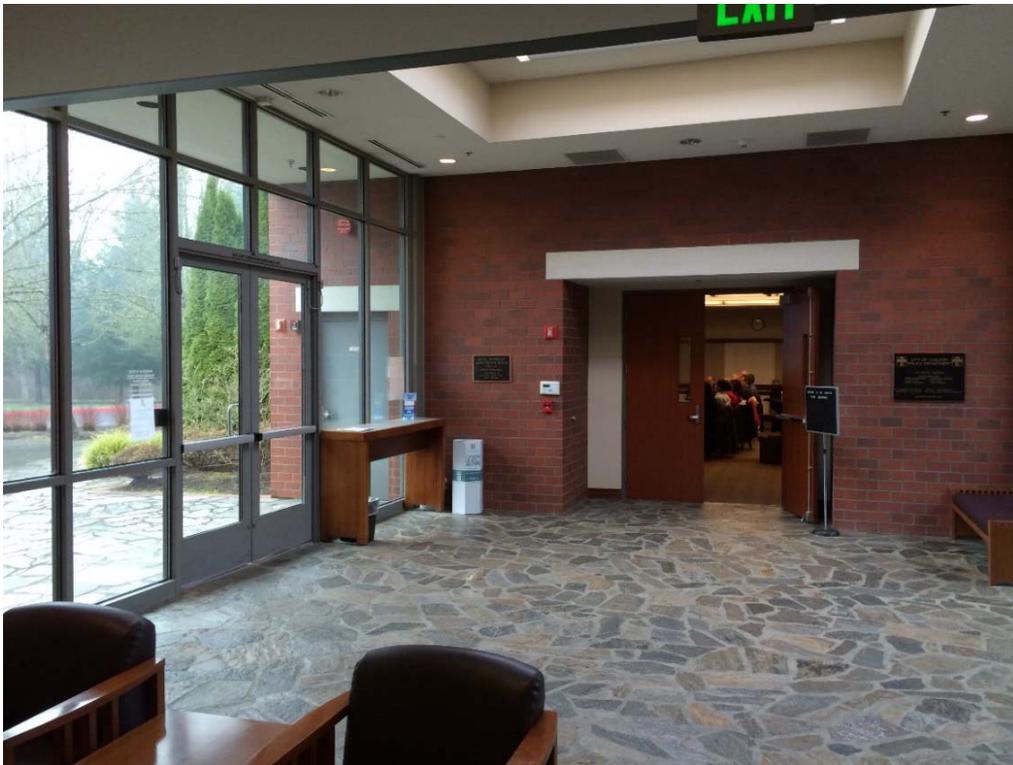
Figure C30.1D Interior finishes in Lobby outside Training Room space

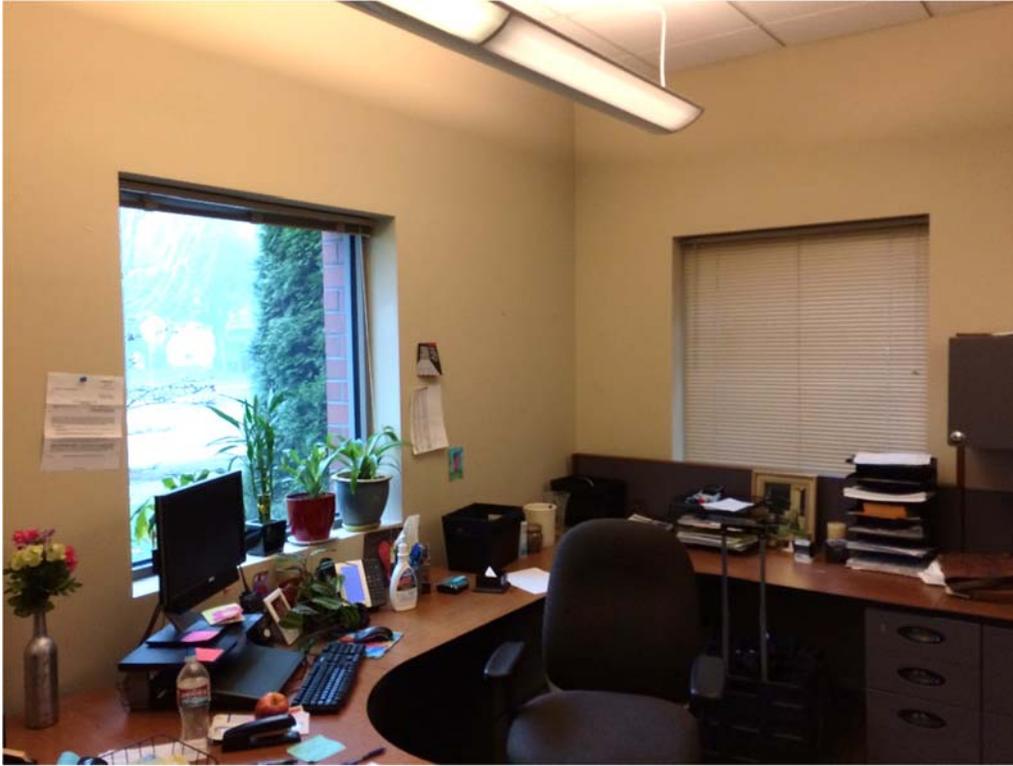
Figure C30.1E Interior finishes Municipal Court shared work space areas (Records room; Prevention room similar)

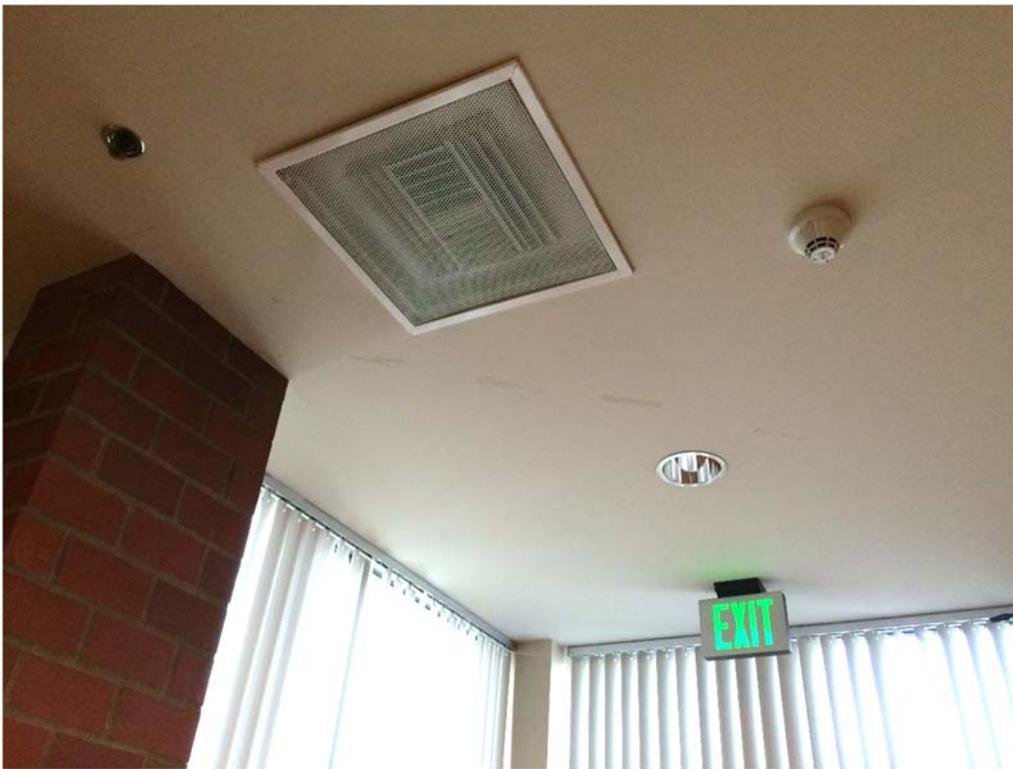
Figure D50.27 Typical exit signage; also typical fire detection and fire suppression

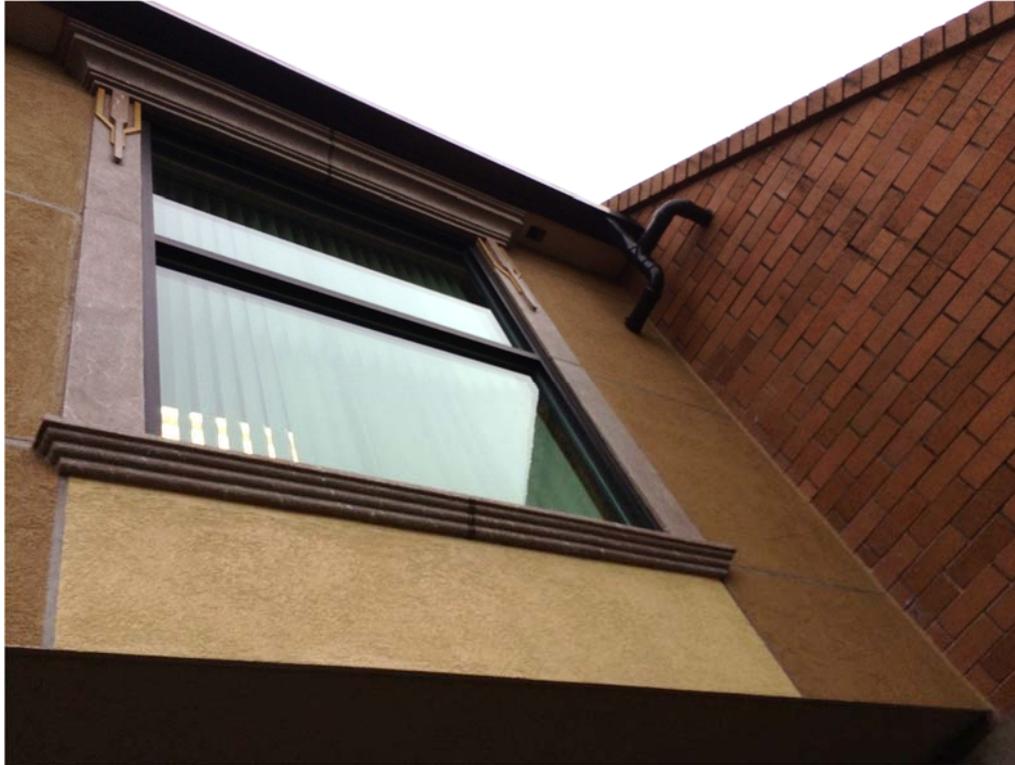
Figure B30.1 Metal roof edge, flashings and gutters appear to be in good condition

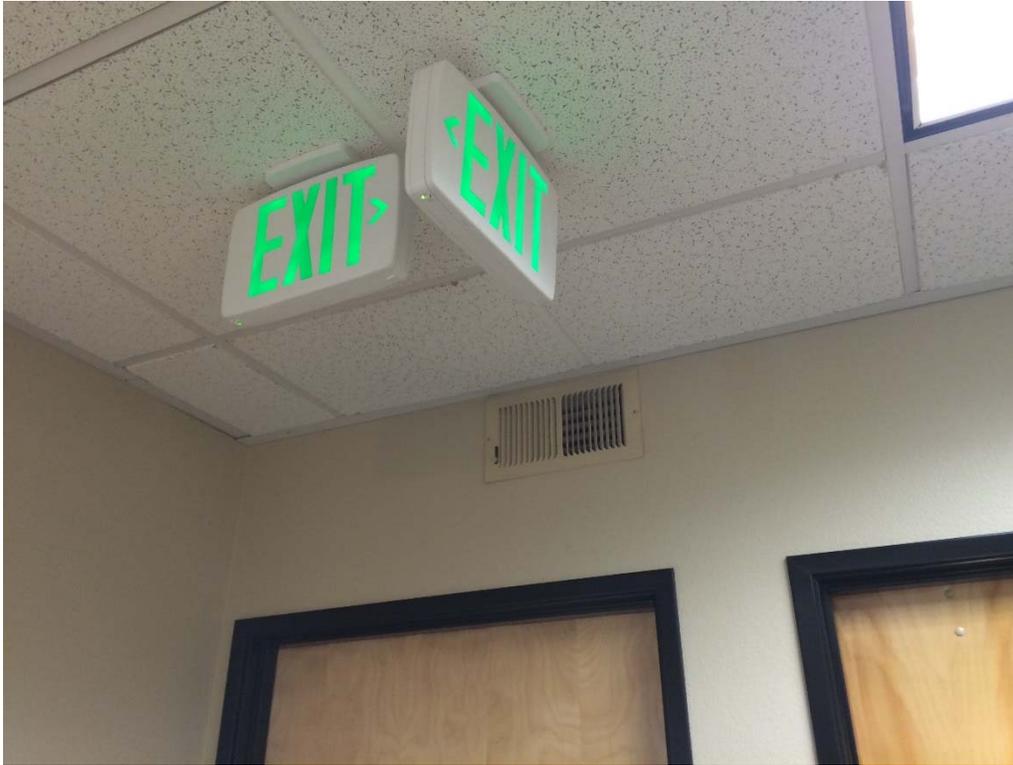
Figure D50.27 Typical exit signage at common area corridor
